SUDAN & NUBIA

2021

Building E at Damboya, second season

Gabrielle Choimet

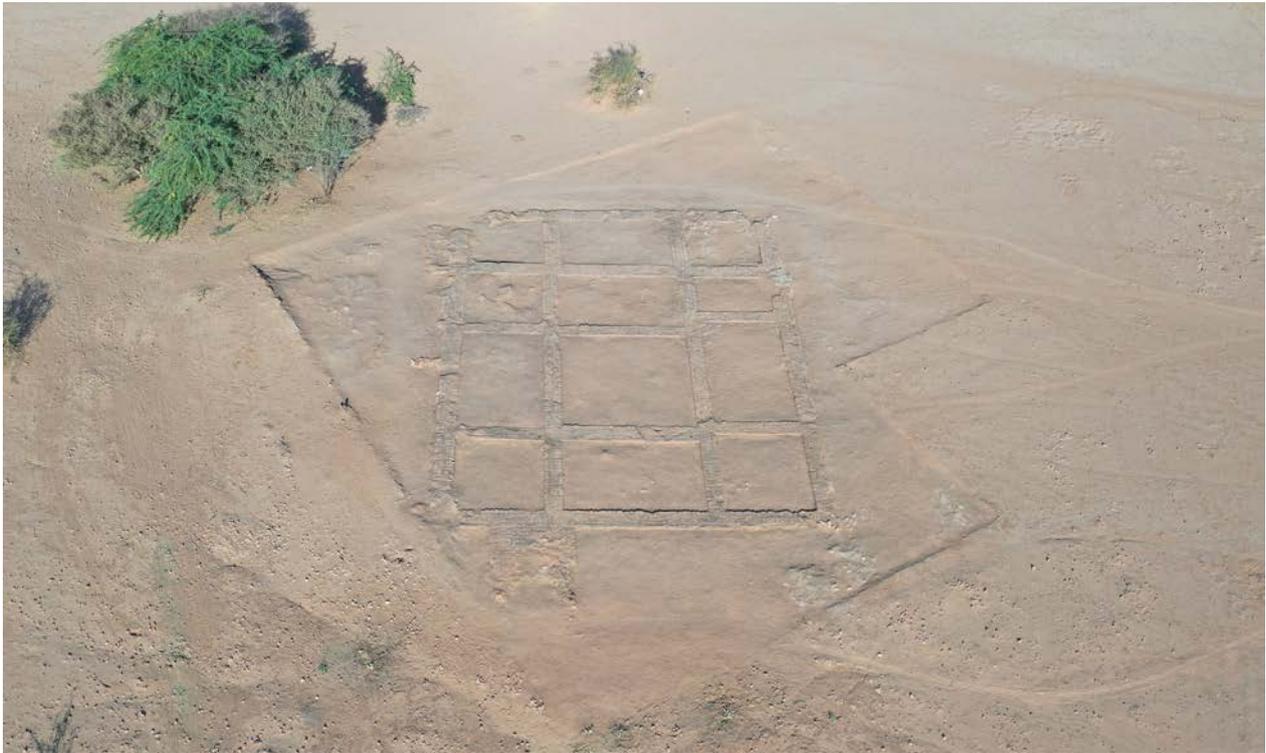
Figure 1. Aerial photo of Sector E from the southeast after the 2020 surface cleaning (© SFDAS).

Located on the northern slope of the main kom of Damboya (Sector G), Building E was discovered and completely exposed in 2020 in order to produce a comprehensive plan (Figure 1). On this occasion, a few ancillary structures were uncovered, including a probable second building (Walls F025 and F026) approximately 3m southwest of Building E, which appeared to be parallel to it (Choimet 2020, fig. 10).

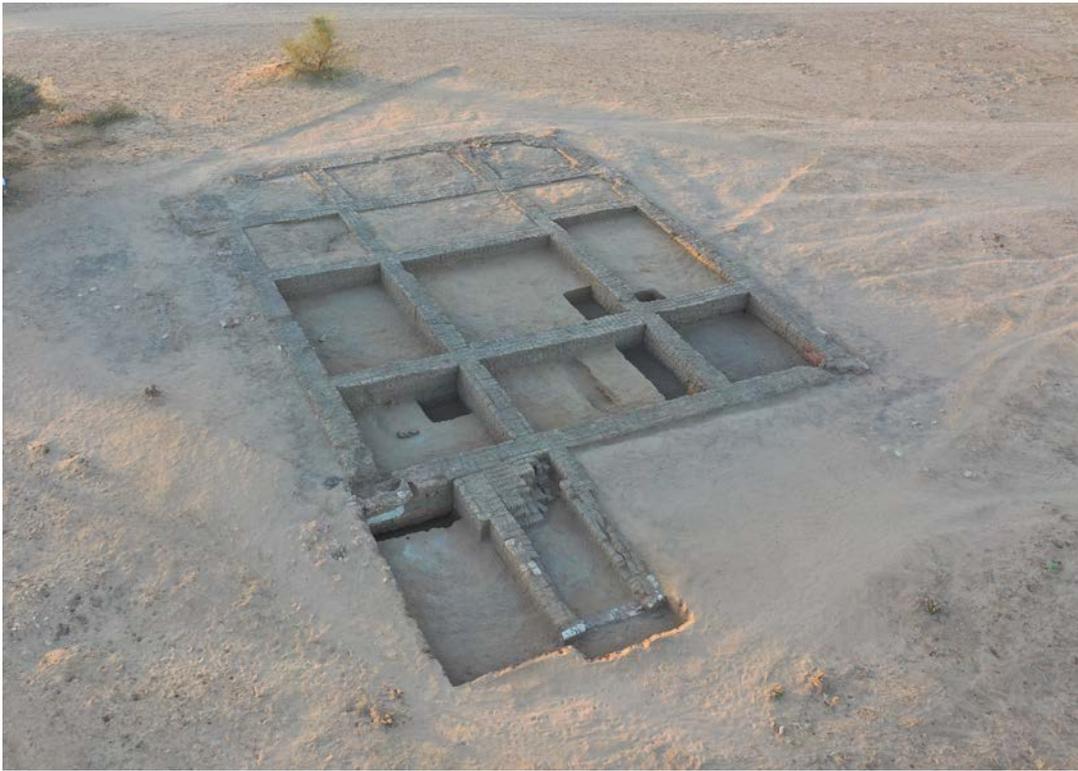
Figure 2. Aerial photo of Sector E after the 2021 excavation. Ramp F003 in the foreground (© SFDAS).

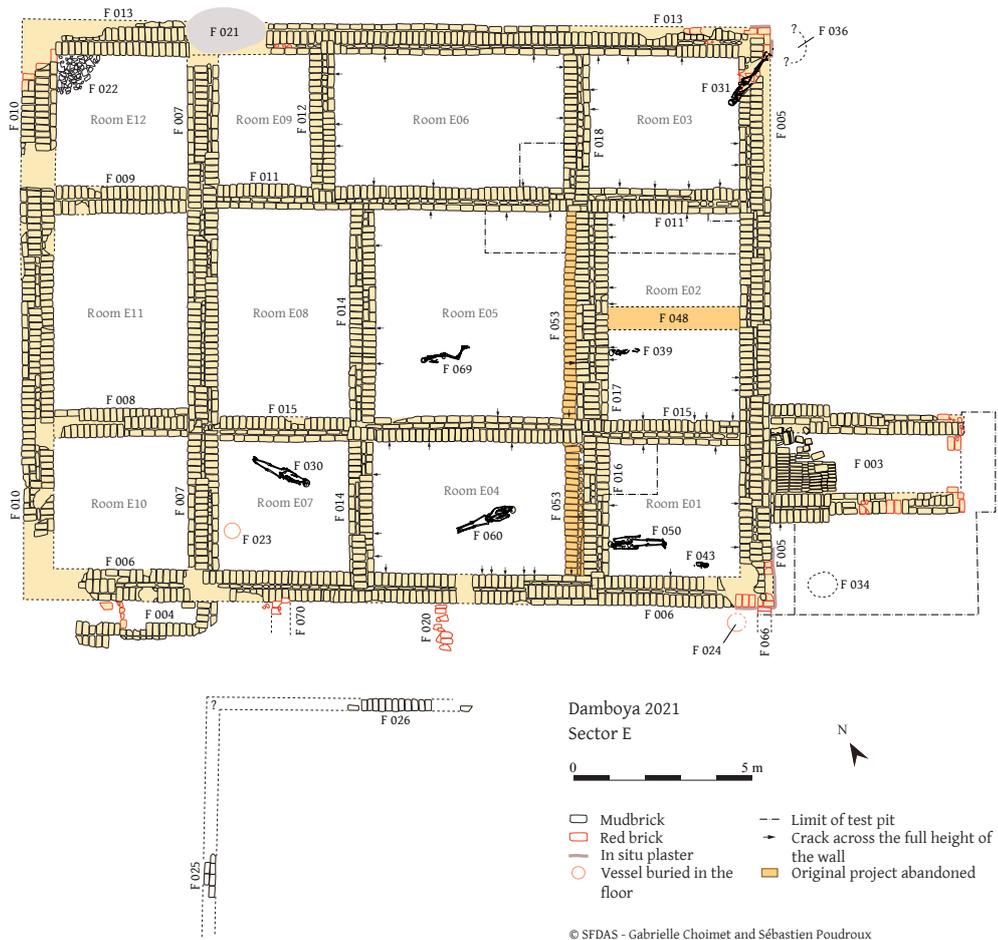
Figure 3. Plan of Sector E (© SFDAS).

Four test pits were dug in the corners of rooms inside Building E and a fifth outside, along Wall F005, between Ramp F003 and the southern corner of the building (Figure 3). Room E03 was completely excavated to geological level, which allowed us to observe in detail the foundations of all its walls. From what we observed during this campaign, all the walls of Building E were constructed at about the same level: the foundation trenches were dug in the sand dune until the level of Nile silt was reached, or a few centimetres above. The slight undulation of the ground mentioned above also affected the foundation levels: the southern corner F005 - F 006 was about 0.2m higher than the eastern corner F005 - F 013.

In the test trench dug in Room E05, F053 showed a total of six courses – without the usual succession of headers and stretchers – incorporated in a thick layer of mortar that had been spread inside the foundation trench. Its western facing showed flat-laid headers while in Room E04 – where Wall F053 was most visible – these headers framed a core of broken bricks (including some red brick fragments), which appeared to be flanked on the other side by stretchers (Figure 3).

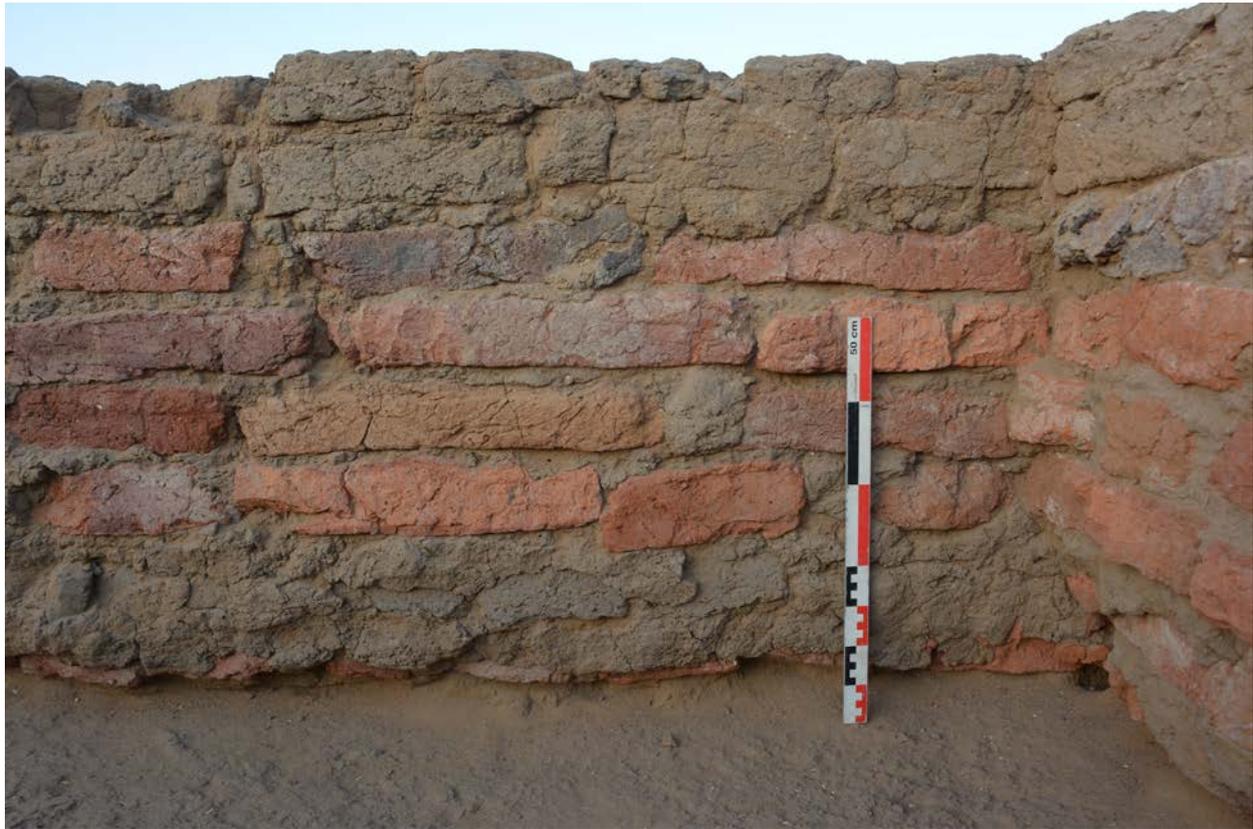
Figure 4. Room E03 after excavation: Corner of Walls F005 and F013 with red brick column drums reused in the foundation and upper courses made of mudbrick (© SFDAS).

The same pattern was observed at the eastern corner, where the use of half-drums inside Room E03 did not exceed six courses, with the occasional use of mudbricks and broken bricks. The upper courses were made of mudbrick in the interior of the room (Figure 4), and red brick in the outer corner.

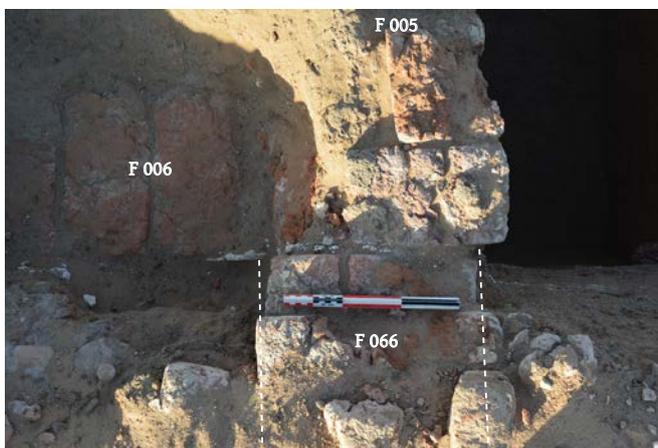
Figure 5. Wall F066 abutting southern corner F005 - F 006 with façade plaster in between (© SFDAS).

006 (Figure 5), but it was nevertheless installed at almost the same depth as the latter³ and is therefore undoubtedly of Meroitic date (Figure 6). As for the low wall F070, it seems, like F020 that reused a torus-shaped red brick (Choimet 2020, 196, fig. 9), to post-date the abandonment of Building E, but a test trench along Wall F006 during the next excavation season should confirm this.

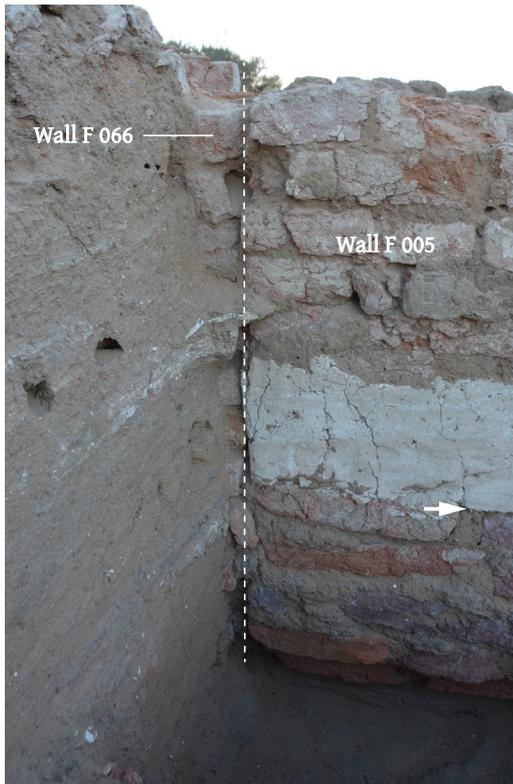
Figure 6. Wall F066 leaning against wall F005. The base of the plaster corresponds to the exterior floor level at the time of the construction of Building E (© SFDAS).

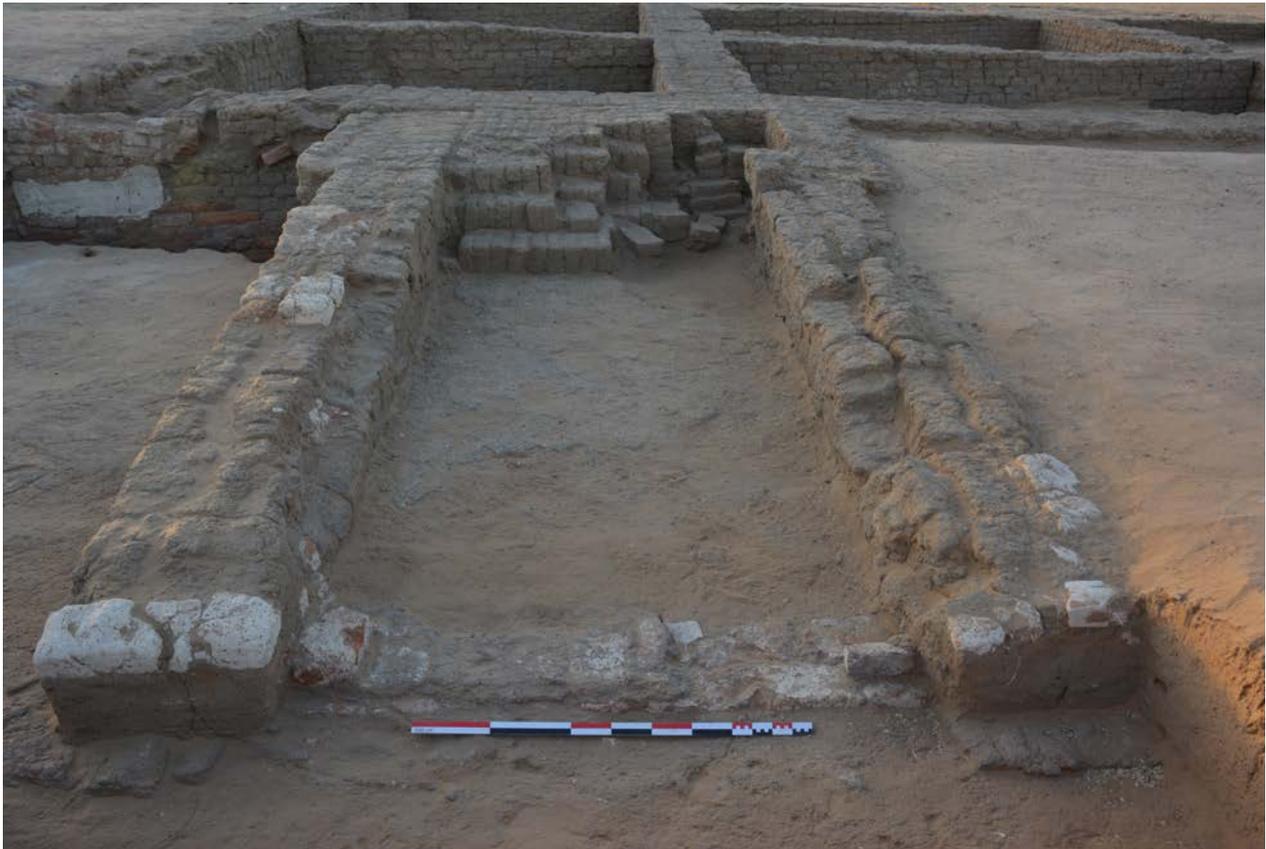
Figure 7. Ramp F003 after excavation, view from the southeast (© SFDAS).

The main entrance F003 was only fully excavated during the 2021 season. Perpendicular to façade wall F005 and framed by two indented low walls, it consisted of a 3.8m long ramp and a 3.25x1.7m landing (Figure 7). Thanks to the slope of a few red bricks preserved *in situ* on the two low walls, the height of the highest part of the ramp could be calculated as 1.14m above the exterior ground level. To this, it is probably necessary to add a 100mm step to reach the landing.

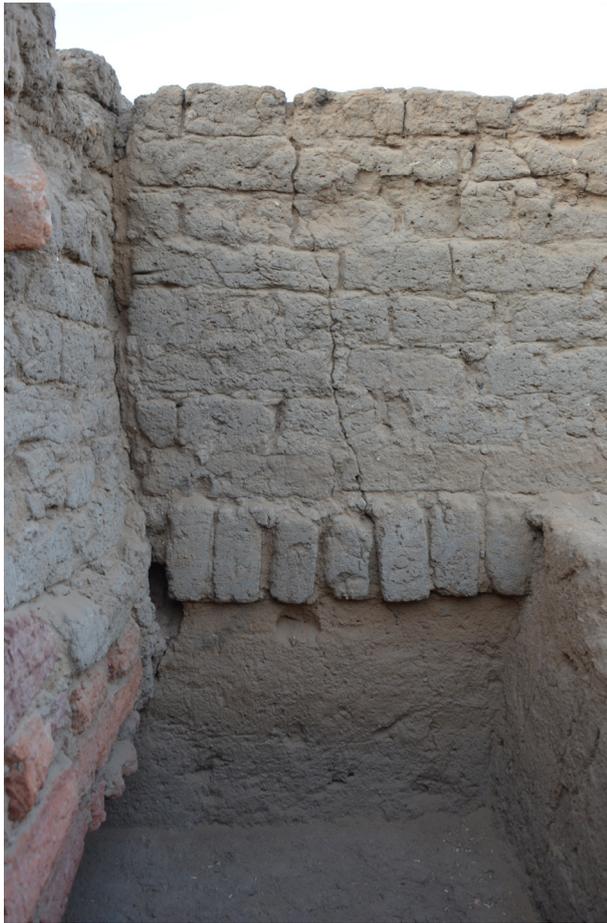
Figure 8. Ramp F003 against Wall F005 (© SFDAS).

The floor of the ramp has disappeared but it probably consisted of sandstone slabs or red bricks, or even perhaps of a pavement of column drums. It covered a filling of red bricks and mudbricks in equal proportions, architectural pieces, soil and overfired bricks, unsuitable for masonry and therefore reused in the fill. This fill was partially plundered, probably in order to retrieve construction materials, as evidenced by the presence of a pit. The landing consisted of four courses of mudbricks laid on edge, which had been overlaid with red bricks or sandstone slabs and two sandstone slabs were found in the destruction layer. Finally, the test trench on the south side of F003 allowed us to observe that the ramp was built 0.25m higher than Wall F005 against which it abuts, and had a single foundation course made of bricks laid on edge (Figure 8).

A large number of cracks in all of the walls of the excavated half of Building E were observed during this campaign (Figures 8 and 18). Such vertical gaps in the walls – sometimes down to the silt level below the foundations – the number of broken bricks and the misalignment of some walls that seem to have

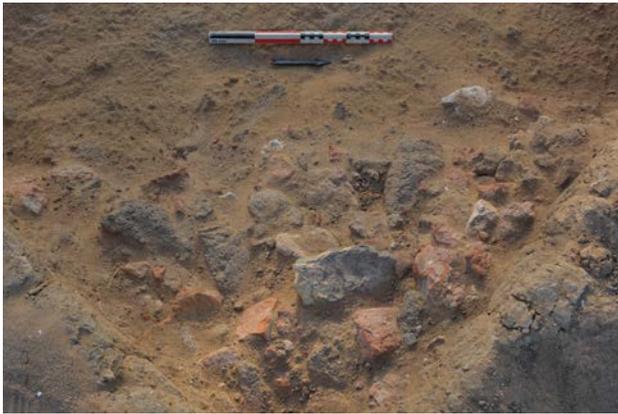
Figure 10. Fill of Room E02 in the eastern corner of the room (© SFDAS).

consisting of broken mudbricks and red bricks mixed with numerous architectural fragments: sandstone and red brick column drums, large red bricks, torus-shaped bricks, etc. (Figure 10). This layer also yielded a remarkable number of plaster fragments, as well as pigment preparation pots and chunks of yellow and blue pigments (ochre and Egyptian blue).

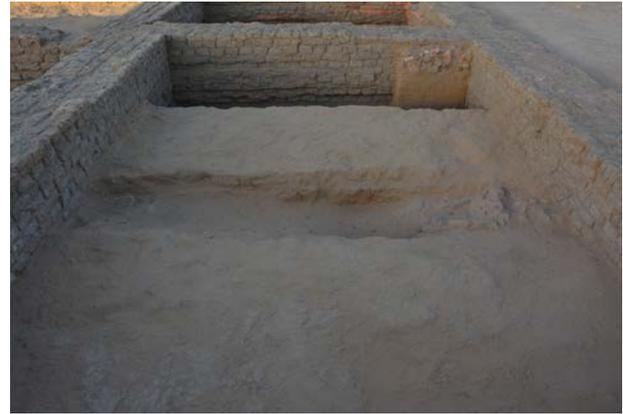
Figure 11. Room E02 after excavation with partially emptied Trench F048, view from the southwest. In the background, section left in the eastern corner of the room (© SFDAS).

In the centre of the room, and filled with the same remains of densely packed construction material, was a trench (F048) approximately 0.6m wide and 0.27m deep between Walls F005 and F017 (Figure 11). Located at the same level as the other foundation trenches, it probably corresponded to a foundation trench for a wall that was never built. This feature was therefore left untouched and subsequently filled with the same material as the rest of Room E02.

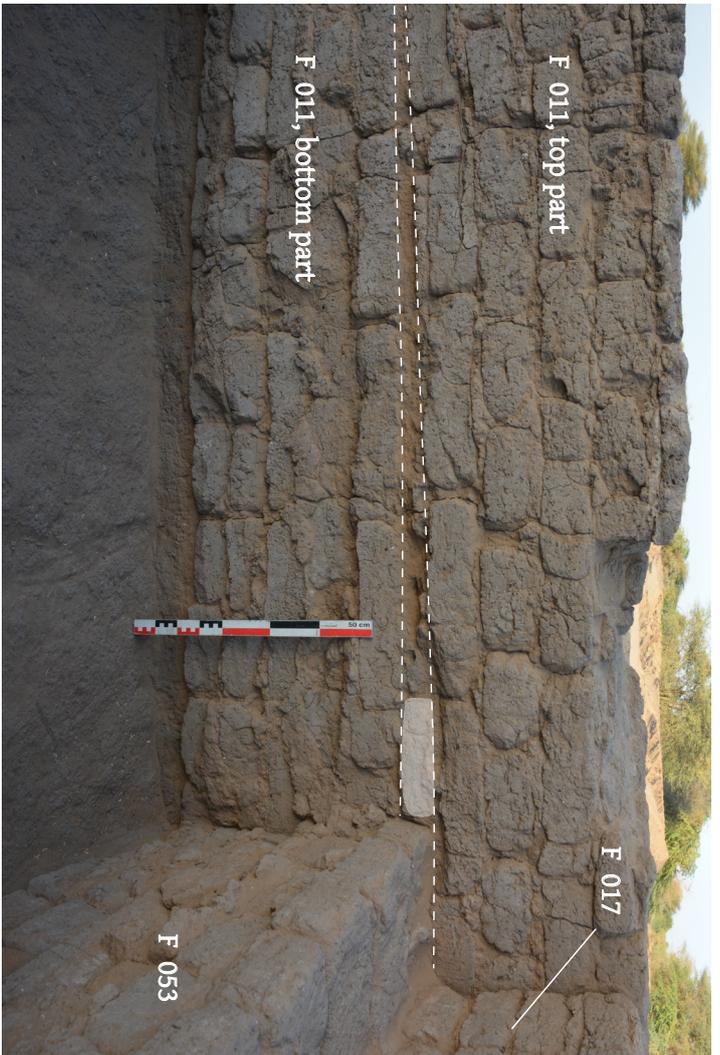
Figure 12. Room E05 after excavation, eastern corner: F011 and F017 built on top of Wall F053 with thick mortar connection (© SFDAS).

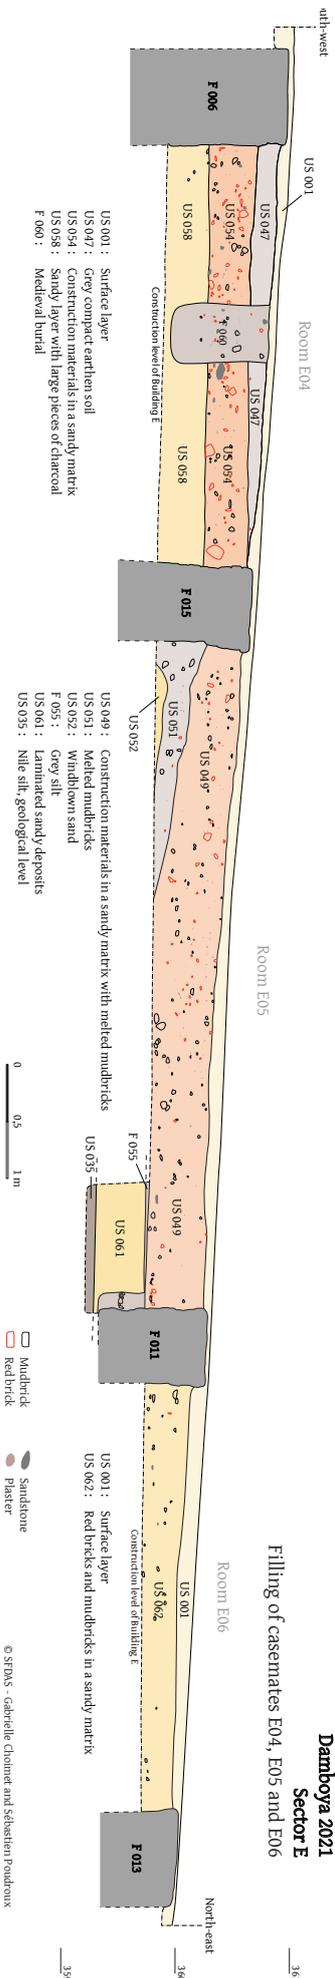
Figure 13. Southwest-northeast section through Casemates E04, E05 and E06 (© SFDAS).

In the second row of rooms excavated during the 2021 campaign, a section was made across the entire width of Building E in order to observe in detail the fills in the different rooms (Figure 13). Room E04 was 3.7m wide and 5.9m long. It was filled with at least three distinct layers: the first consisting of grey compact building soil preserved to a maximum thickness of 0.2m, which overlapped a second layer, about 0.4m thick, which yielded a lot of mudbrick, pottery, a few pieces of painted plaster, animal bones and a few lithic pieces. Finally, at the bottom

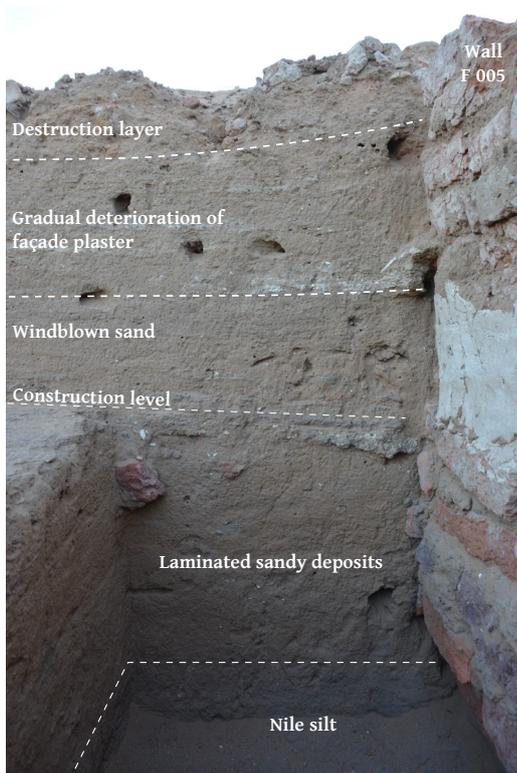
Figure 17. Section near the southern corner of Building E, view from the northeast (© SFDAS).

Outside Building E, the ground level was gradually covered by windblown sand deposits (Figure 17). In section, these deposits were visible for about 0.2m, after which the façade plaster started to decay. The final level of destruction of Building E was situated 0.52m above the original construction level of the edifice.

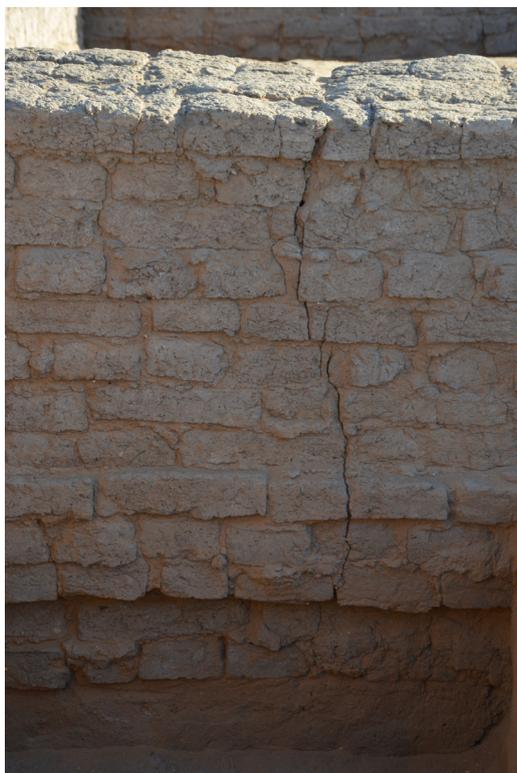
Figure 18. Room E01 after excavation, Wall F015 (© SFDAS).

moved out of their original axis¹⁰ were too systematic to be attributed to a construction defect. An earthquake seems, at this stage, the most plausible cause to explain this.
