SUDAN & NUBIA

Preliminary report on excavations at Naga 2020-2022

Karla Kroeper and Christian Perzlmeier

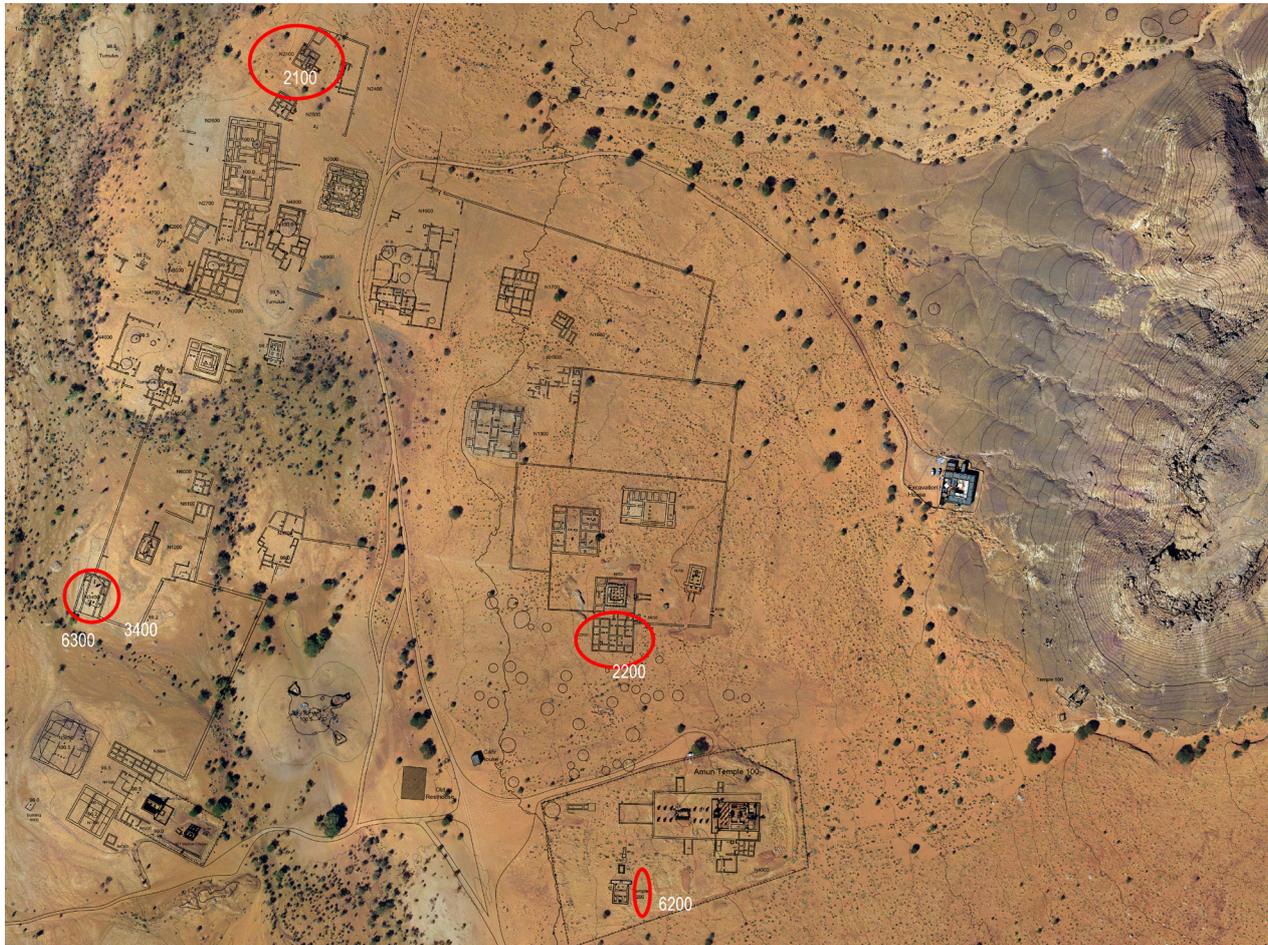
Figure 1. Plan of the central part of Naga ‘city’. Excavated and unexcavated buildings. Circles show the location of buildings described in this article (original plan U. Weferling 2001; since 2018 developed and produced by TrigonArt BauerPraus GbR. © Naga Project).

Despite the coronavirus pandemic and internal political problems in Sudan, the Naga Project of the Staatliches Museum Ägyptischer Kunst in Munich undertook three excavation campaigns in 2020 (January to March), 2021 (October to December) and 2022 (February to March). During these campaigns work continued on several larger buildings that had been partly excavated in previous years (Figure 1).¹

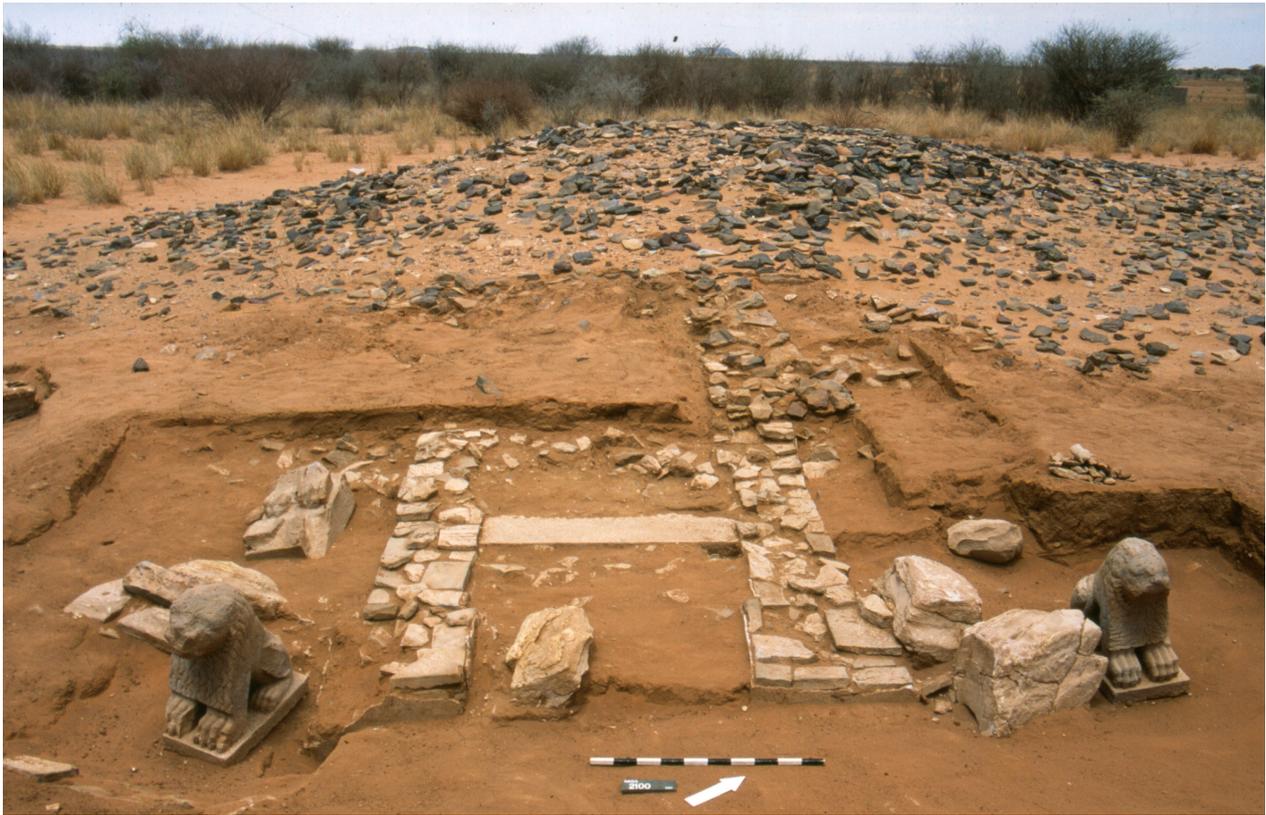
Figure 2. View of Building 2100 during the removal of the lion sculptures in 1996 (© Naga Project).

In 1996, the eroded tops of the heads of two lion sculptures in the northwest area of the site were noted and mapped (Gamer-Wallert and Zibelius 1983, 37, Taf. 52-54). In 2001 (Schlüter 2020, 36ff) the area was partly excavated in order to remove the lions for safe keeping (Figure 2). During this excavation Building 2100 was associated with the lions. Another sculpture was discovered on the south side of the building near a carved sandstone block, which was probably part of the base of another lion sculpture. Since the building was not part of the excavation programme at that time, the area was covered with sand and left for a later period.

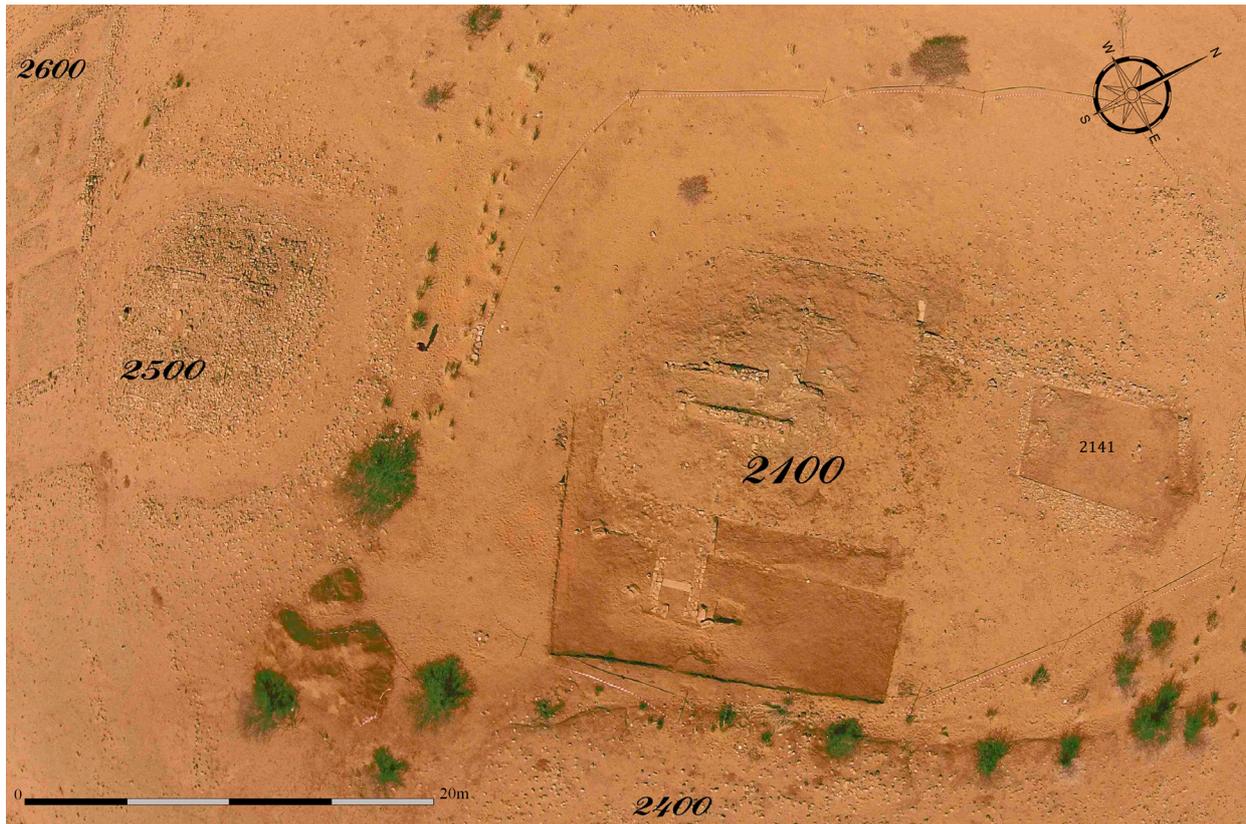
Figure 3. Location of Building 2100. Aerial view at the beginning of the excavation in 2020 (© Naga Project).

Nearby, to the east and south, other buildings are visible on the surface (Figure 3) and may eventually form, together with 2100, a compound or district within the city. Such groups of buildings, surrounded by a common wall, have also been noted at other parts of the site.

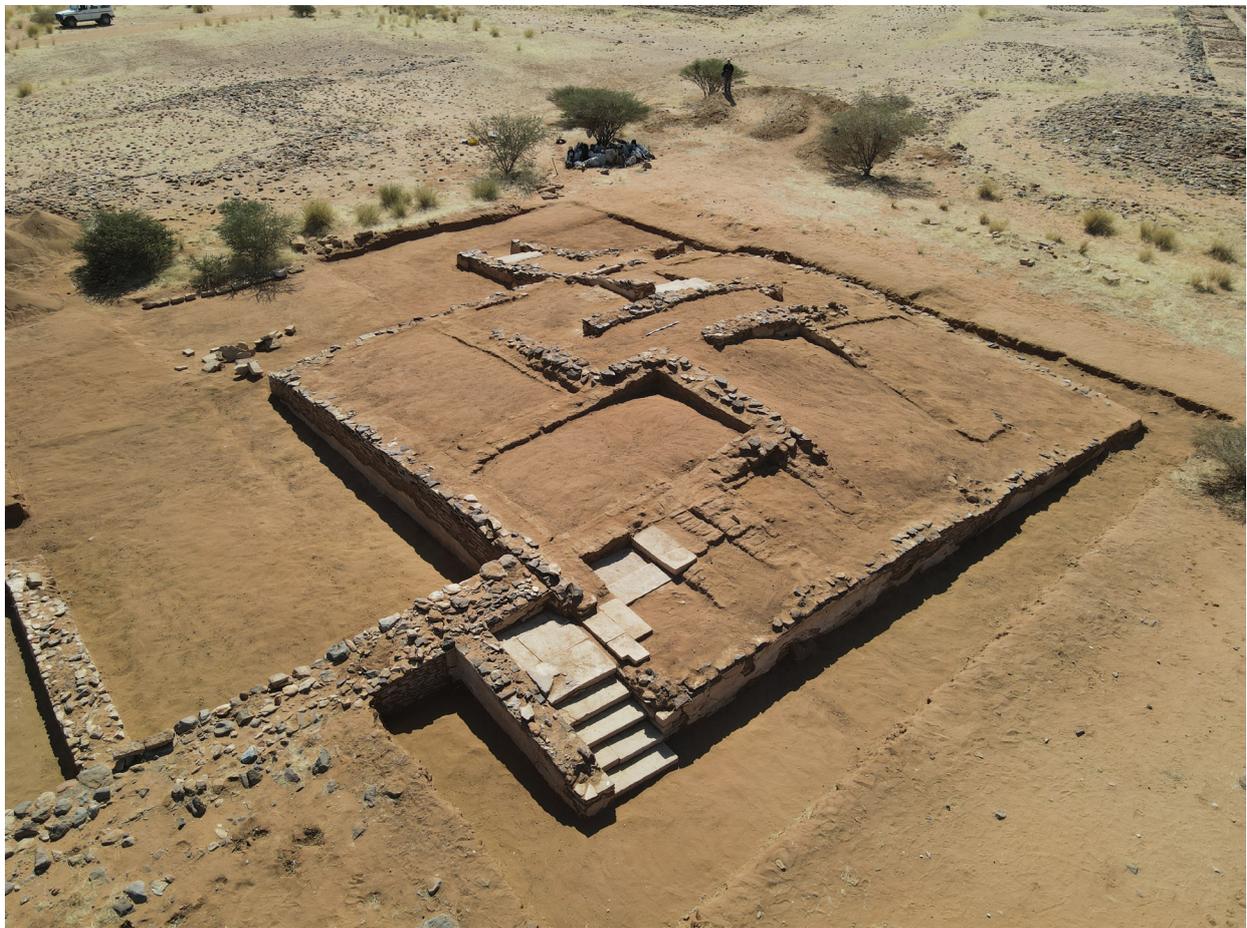
Figure 4. View of 2100 from the northwest (© Naga Project).

Abutting the northwest part of Building 2100 is an interesting combination of rubble stone walls (area 2141); the most well-preserved runs about 13m towards the north (2141). To this was added haphazardly at the north end, probably in different time periods, other irregularly built walls and scatters thereof, forming an irregular rectangle that was not closed at the northeast end (Figure 4).

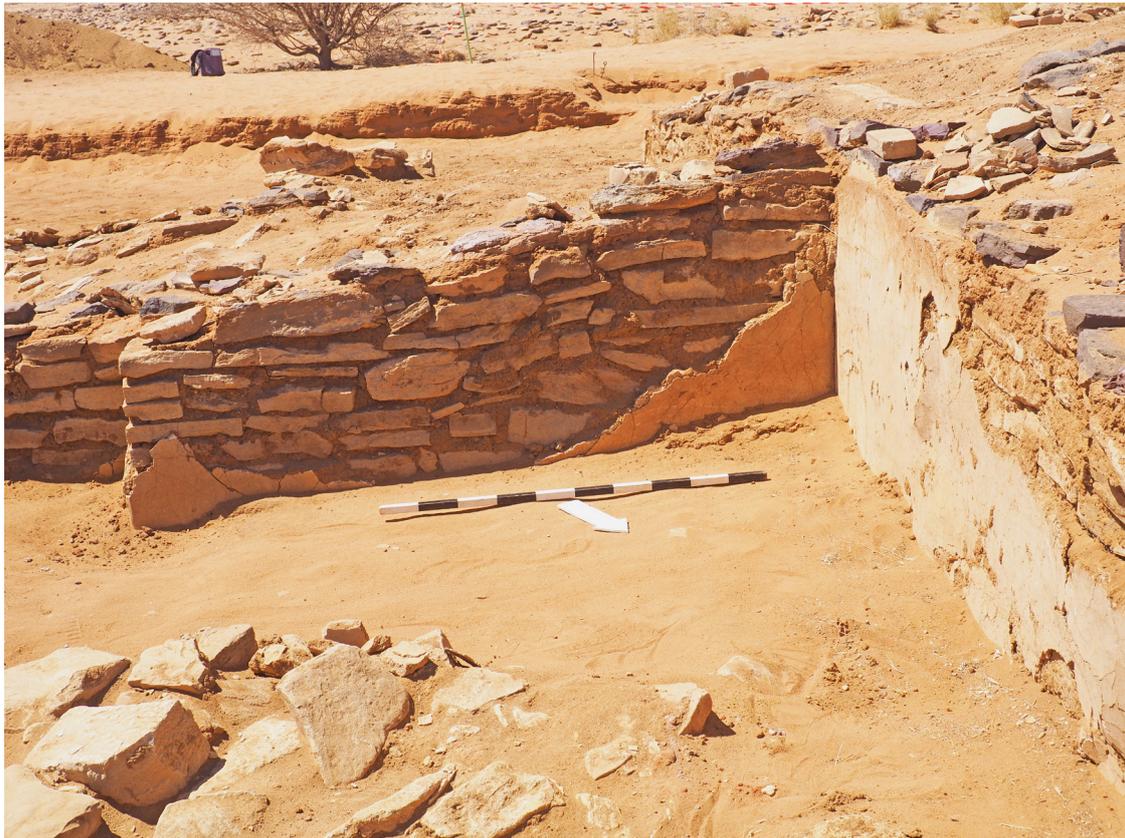
Figure 6. General condition of the rubble walls with thick layers of plaster already separated from the walls (© Naga Project).

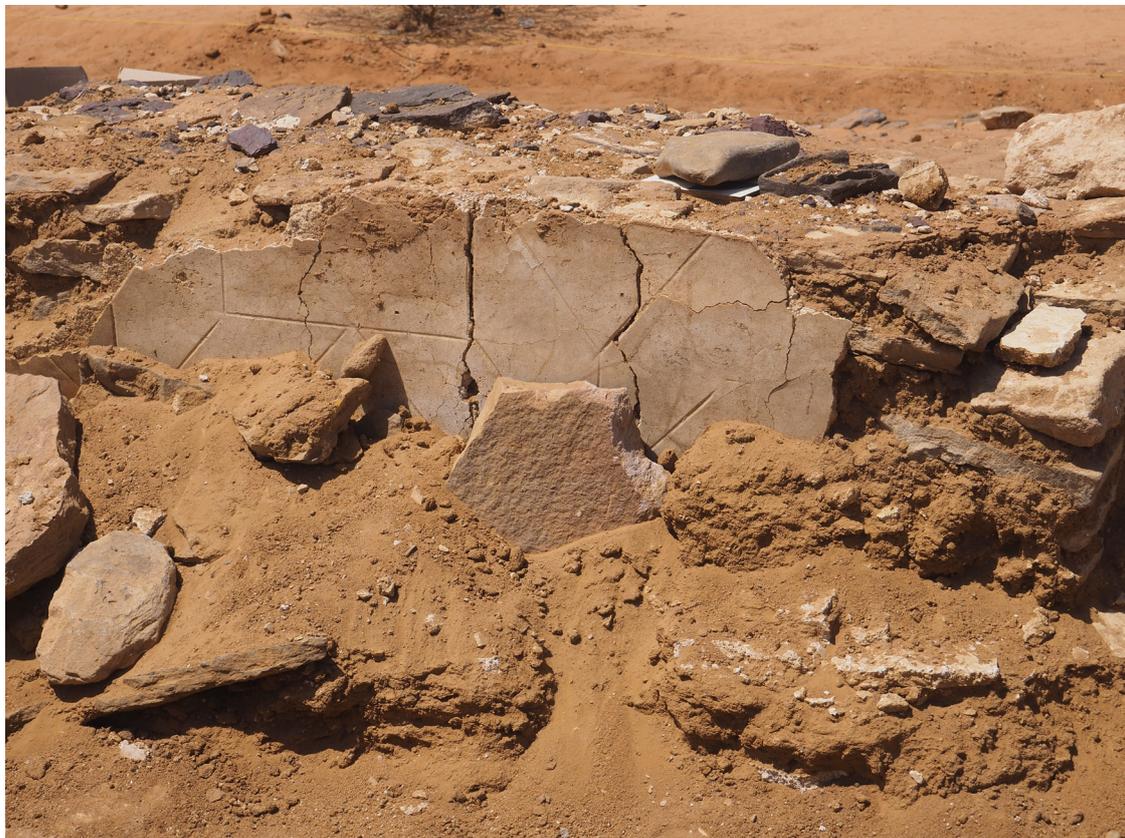
Figure 7. Fragile cracked decorated plaster partly disengaged from the wall (© Naga Project).

Unfortunately, the plaster on all three walls was found completely loose, cracked and separated from the wall, while, during any attempts to remove it, it usually disintegrated into very small pieces. Some of the larger more solid parts, however, were removed and taken to the storeroom to await analysis. The rest was left *in situ*, protected with large slabs of stone placed a very small distance from the walls; the space between wall and support was then filled with very finely sifted sand. The whole room was then refilled with stones and sand. Over many years, this kind of covering has proved to be the most effective measure to preserve delicate plaster pieces (for example, the painted altar in the Amun Temple).

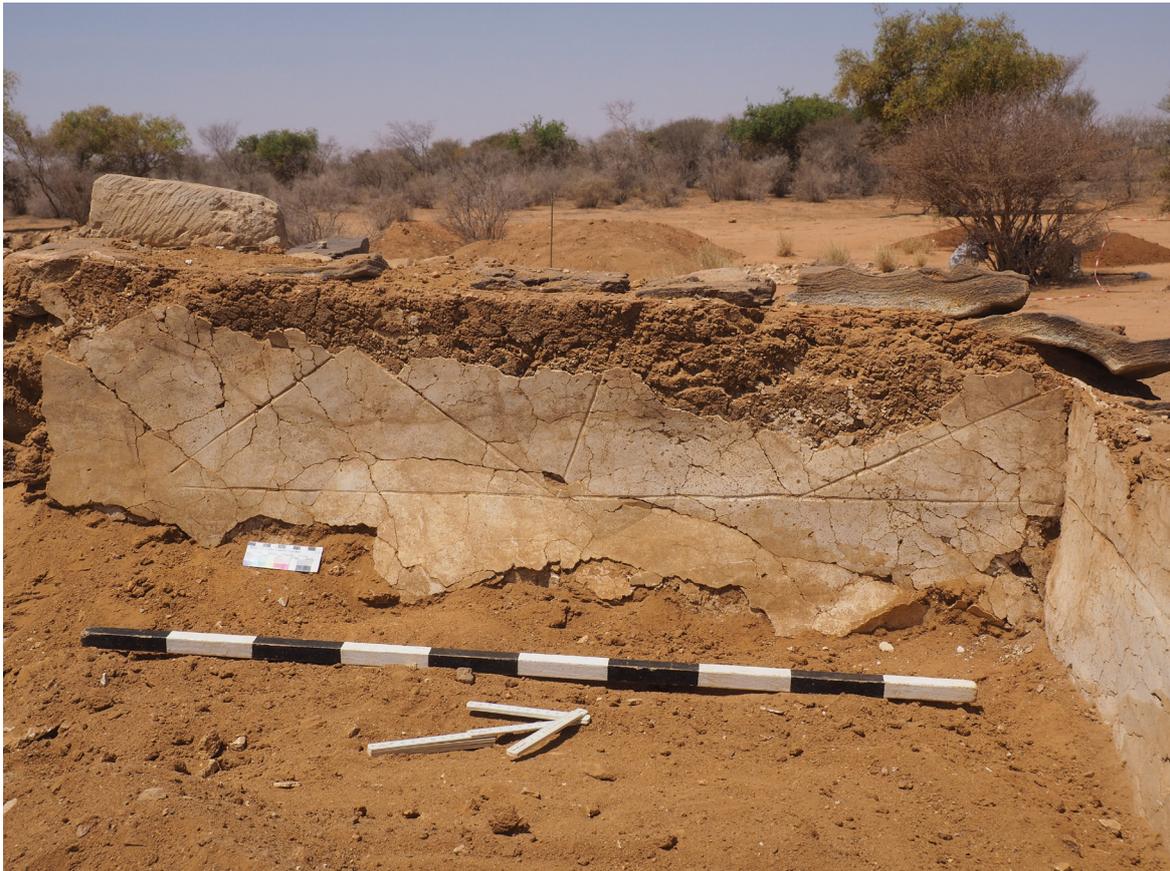
Figure 8. Remains of engraved rhomboid decoration in Room 2105 (© Naga Project).

Area 2105 had been partly exposed in 1958 by the Butana Expedition, when part of a decorated plaster section was photographed (Hintze 1960, 395). This year it was found that actually three walls (north, east, west) carried decoration made up of lightly engraved lines applied to the still wet plaster. The design consists of horizontal lines over which diagonal lines have been placed to make up rhomboid forms, sometimes arranged in a star-like manner with the lines extending in all directions (Figures 8 and 9). The remains of painting consisting of different shades of red (dark red to orange), blue and yellow were also found. The painted design has not yet been reconstructed due to the fragmentary state of the pieces.

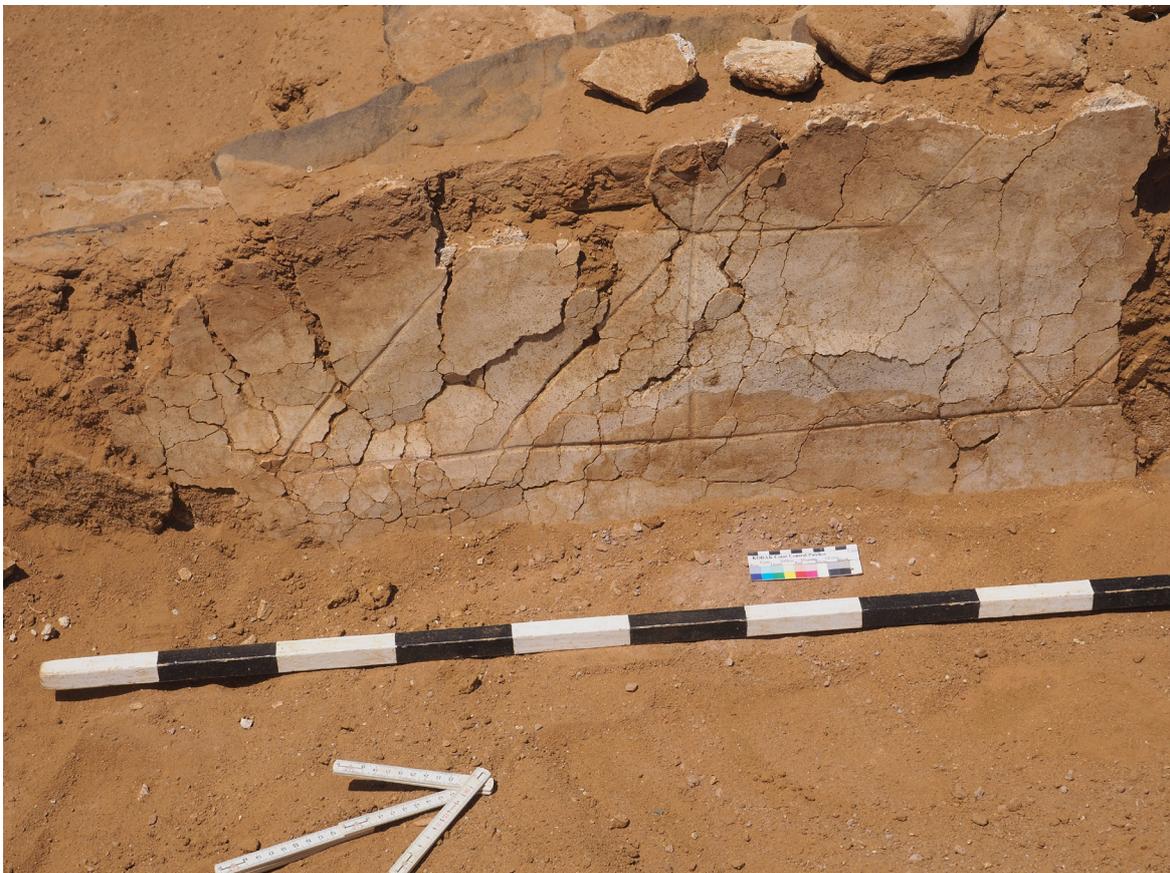
Figure 9. Remains of engraved decoration in Room 2105 (© Naga Project).

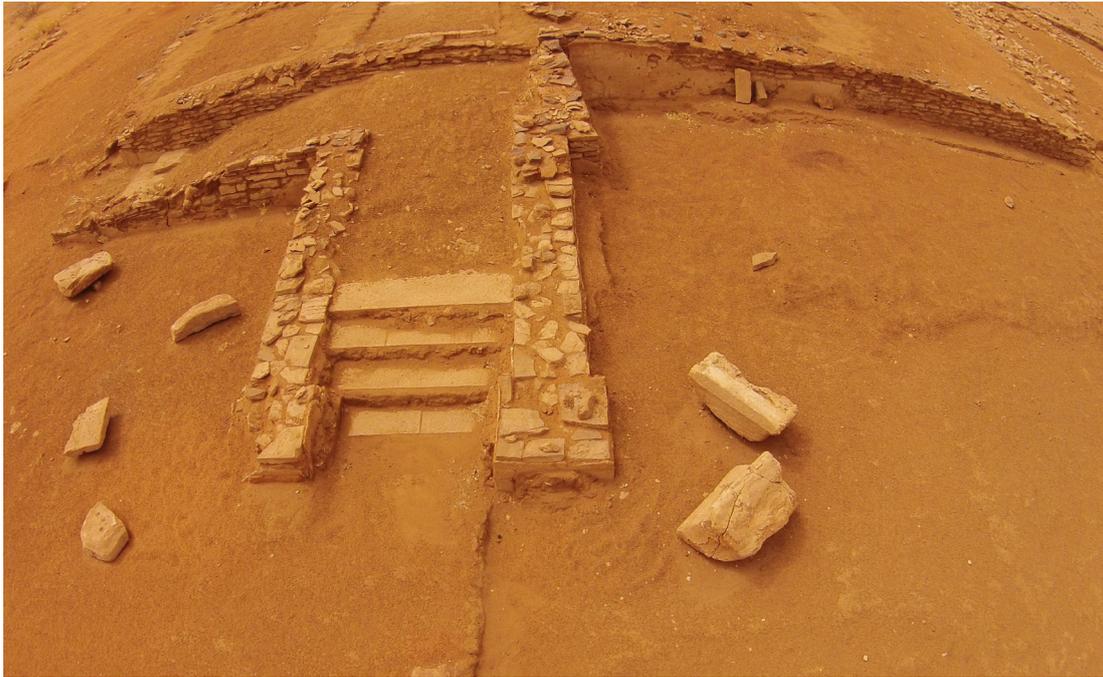
Figure 10. View of Ramp 2138 from the east. Askew section of the northern side wall of the ramp and various carved large blocks *in situ* (© Naga Project).

The best-preserved part of this small, and so far, most northerly, building at Naga is the east side. There a complete ramp (2138) was excavated and found to be c. 6m long, c. 1.50 to 1.20m wide and ascending c. 1.12m to the top of the podium to which it connects (Figure 11). The side walls of the ramp are built of quarry/rubble stones, ending in carved sandstone blocks (including a cavetto cornice) found next to the ramp.

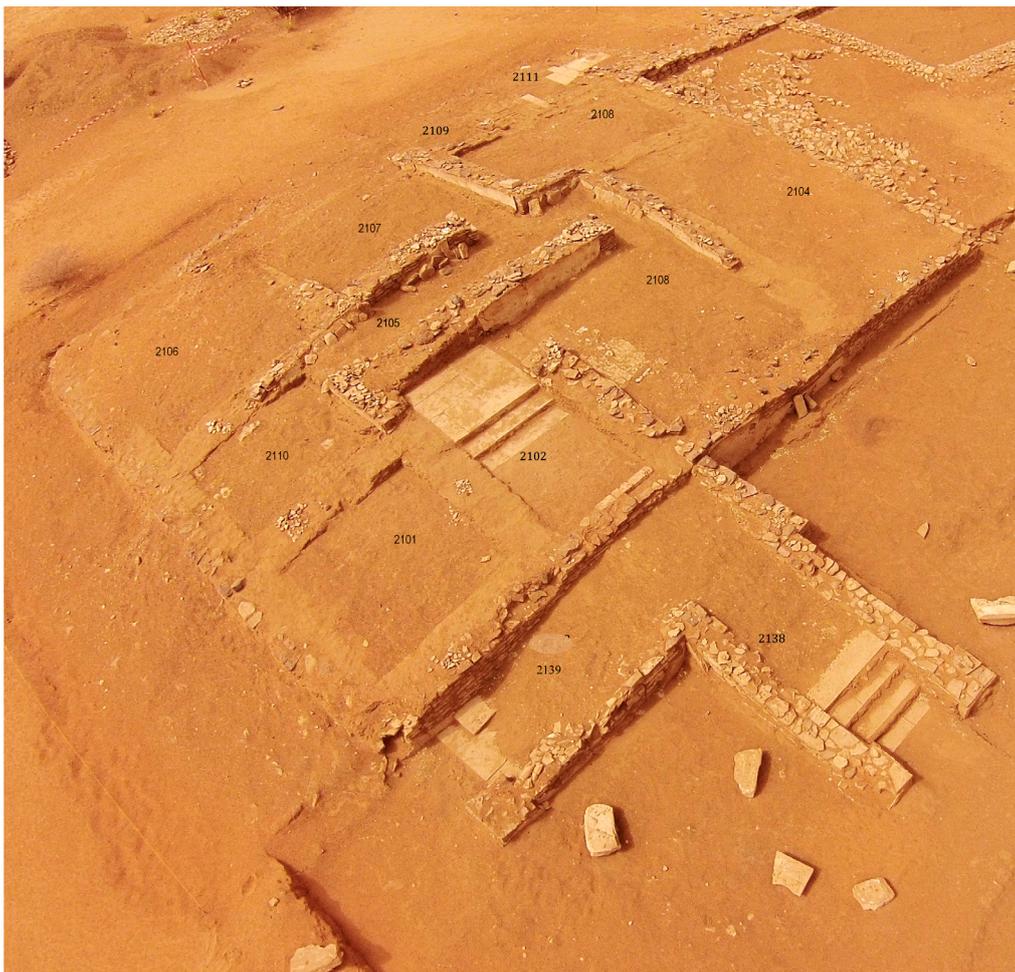
Figure 11. General view from the south at the end of the excavation with the smaller ramp in the foreground (© Naga Project).

Four steps made of well-carved sandstone slabs are situated inside the ramp. The whole construction was covered with thick layers of plaster. The main entry from the east therefore was quite elaborate with lions and the white stone steps leading up to the podium (Figure 10). One section of the northern sidewall of the ramp is askew, which, as excavation has shown, is a feature deliberately constructed in this fashion. Perhaps it stands in connection with the junction of the second ramp coming from the south. A smaller ramp, c. 1.30m wide (inside) and c. 4m long (2112), was constructed by adding a wall parallel to the podium from south to north that joins the larger ramp at the top. The end of the wall at the entrance (2111) was also finished as a rectangular post and carved stone blocks were found nearby. Only two stone steps marked the entrance to the ramp from the south; however, as this end is partly destroyed there might originally have been several more (Figure 11).

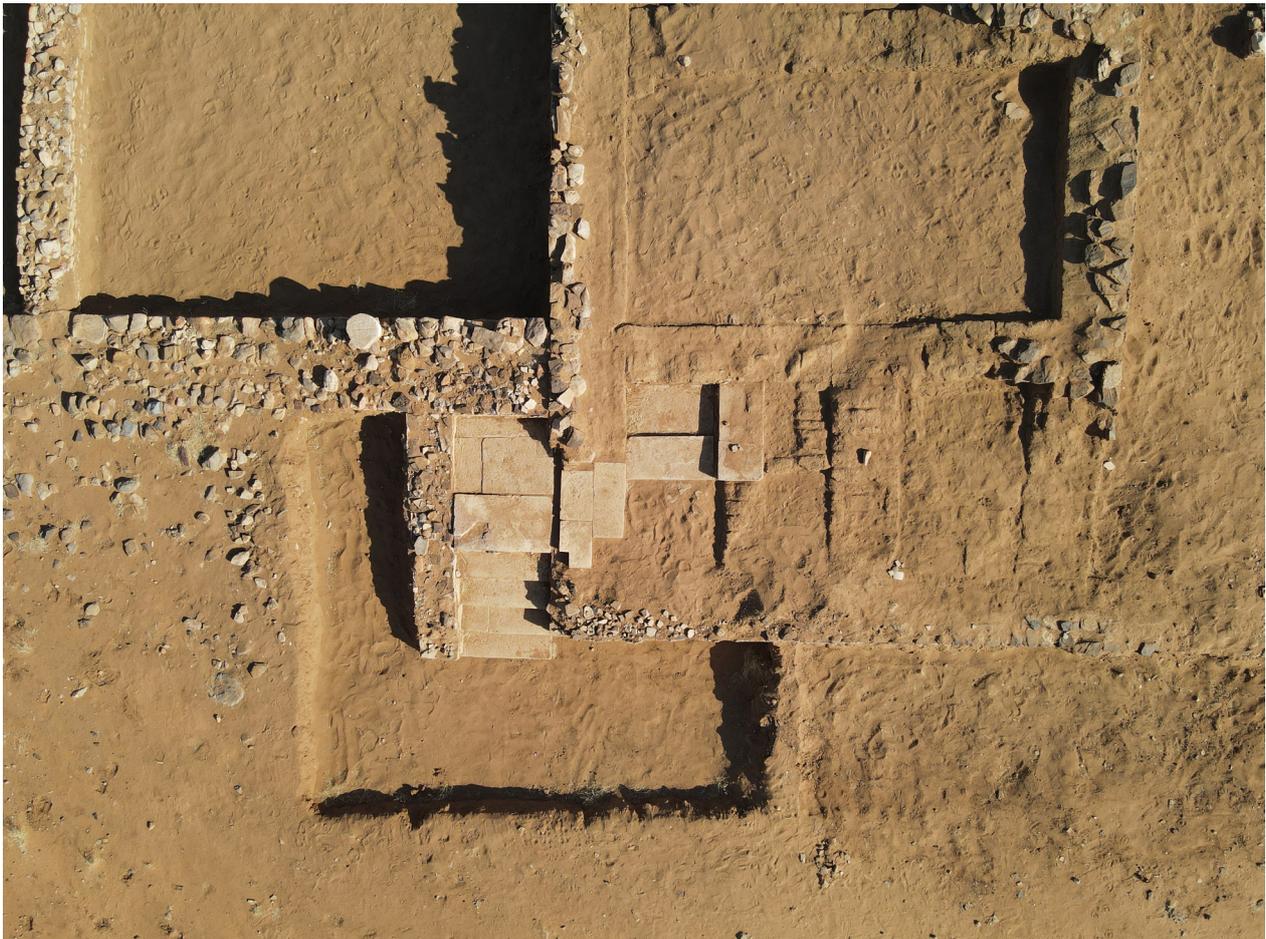
Figure 12. Entrance at the northwest corner of Building 2100 (© Naga Project).

Also discovered during excavation this year, was a second small porch about 1.35m wide, which was built abutting the outside of the podium wall at the back of the building in the northwest corner. Five stone steps lead up and to the right into the building itself and into a small vestibule (2111). The floor may have originally been covered with stone flagstones (similar to 2102) of which only a few pieces remain. Another stone step finally leads into Room 2109 over another stone step (Figure 12).

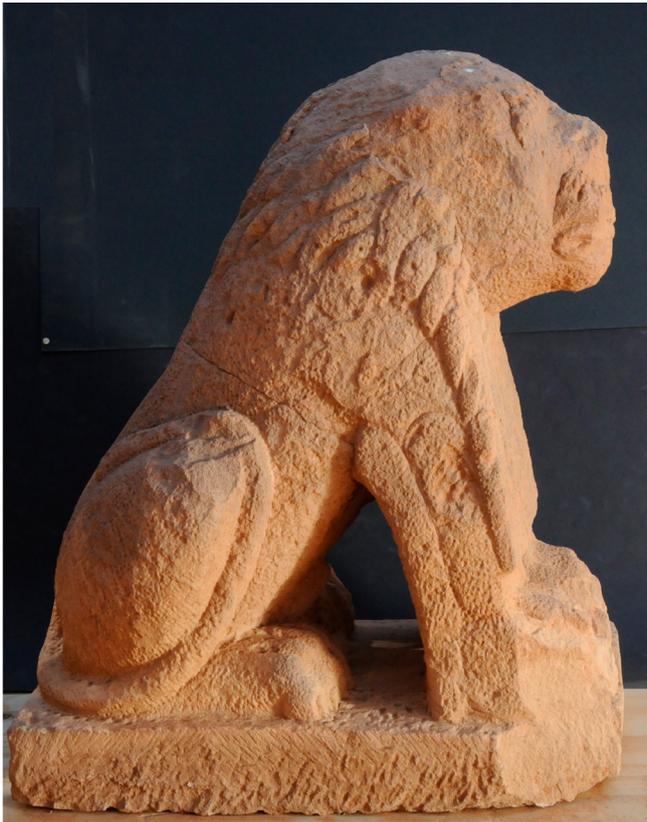
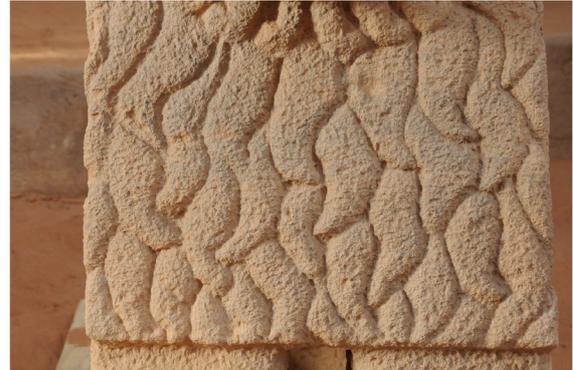
Figure 13. Lion sculpture 2100.1 and detail of mane (© Naga Project).

small faience pieces, mostly undecorated, were collected. As mentioned above during the clearance of the east side of the building in 2001 two sandstone lions (Wildung 2018, 162-165) were found in approximately their original positions flanking the large ramp and lying about 0.70m below the present ground level (Figures 13 and 14). During their excavation it was noted that the sand immediately surrounding the lions appeared to consist of a light-coloured sand quite different from the more compact and darker soil in the area. It seems therefore probable that the statues were previously exposed, and the excavated hole refilled with windblown sand; when this might have happened or by whom this was carried out is not known. Both are fairly well-preserved except for the front part of the head where the nose is partly broken and the mouth and eyes somewhat eroded due to their exposure over many years on the surface.

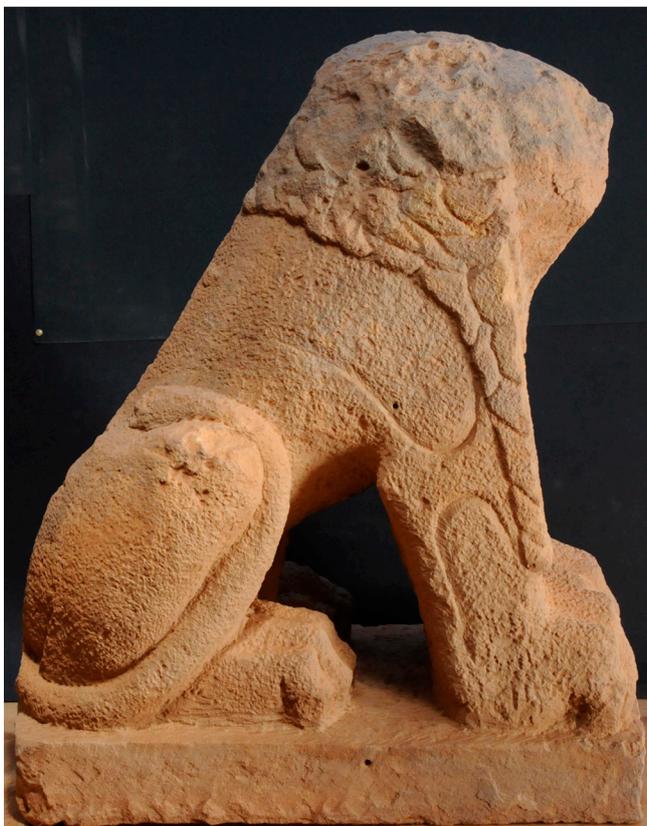
Figure 14. Lion sculpture 2100.3 and detail of mane (© Naga Project).

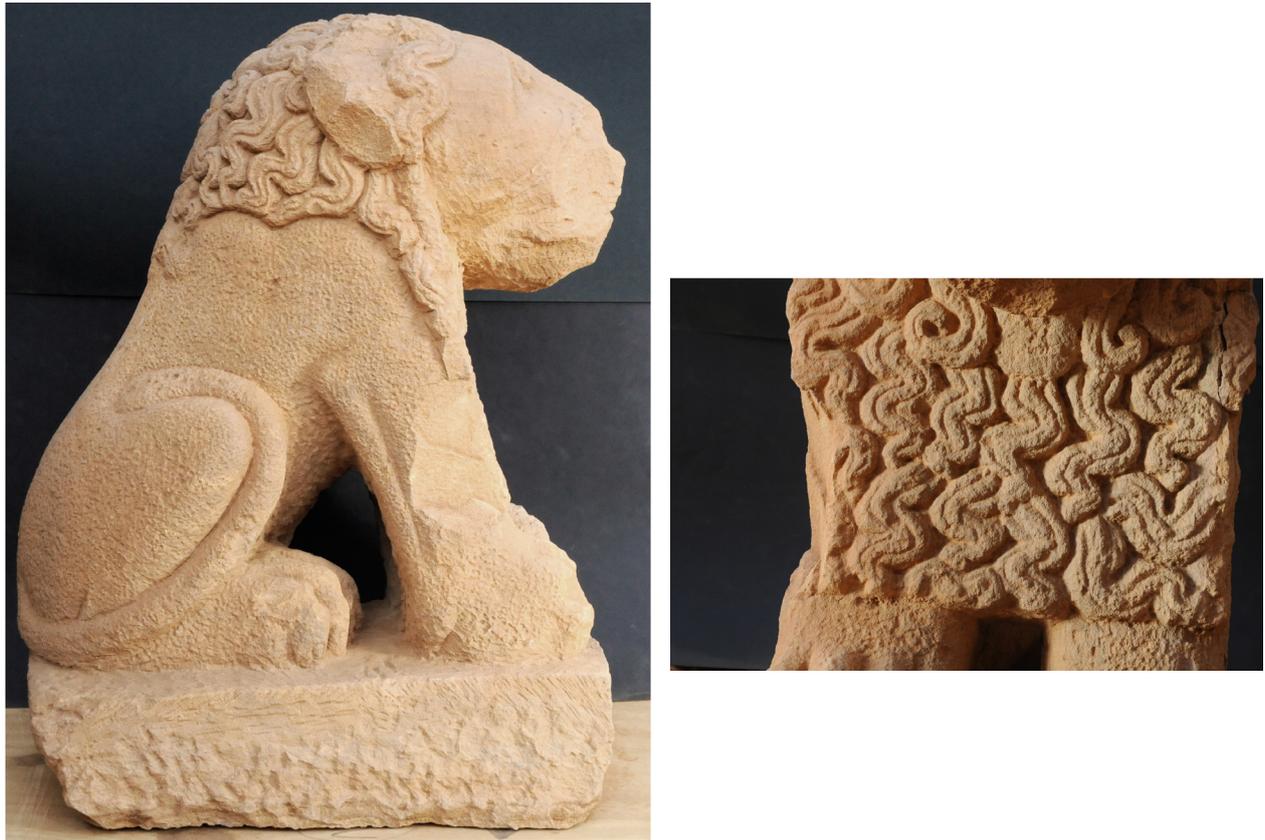
Figure 15. Lion sculpture 2100.2 and detail of mane (© Naga Project).

The third lion was found on its side c. 3.5m away from Ramp 2138, with one side well-preserved (Figure 15), and the other side partly destroyed. The manes of all three sculptures are carved in great detail with distinctly bold chiselled curls and fleece, the surface is pecked to imitate hair, and no remains of paint were preserved. Lion sculptures 1 to 3 are approximately the same size: 0.81m-0.86m in height including rectangular bases (0.42-0.43m x 0.67-0.71m) varying in height from 90-220mm.

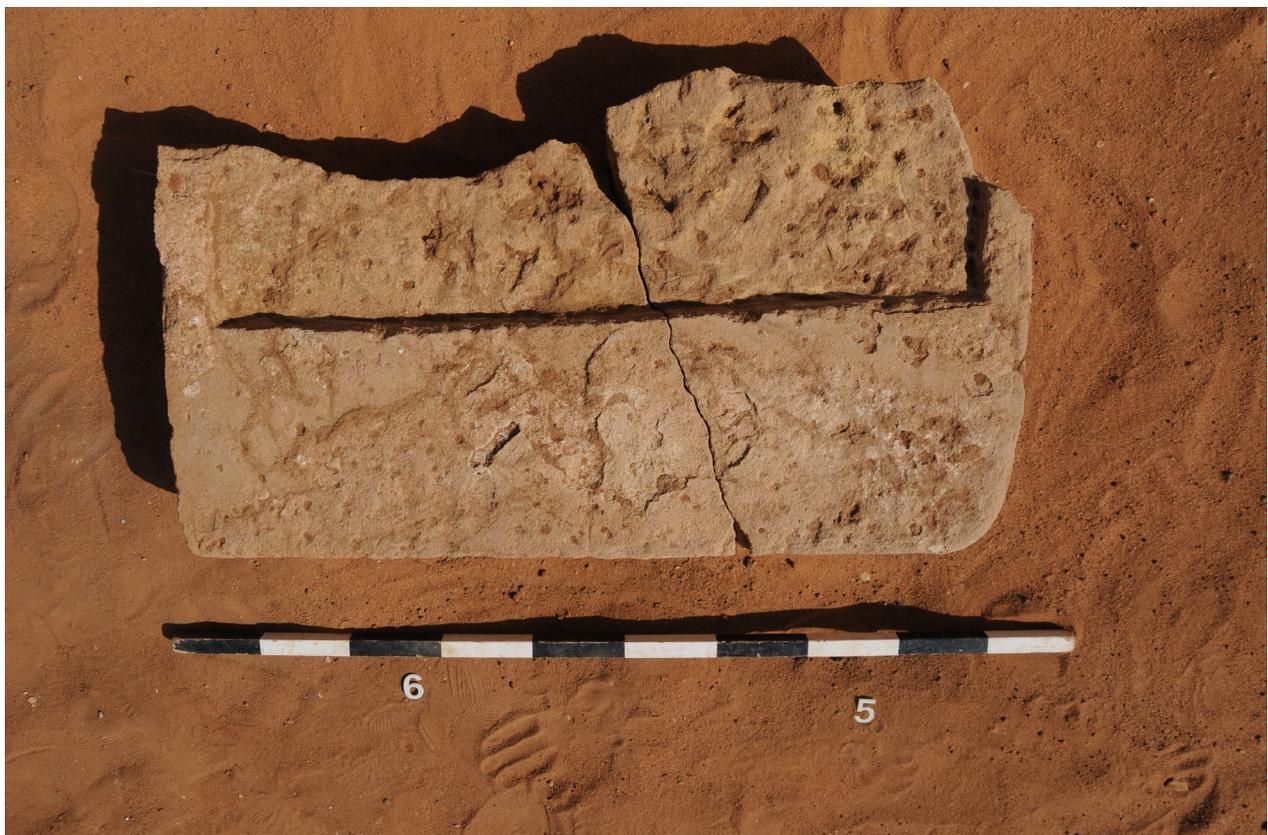
Figure 16. Part of the upper stone of a podium with a sunk recess into which the lion sculpture was placed (© Naga Project).

The bases are not well-smoothed and, from the evidence of blocks found nearby, it is clear that the sculptures with bases were placed in a recess that was cut into a separate stone. Figure 16 shows the uppermost stone of a pedestal for the sculptures; similar arrangements have been found in other buildings at Naga such as Temples 600 and 700.⁴ The entire base and pedestal was then covered with plaster to hide the chisel marks. There was no evidence that the lions were themselves originally covered with plaster or painted.

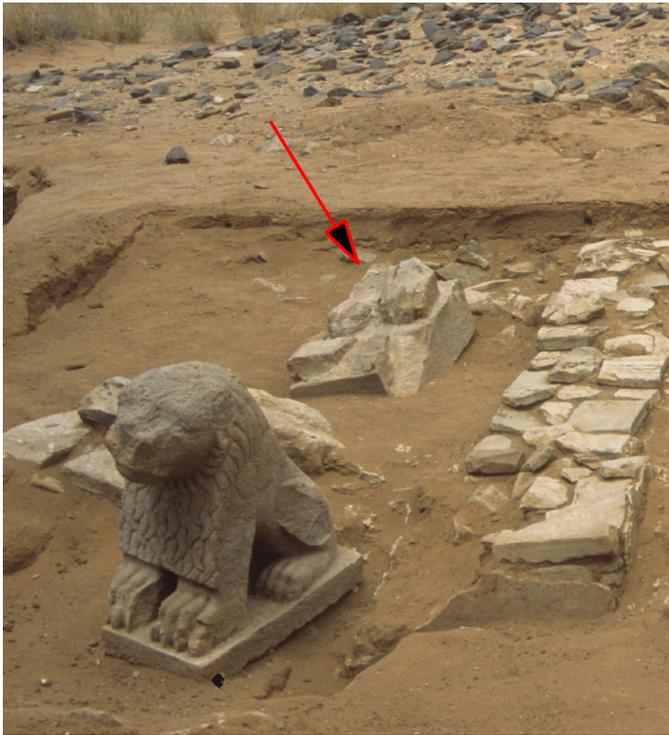
Figure 17. Base of a lion with remains of paws (2100.4). Find location in 2001 (© Naga Project).

Nearby on the south side of the ramp, near what we now know to be Ramp 2112, the base of a fourth lion (Figure 17) was discovered with only a rear paw and part of a front paw preserved. The 400mm high base is somewhat higher than those of the sculptures described above. The rear quarter of another lion (Wildung 2018, 166-167) with part of the tail on the right side of the body⁵ (Figure 18) was discovered to the north of the larger ramp.

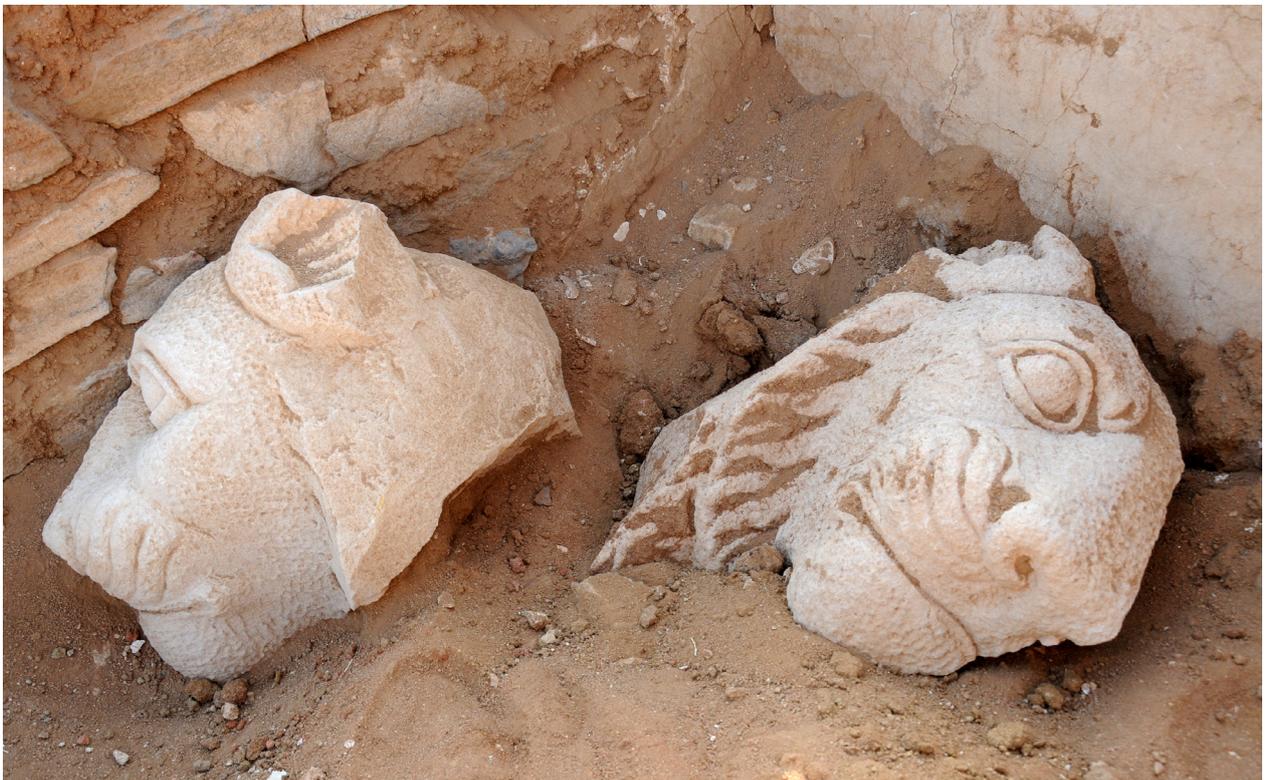
Figure 19. Discovery of the sculpture of a lion head *in situ*. Split into two halves (© Naga Project).

All pieces are made of hard sandstone very similar to the rams at the Amun Temple. At the beginning of this season a small decorated fragment of stone (160 x 180mm) of the same material was found on the surface near Building 2100 but was not directly associated with the building itself. It was recognised as being a part of the mane of a lion but did not fit on any of the already known lions mentioned above. During the excavation of the northeast corner of the podium and ramp, removing about 0.70m of rubble directly in the corner between ramp and podium wall, the head of a lion sculpture split vertically in two parts was discovered (Figures 19-21). The preservation state was such that it looks as if just made! Part of the mane, the smaller neck mane and, for the first time, a completely preserved face with muzzle, eyes and lips is present. Furthermore, the aforementioned fragment fits on the back of this head.

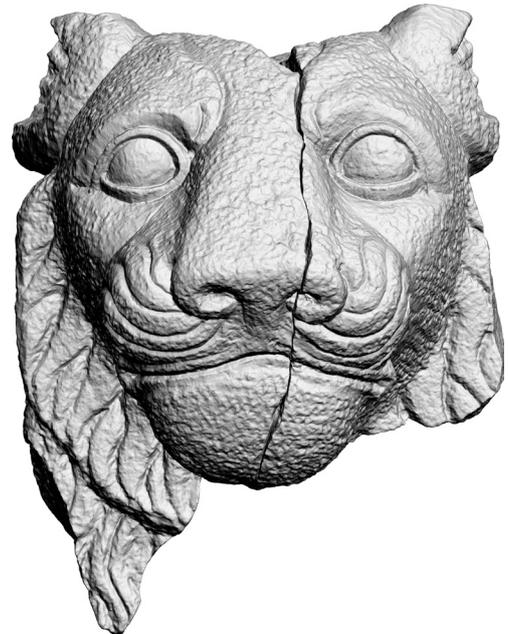
Figure 21. Frontal view of the new find (2100.8+9), photo and scan (© Naga Project, 3-D Scans by TrigonArt BauerPraus GbR).

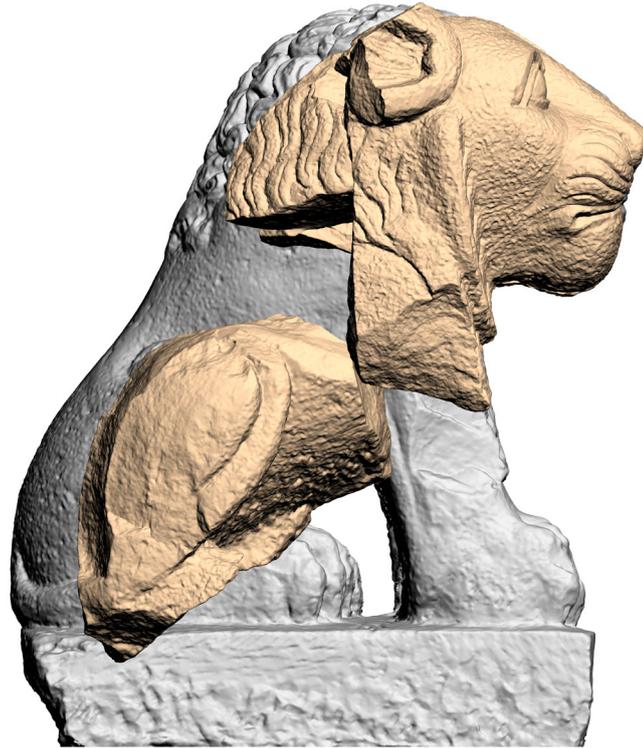
Figure 22. Possible reconstruction of the lion from the northeast side of the ramp from the two pieces 2100.5 and 2100.8+9 (© Naga Project. 3-D Scans by TrigonArt BauerPraus GbR).

To summarise the find situation in front of Building 2100, three complete lions were discovered, as well as one base with two paws preserved, the rump of one lion and the new lion head. It seems likely that the rump and the base probably belong together, due to their relative sizes and findspots. The ‘new’ lion head, could then be part of this lion (Figure 18), of which only fragments have been found in the past, particularly as they were all found next to the main ramp. So, although no exact joining parts of the various pieces are preserved, they most likely all belong together. The sculpture would then correspond to Lion 2100.2 (Figure 15) found on the southern side of the ramp. There must have been at least four lion sculptures placed on the east side of this building as part of the decorative scheme: two certainly at the end of the large ramp, two more perhaps at the junction of the two ramps. This would correspond approximately to the locations of the pieces as found during the excavation.

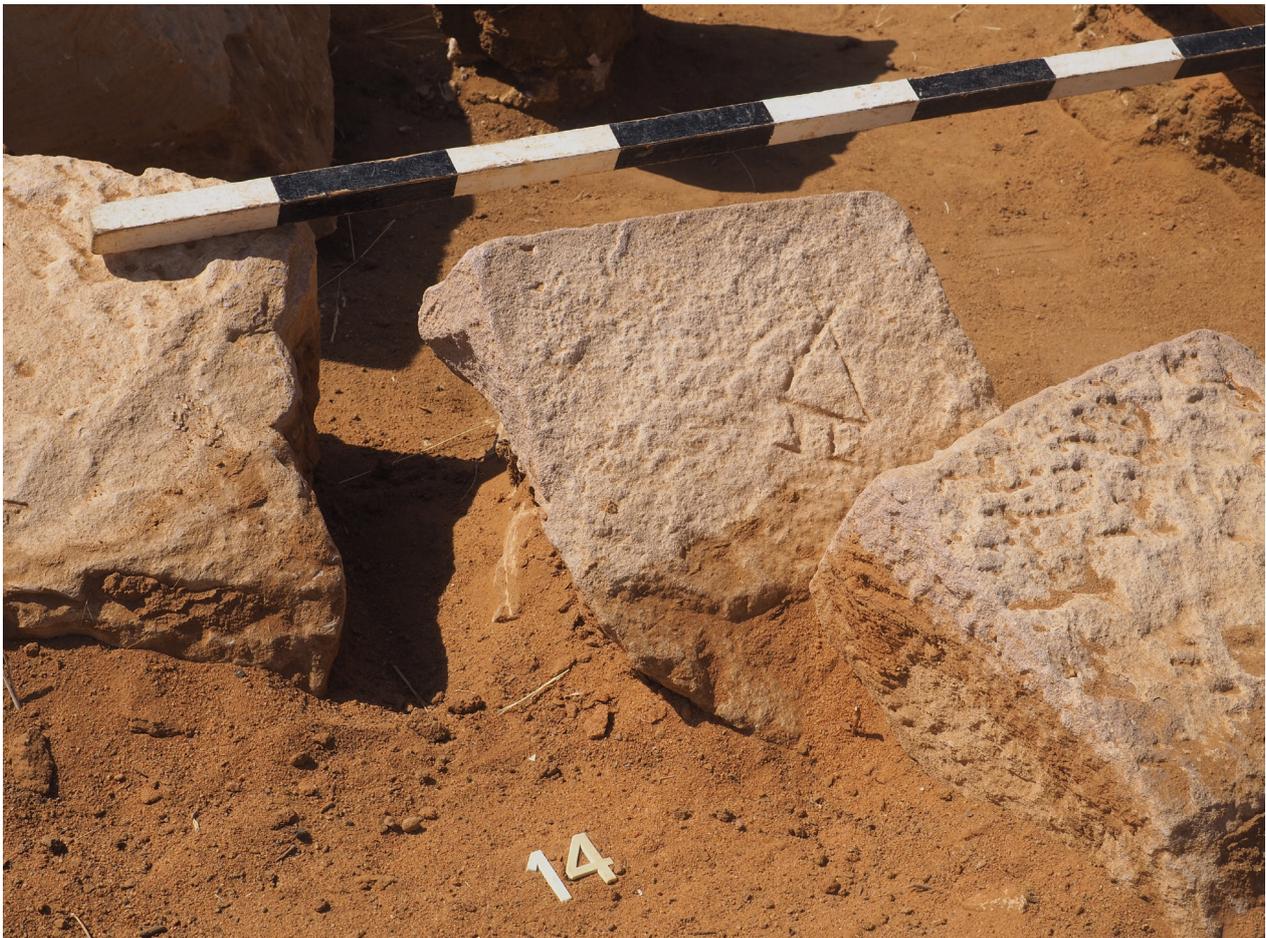
Figure 24. Quarry marks on sandstone blocks from the northeast corner of the podium (© Naga Project).

The elaborate front, in addition to the decoration of the central ‘room’, indicates that this building had some official function. Perhaps considering its northerly location at the edge of ‘Naga City’ it might have served as a reception building for arrivals or for some other official festive function, as seems indicated by the impressive entrance. As excavation continued in 2021 and 2022 a larger wall running toward the north, enclosing this and other buildings was found. At the northeast corner of the podium several carved sandstone blocks were found with engraved quarry marks (Figures 24 and 25).

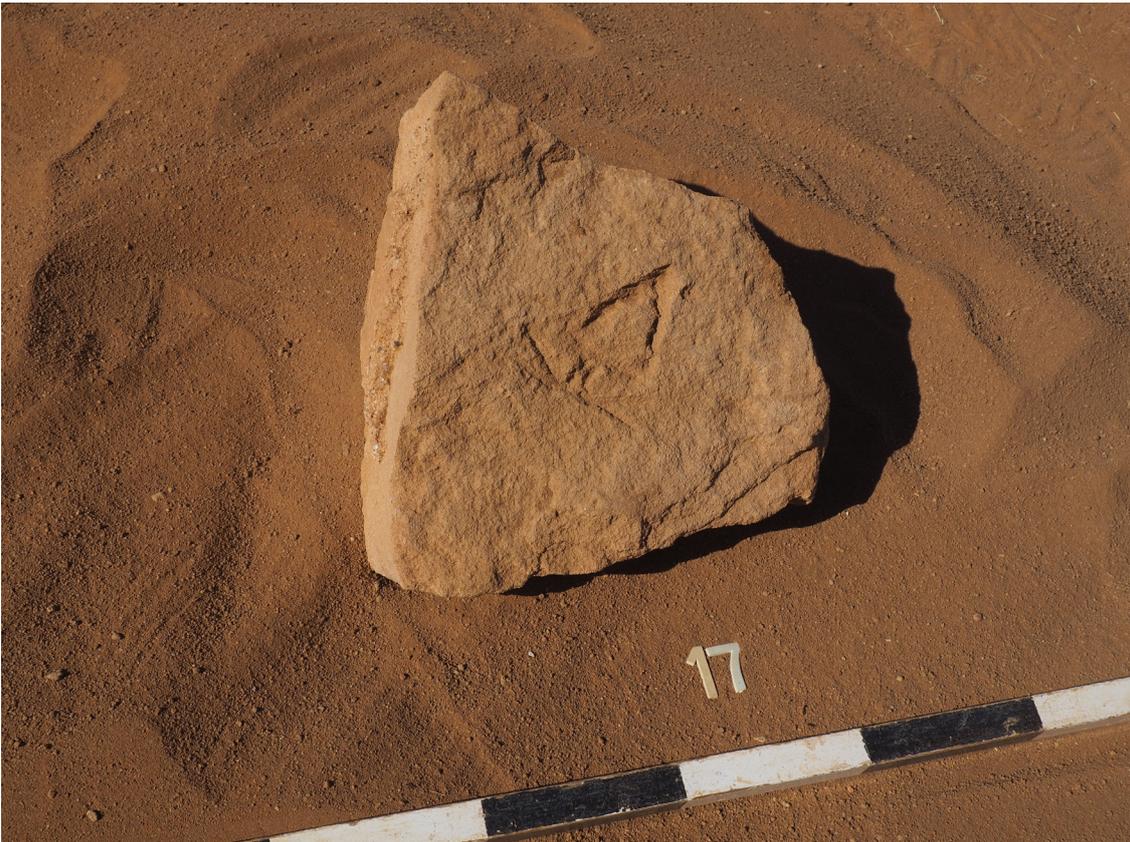
Figure 25. Quarry marks on sandstone blocks from the northeast corner of the podium (© Naga Project).
