SUDAN & NUBIA

Preliminary report on excavations at Naga 2020-2022

Karla Kroeper and Christian Perzlmeier

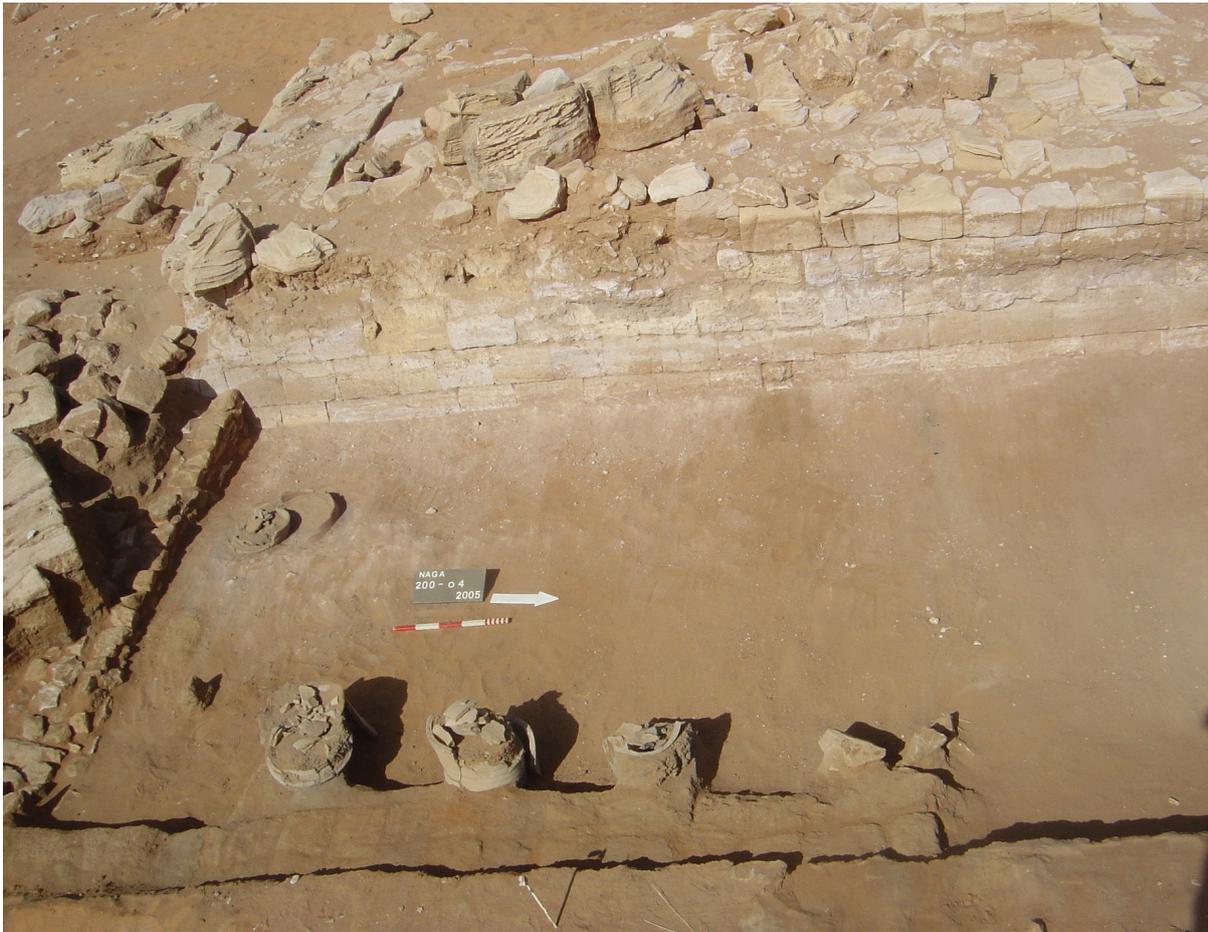
Figure 26. Extension on the east side of Temple 200 as found in 2005 (© Naga Project).

Work continued in 2021 east of Temple 200, where the excavation of the temple itself was finished in 2005. At that time additional walls leading east-west from the eastern temple wall were already noted but not further excavated. The placement of many large pots along the wall made a preliminary interpretation of an appended cooking area to Temple 200 most likely (Figure 26).

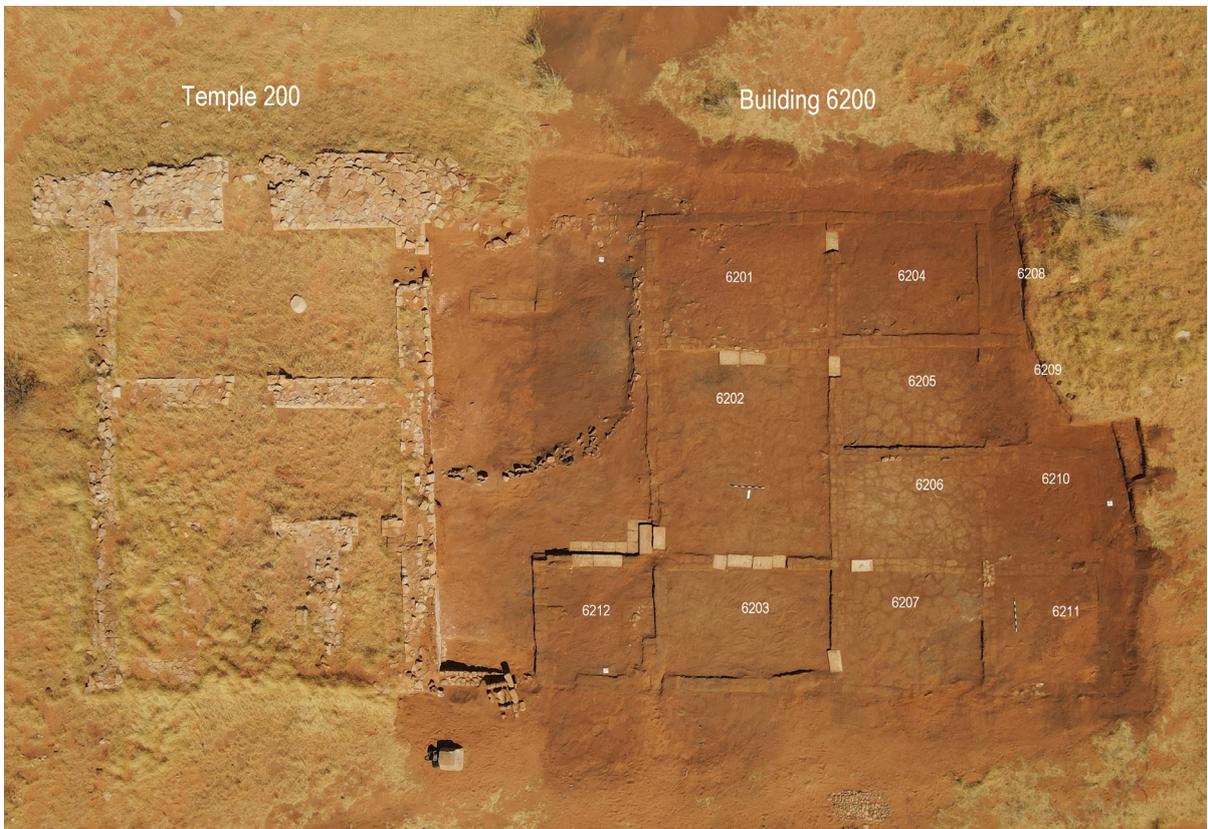
Figure 27. View of Temple 200 and Building 6200 in 2022 (© Naga Project).

During excavation in 2022 it was revealed that a supply building had been connected to Temple 200 (Figure 27). This building numbered 6200 contains 12 rooms and has an overall size of 14.25m x 12.85m. It represents a similar conglomerate of temple plus supply rooms as known from other areas in Naga, for example next to the Amun Temple (with the connected Building 4000), the Lion Temple (with the connected Building 3800) and Temple 600 plus 650 (with the connected Building 2200).

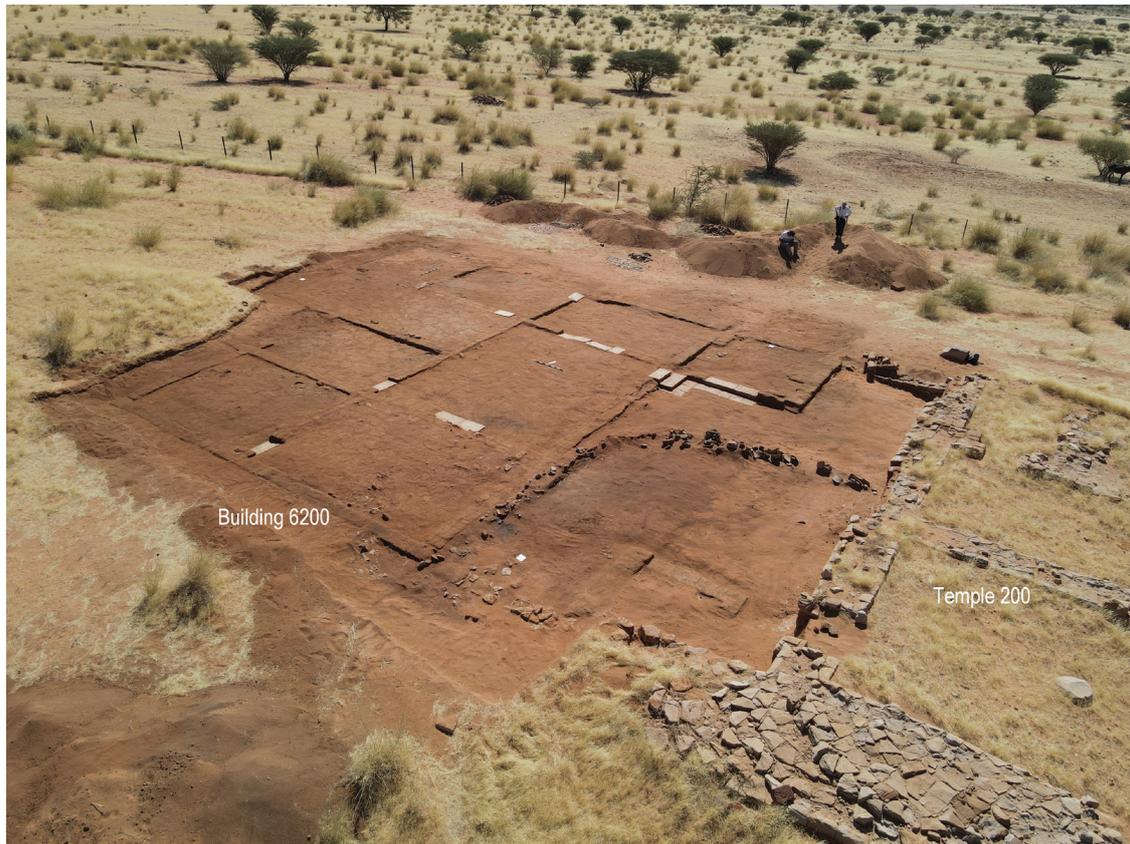
Figure 28. In the foreground the quarter circle space defined by ceramic sherds. View from the southwest (© Naga Project).

Both the foundation of the walls and the doorsills are at the same level as the building level of Temple 200. An interesting feature is a quarter circle space formed by hundreds of broken body sherds placed upright in a light mud base and curving from the northwest end of the east wall of the temple toward the east wall of Building 6200 (Figure 28). What the function of this division or separate space might have been is unclear.

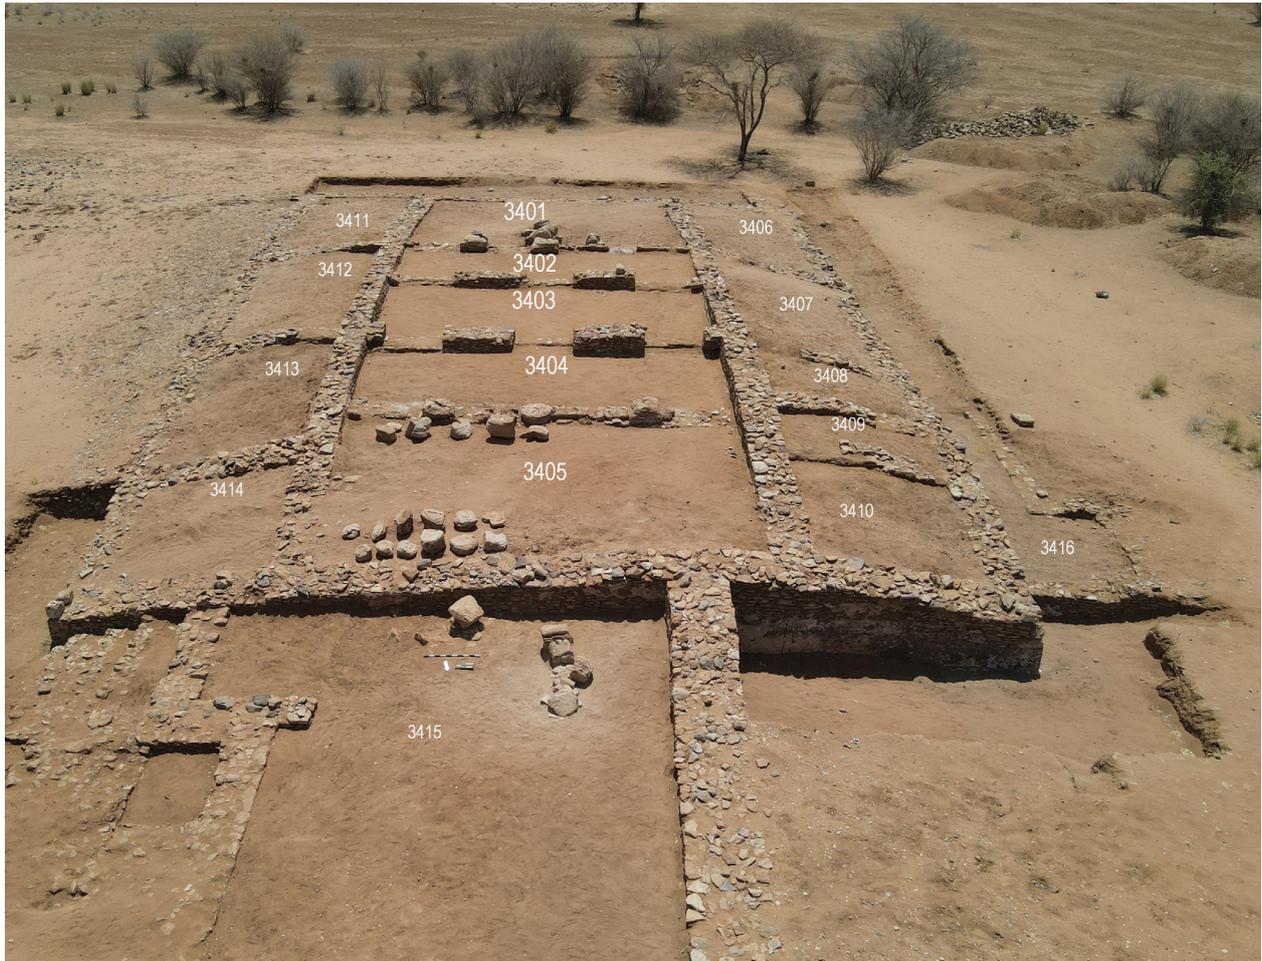
Figure 30. View of 3400 from the north. Columns already removed (© Naga Project).

The central part of the building consists of one roofed room with three doors at each end for accessing the room (3403). Interestingly the doorways were here, as found in other buildings in Naga, filled with one layer of burned bricks probably added later to raise the level. Both ends of this room are flanked by a porticus formed by three columns that are, in the south, placed on square bases (3402). In the north, two columns (3404) are placed on square bases but the central column has an unusual round base, perhaps an indication of the exceptional position of the northern part of the building. The columns had collapsed and were very badly eroded, but two fragments of papyrus-shaped capitals were identified (Figure 30).

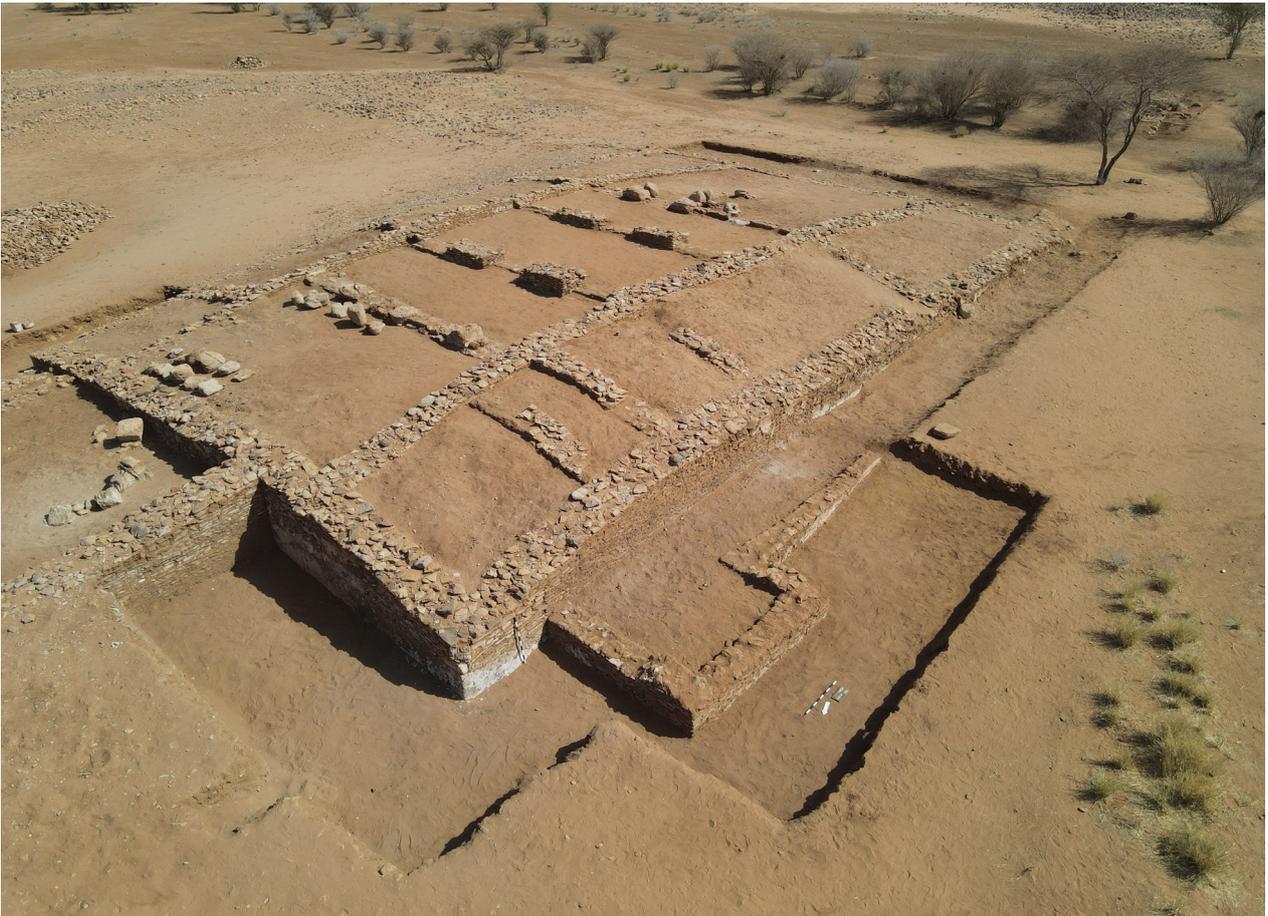
Figure 31. View of 3400 from the northwest. Small ramp in the foreground (© Naga Project).

preserved to an appreciable height of c. 1.80m (Figure 31). Apart from several large-size broken pots with ashes inside in unrelated positions and probably from a later phase, and a few fragments of faience, no finds were made on top of the podium. Several sondages were made into the podium itself on the east side in which various broken vessels were found in the rubble fill. Indications are that the building may have been a guard station, observation platform or waystation. An exact building date (inscriptions were not found) could not be determined; however, the few ceramics present indicate a date range similar to Building 1200, of which the following C¹⁴ dates exist (Figure 32):

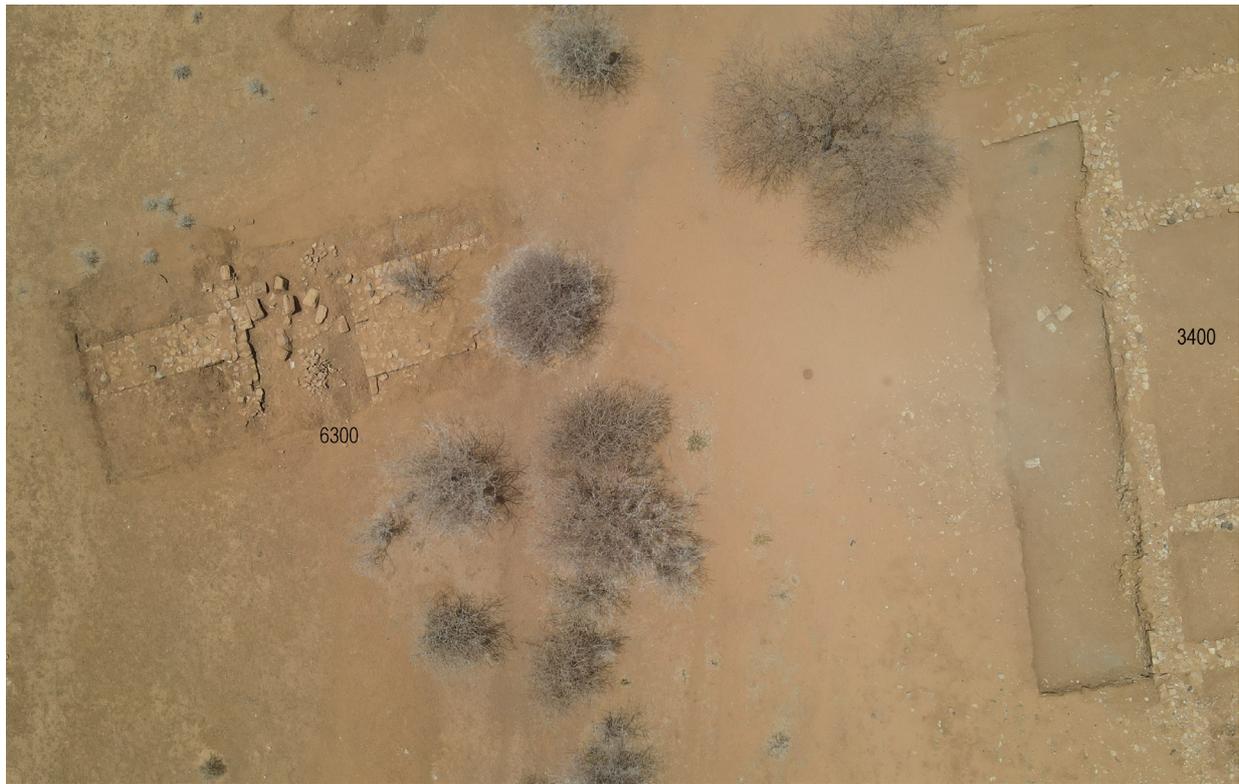
Figure 33. View of Gateway 6300 in 2022 (© Naga Project).

After initial excavation in this area, the large blocks were shown to belong to a gateway oriented east-west (Figure 33). Unfortunately, their location is in the middle of a wadi that is often flooded so the preservation is poor. Only the lowest layer of the gate is preserved. The wall running to the south of the gate may connect to Building 3600 near the lion temple. This is the first documented gateway in the south-west area of the city of Naga.

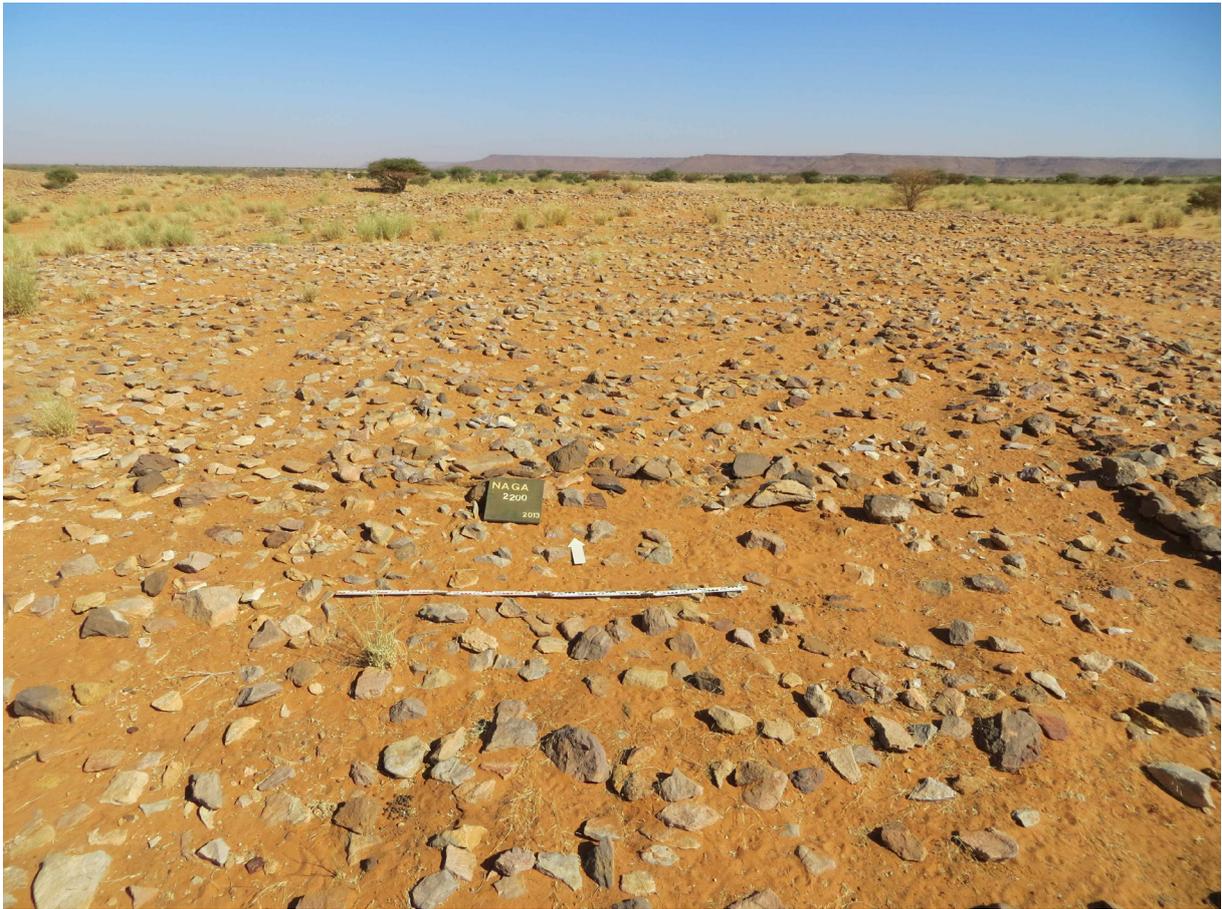
Figure 34. Building 2200 before excavation (© Naga Project).

Excavation in 2200 started in 2019 (Figure 34) and work continued in subsequent years due to its large size. The building lies to the east of Temple 600 and 650 and is c. 29m x 29m in size. The walls of its 20 rooms are built completely of stone rubble (Figure 35). Some of those in the west and south are almost completely eroded, but the walls of the central rooms are preserved up to a height of 1.30m.

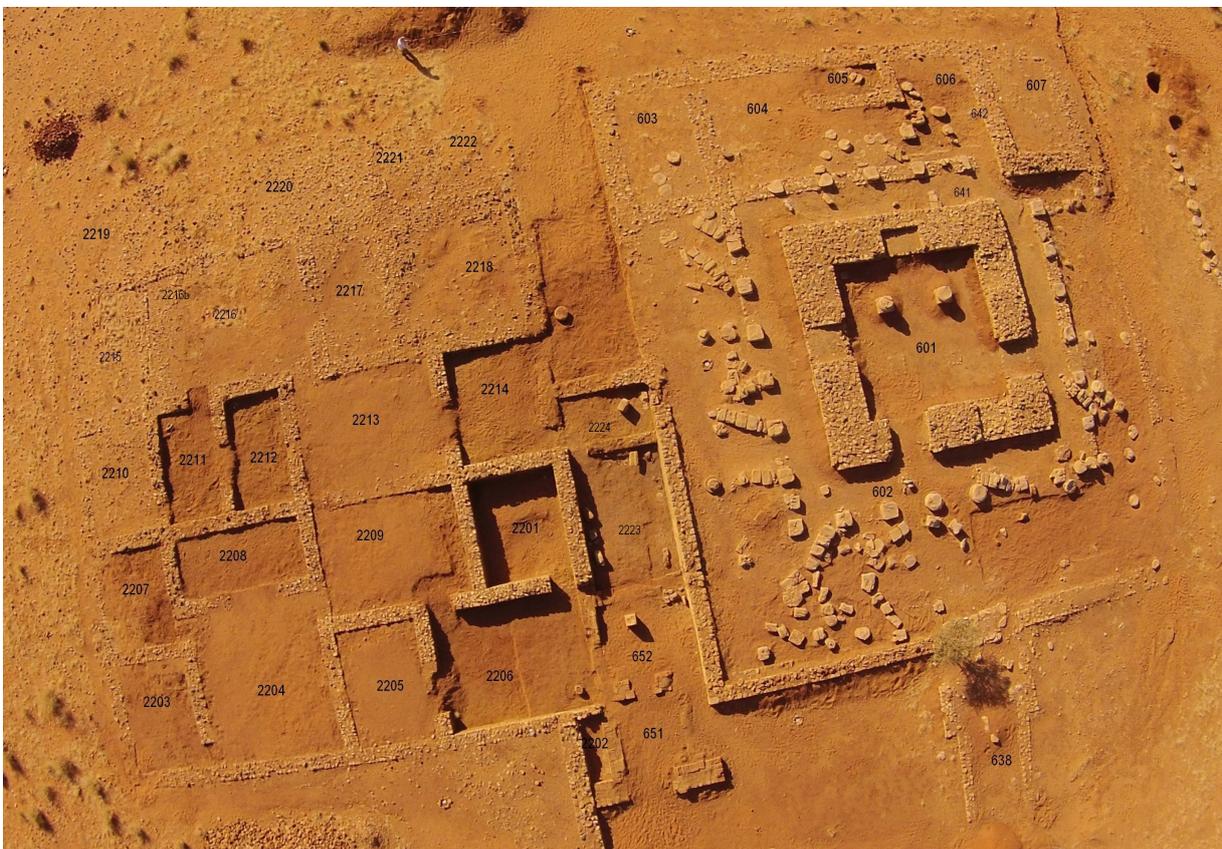
Figure 35. View of Building 2200 in 2022 (© Naga Project).

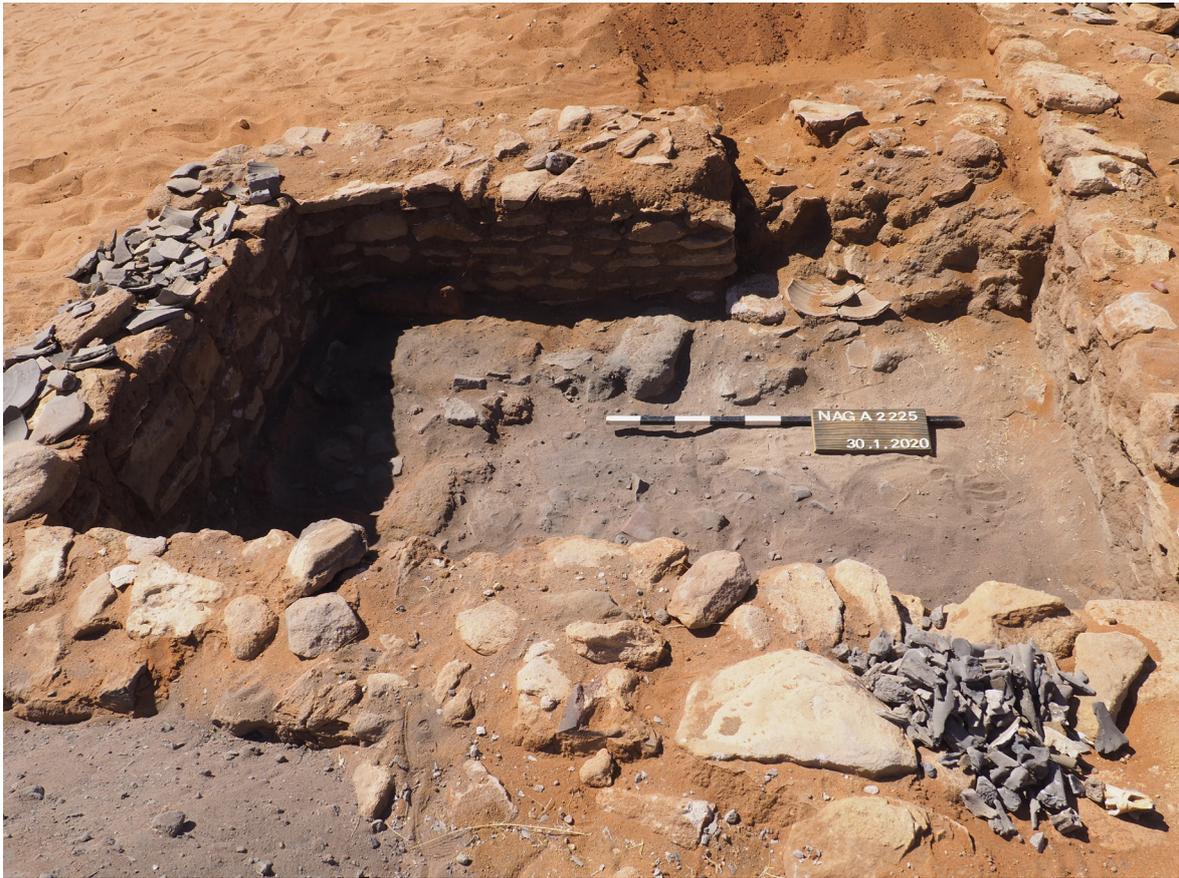
Figure 36. Dump filled with ashes ceramic and animal bones (© Naga Project).

Some smaller 'rooms' were used as dumps, filled with ashes, animal bones and hundreds of potsherds (Figure 36). Generally, the rooms are either completely empty and the floor very clean or they are overloaded with potsherds and whole pots. In some cases, the small rooms seem to have been reused, as sometimes a small wall was added internally built on the vessels and potsherds which lay below (Figure 37).

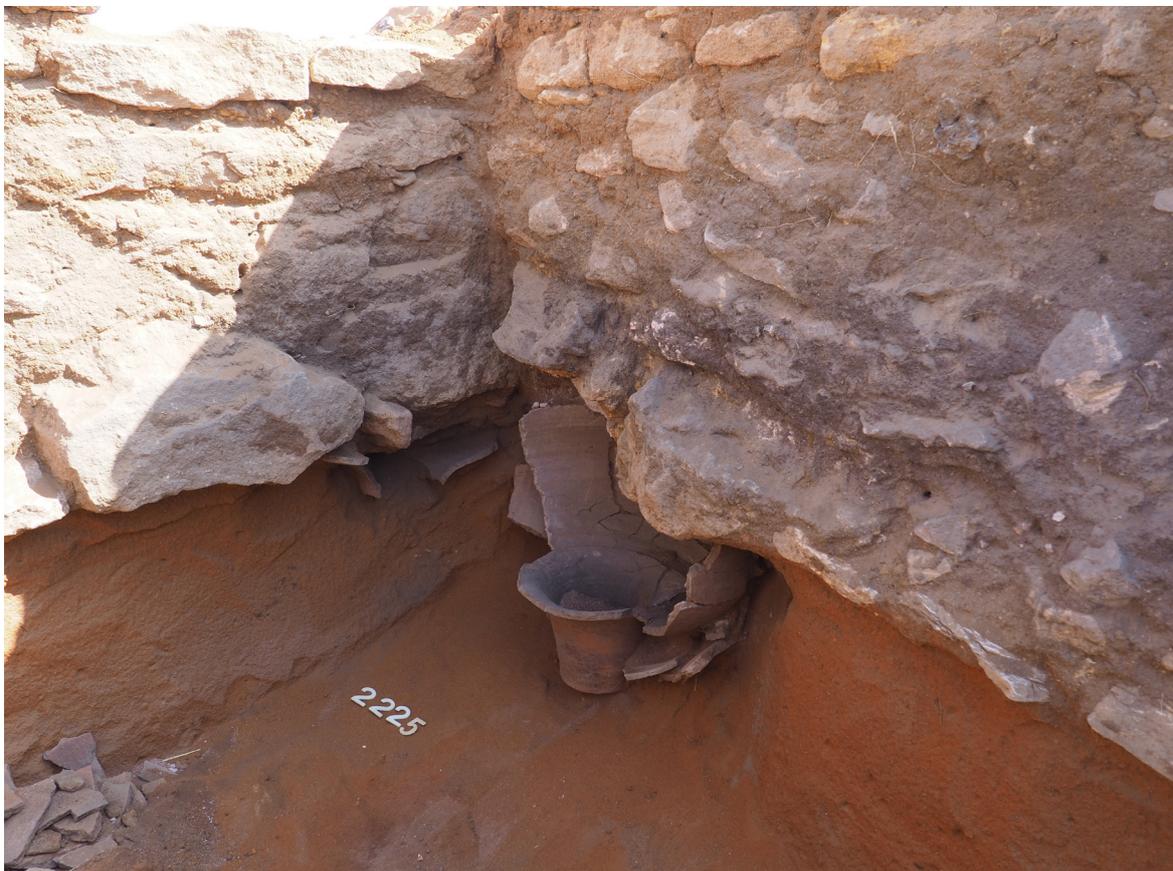
Figure 37. Wall built on top of previously used ceramics (© Naga Project).

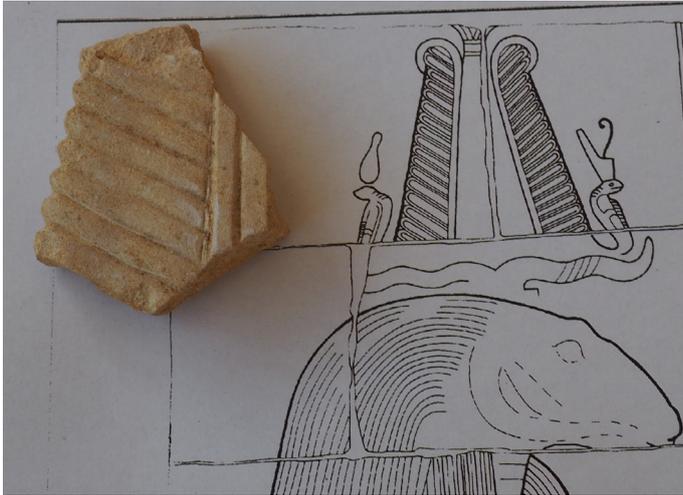
Figure 38. Stone fragment of a relief (© Naga Project).

In a few cases other types of finds were made in various rooms, including a small stone carved feather fragment, part of an Amun crown (Figure 38). Fragments of a ceramic offering plate with an *ankh* sign were also discovered (Figure 39). The vessels found in the different rooms are of the type already known from other buildings; however, in rare cases they are of an unusual type such as a floral painted amphora, which is unique at Naga (Figures 40 and 41). Three rooms excavated during the last campaign (2022) turned out to be fully stocked kitchen rooms, with 25 pots *in situ*. In some cases, several pots had been

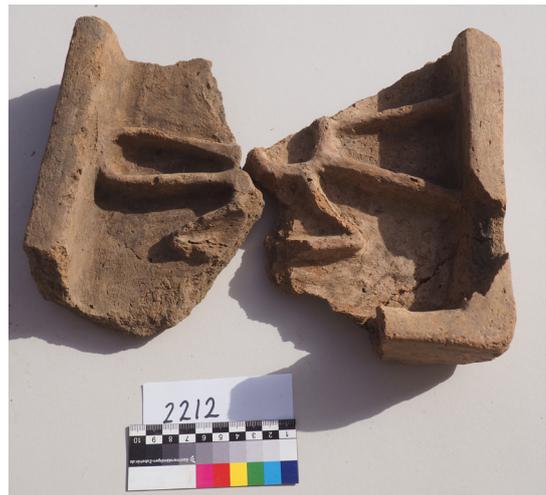
Figure 39. Ceramic offering plate (© Naga Project).

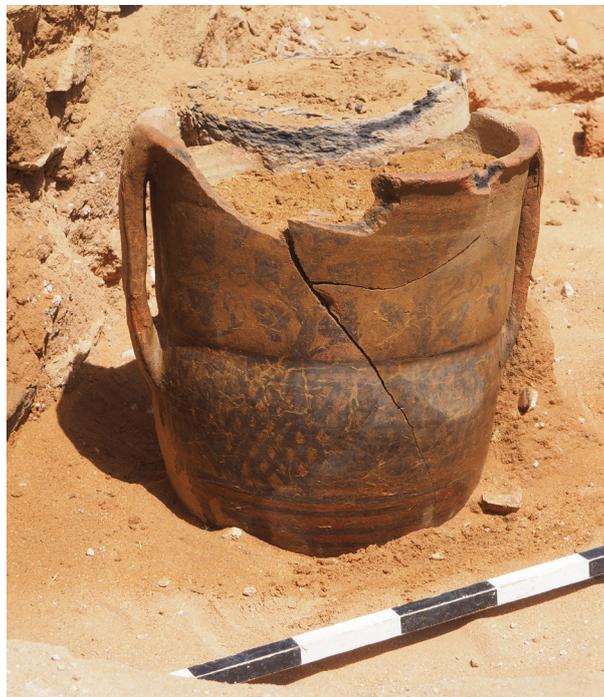
Figure 40. Amphora with floral decoration (© Naga Project).

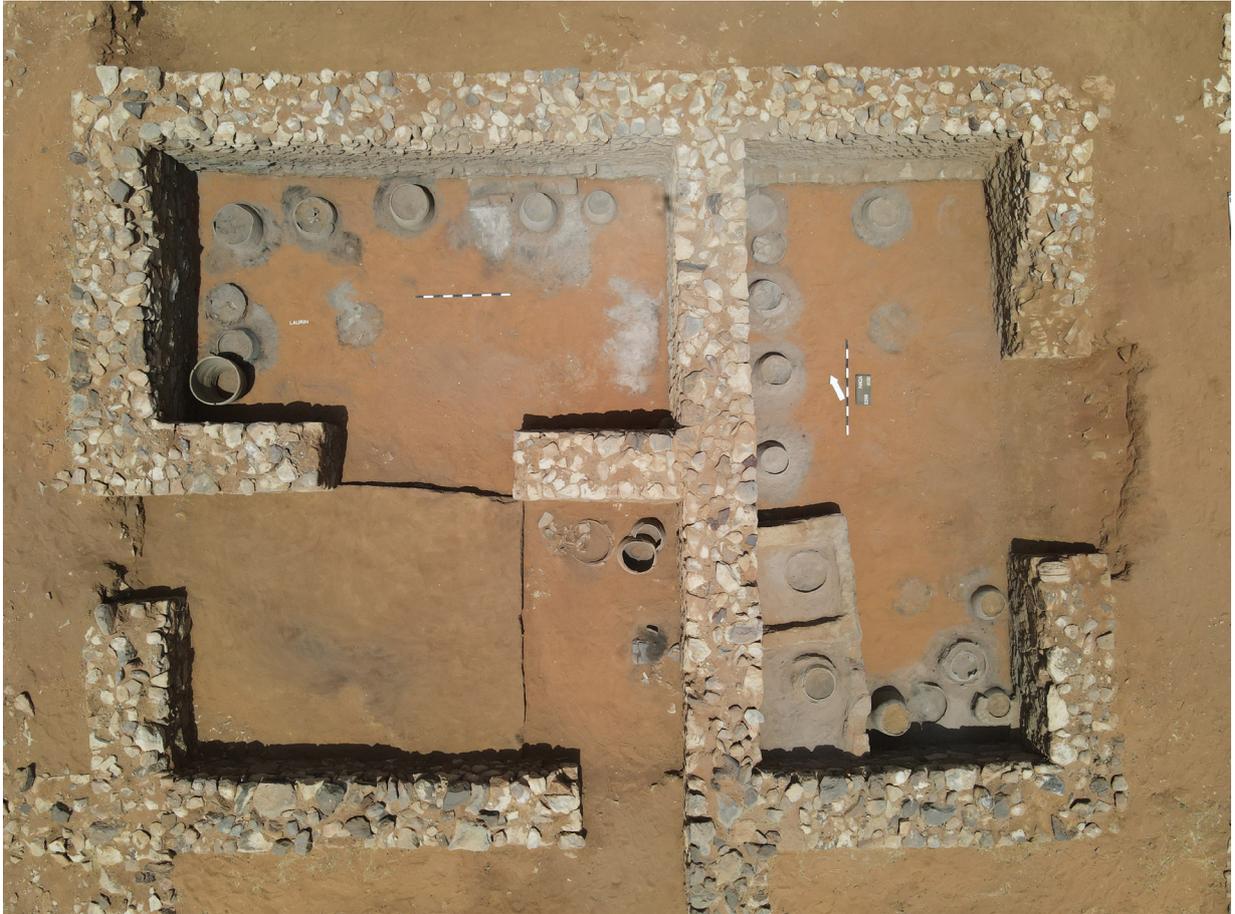
Figure 42. Kitchen rooms (2208, 2211, 2212), Building 2200 (© Naga Project).

stacked on top of one another. In Room 2208 a small installation of four layers of burned and unburned bricks was added to the room in which several very large vessels were placed. Interestingly at floor level a hole connected Rooms 2208 and 2211. It was filled with ashes. Almost all the ceramic pots were broken and often sherds as well as ashes and animal bones were found inside. Beside the central kitchen and cooking unit, the building also had magazines and storage areas (Figures 42 and 43). The date according to the C14 results fits well with the date of the adjacent Temple 600 (Figure 44).

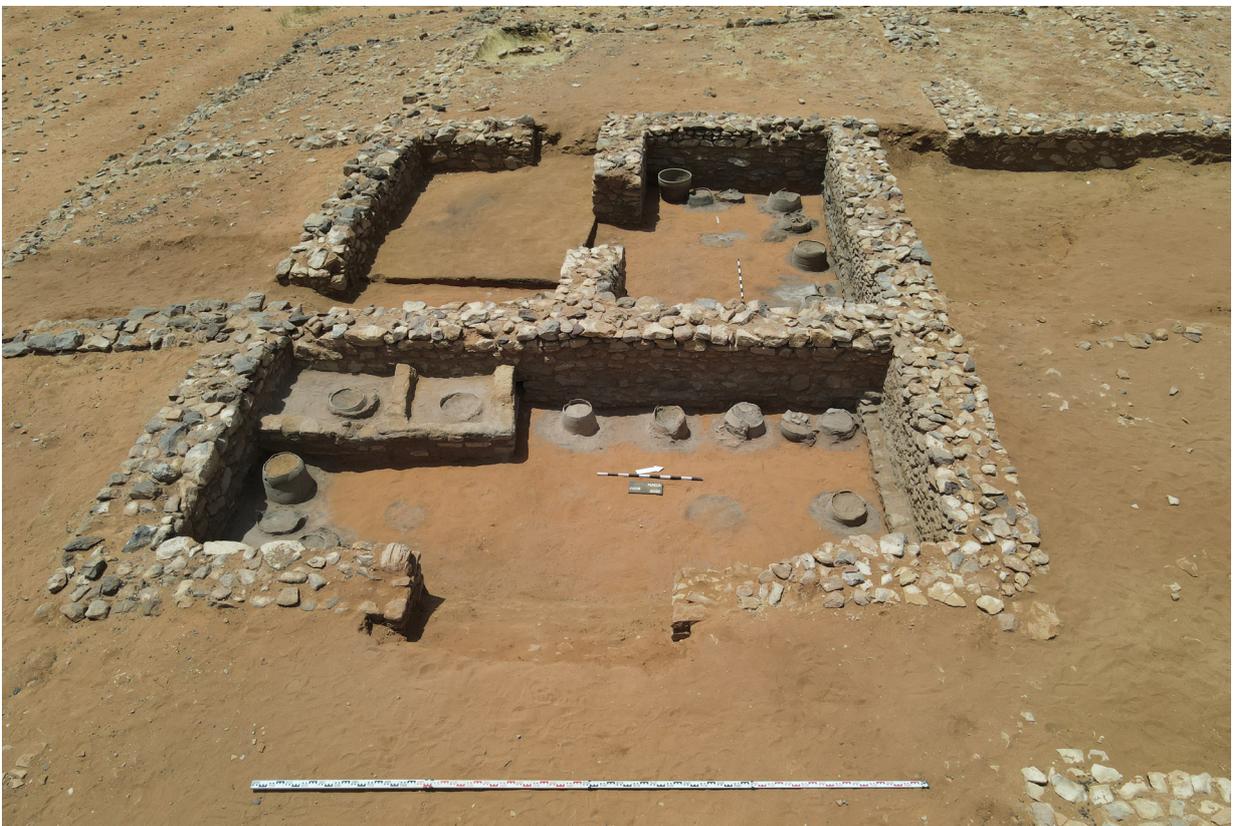
Figure 43. Kitchen rooms in Building 2200 view from the east (© Naga Project).
