7. Excavations in the temenos gateway, Area (TG5)

Derek A. Welsby

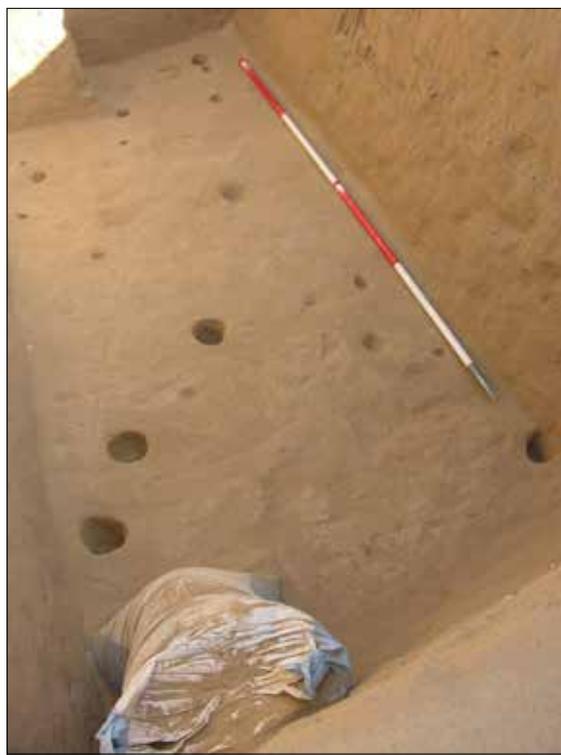
Plate 7.1. Period 1 surface and post-holes to the east of the later gateway looking north – scale bar 2m.

Not wanting to destroy the extent remains of the temenos gateway this period was only visible in two small areas to the east and west of the gateway (Figure 7.1, Plate 7.1). The contemporaneity of the surface reached in these two trenches 5.5m apart seems certain. The hard silt surface was pierced by a large number of post-holes. In the limited area exposed no plan of any structures was visible. The post-holes fall into two main groups, larger holes ranged in diameter from 90mm to 120mm and smaller stake-holes from 30-70mm. The former were up to 190mm deep, the latter were often very shallow. Some but by no means the majority were natural features, animal or root holes.

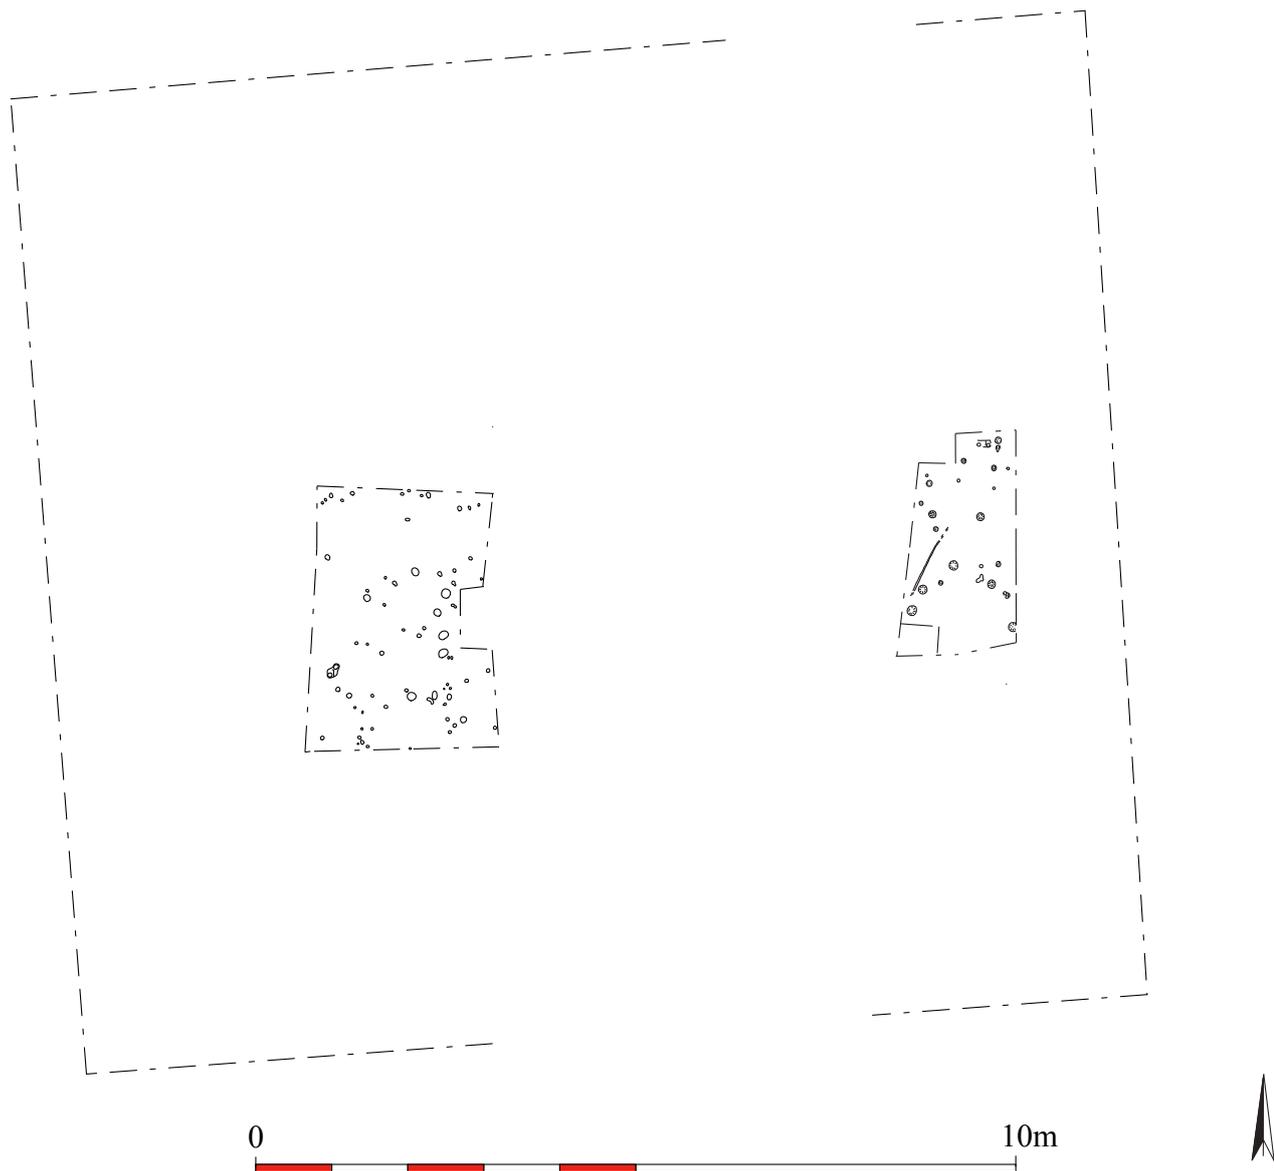
Figure 7.1. Area (TG5), Period 1 (scale 1:100).

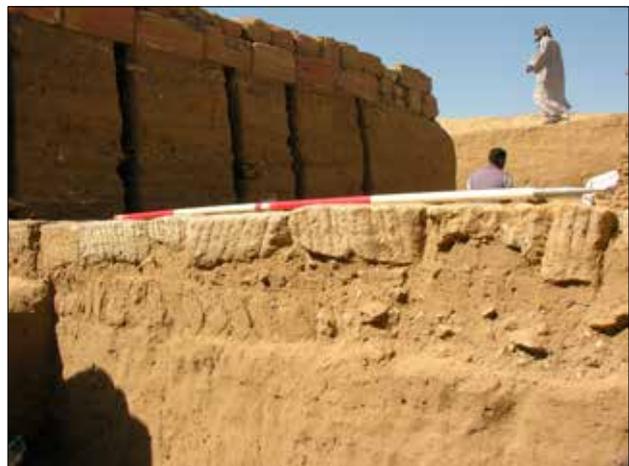
Plate 7.2. Mud brick and rubble foundation for the stone paving in the Period 3 gateway – scale bar 2m.

on edge while those to either side were angled in towards the centre forming a slightly convex surface (Plate 7.2).

In the construction phase of Period 3 the timbers were removed from the large post-holes and a vertical sided foundation trench was cut into the surface. Into this was placed towards the centre of the gateway a row of mud bricks only visible on the east side of the gate paving in the sondage. Those right in the centre of the gateway were set

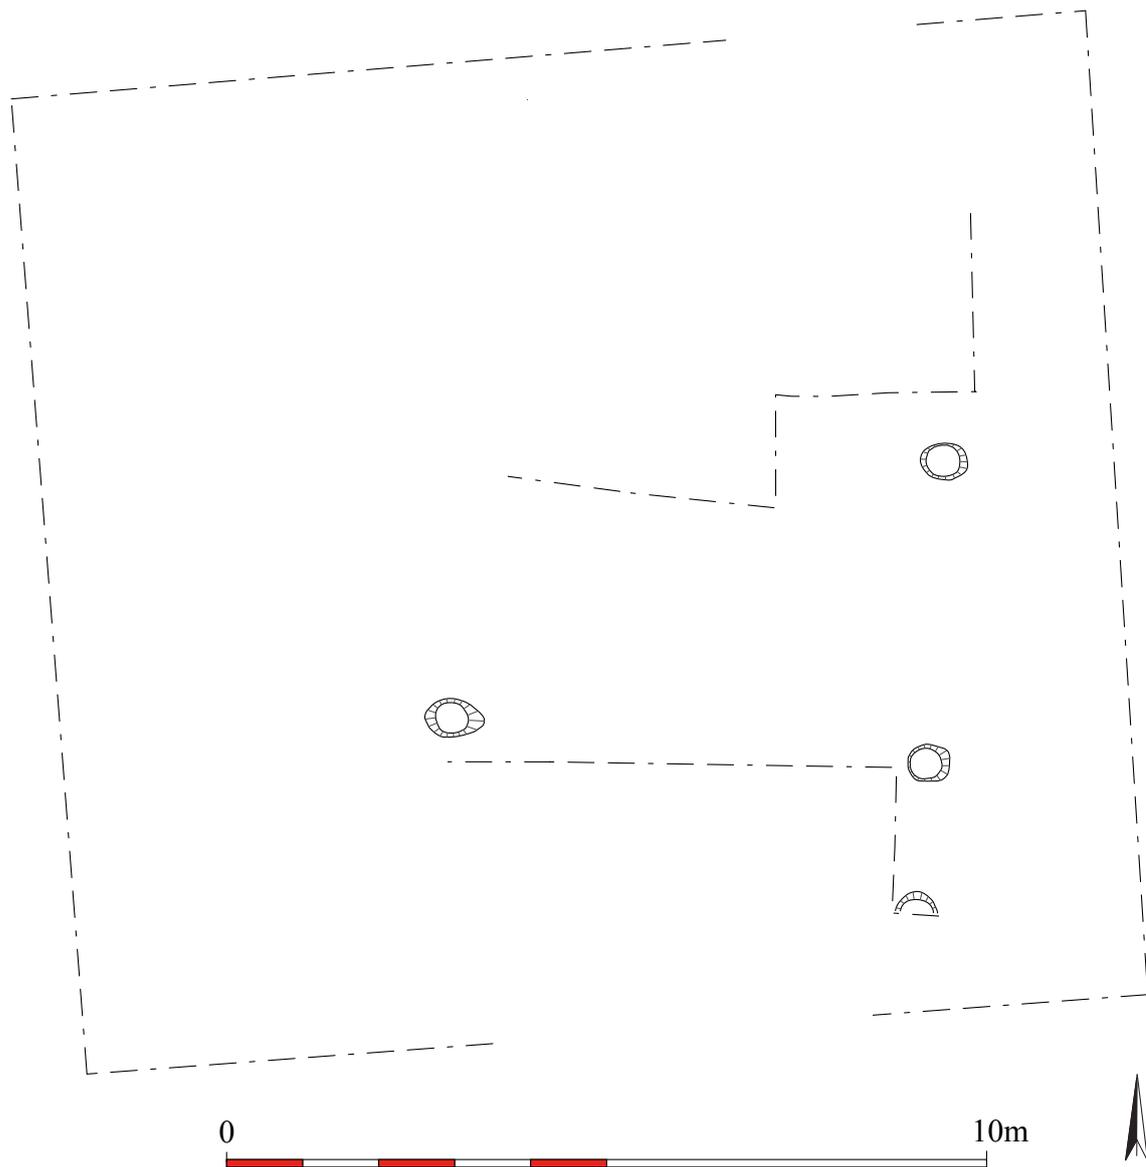
Figure 7.2. Period 2 post-holes (scale 1:100).

Surfaces (TG5)115 and 116 were cut by four large post-holes, three to the east of the later gate and one to the west (Figure 7.2, Table 7.1). Others can certainly be postulated. Those to the east formed a row 6m in length centre to centre parallel to the later temenos wall but were not evenly spaced. Too small an area was excavated to suggest a function for the posts set into these holes. That in the south-

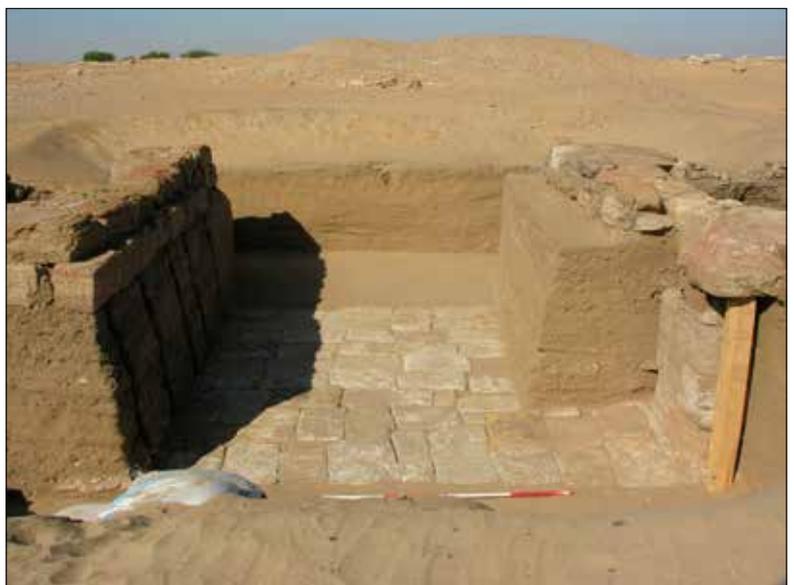
Plate 7.3. Stone paving in the Period 3 gateway – scale bar 2m.

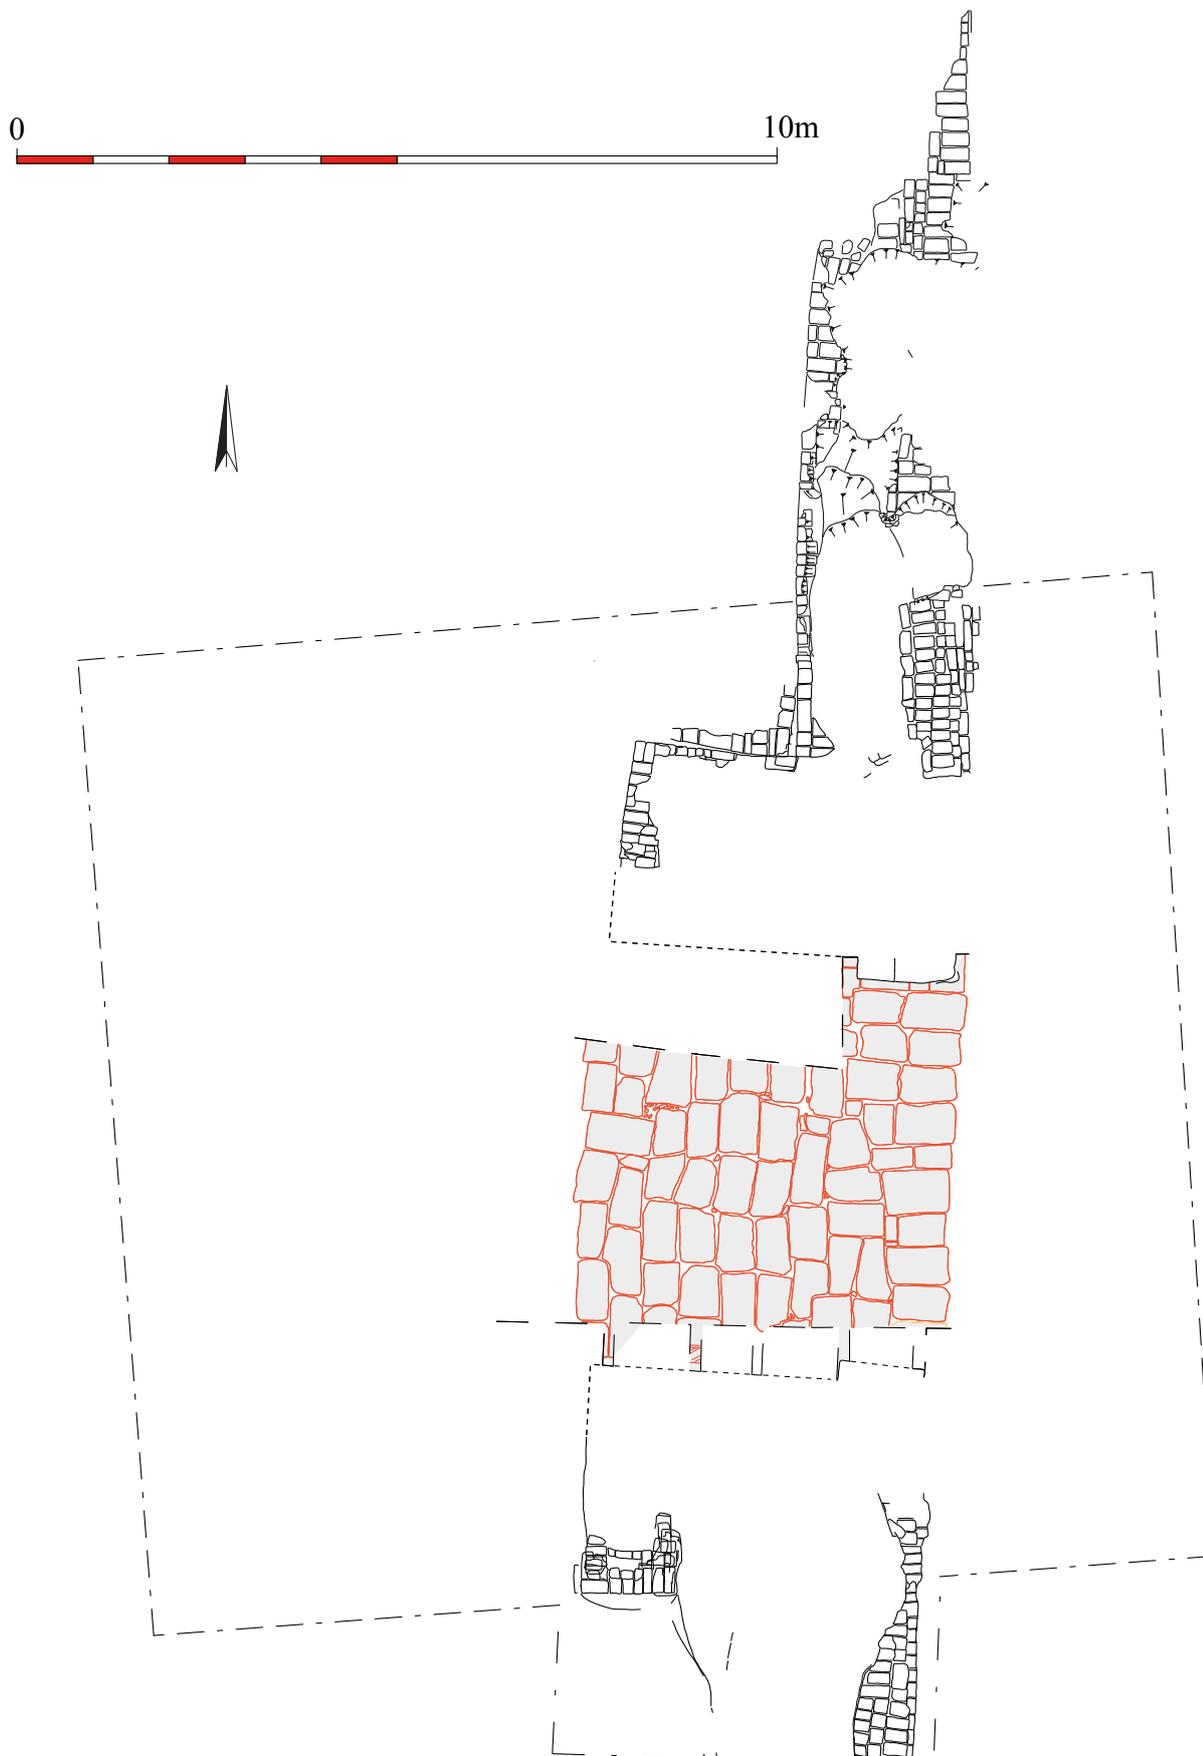
Figure 7.3. Period 3. Stone gateway and paving (in red) in the mud-brick temenos wall (scale 1:100).

Period 3. Construction of a massive stone gateway and mud-brick wall. The stone pavement with an elaborate foundation was built first and then the stone revetment of the gate passage was set directly upon it. The stone pavement although showing little wear was in use for a long period during which the north jamb was severely wind eroded.

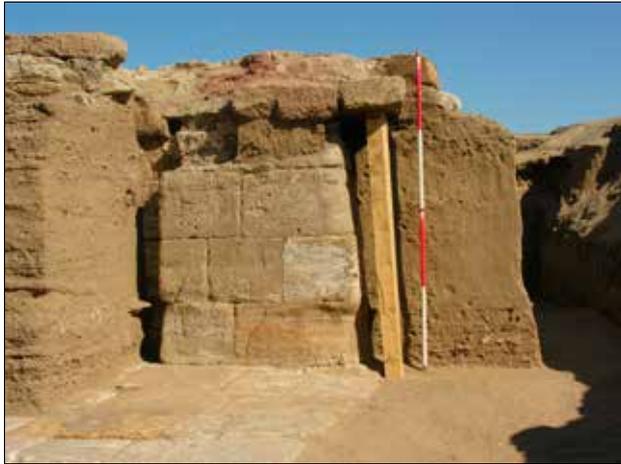
Plate 7.4. The north jamb resting on the stone paving in the Period 3 gateway – scale bar 2m.

walls of the gate which used it as their foundations. Both these walls were only revealed in part as the later walls were largely left *in situ* making total excavation impossible. The south wall was glimpsed in several narrow slots. Of what could be seen of it, it can be confidently assumed to have been similar to the north passageway wall. The eastern end of this was cleared and consisted of four courses of well-dressed white sandstone masonry surviving to a height of approximately 1.6m (Plate 7.4, Figure 7.4). The front face was battered at an angle of about 5°. The jamb measured 1.29m east-west and projected 286mm from the wall line.

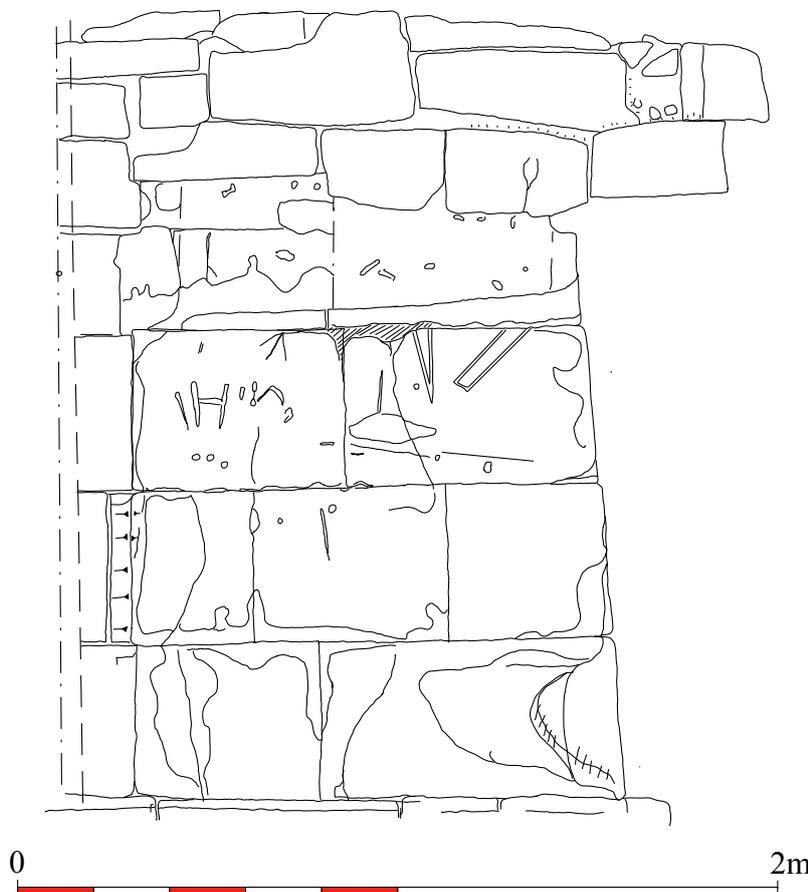
Figure 7.4. Period 3 north gate jamb with the Period 6 revetment above (scale 1:20).

Together with the southern jamb they will have reduced the 5.6m wide passage to 5.07m. No evidence was found for the location of the door pivot nor for any bolt mechanism either in the pavement in the centre of the gate or in the north passage wall. There was no scoring resulting from the closing of gates. The eastern corner of the gate passage was rounded and severely wind-eroded particularly on the lowermost block indicating that it was exposed to aeolian erosion for some considerable time.

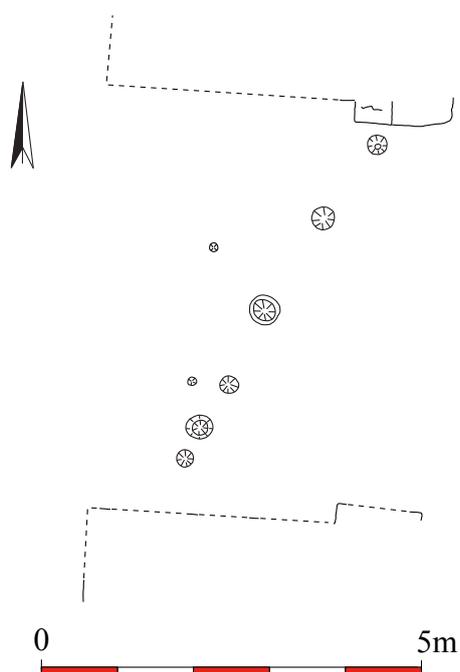
Figure 7.5. Period 3-4, post-holes (scale 1:100).

At a level 1.1m above the paving was a sandy surface [(TG5)79] with some admixture of silt and charcoal. Cutting this was a line of six post-holes running obliquely across the gate passageway (Figure 7.5). These attained a maximum depth of 110mm and a diameter of 330mm. Looking at the spacing and dimensions of the holes it appears that initially there were only four posts (another may be hidden at the south end under the unexcavated baulk), the southern three 1.68 and 1.44m apart centre to centre while the gap at the

north end was 1.2m wide. That at the northern end of the line was set very close to the stone face of the passageway and the situation was probably similar at the other end. Two smaller posts were then added in the southern section of the line and two much smaller posts/stakes was set a little behind the line. The largest post-hole (post?) was that in the centre.

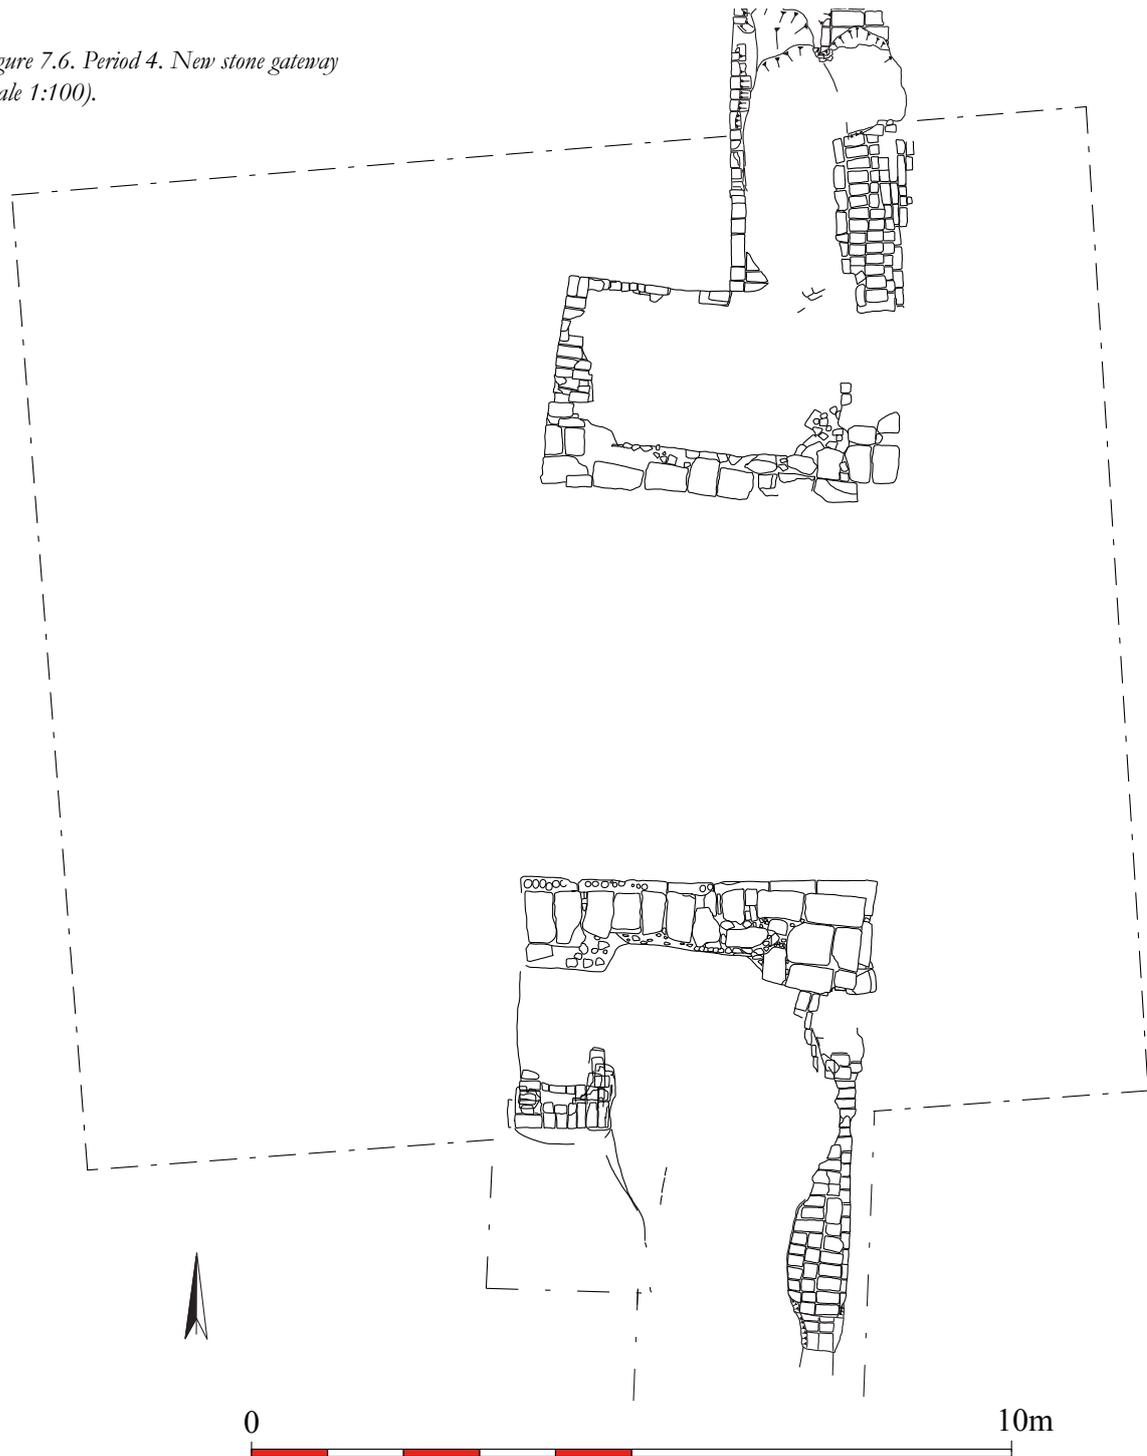
Figure 7.6. Period 4. New stone gateway
(scale 1:100).

structed utilising reused large stone blocks (Figure 7.6). These, surviving to a height of two courses, about 400mm, were laid in a careless fashion in some cases with the bedding planes of the stones set vertically. The lowest course projected between 191mm and 243mm from that above on its north side and also to a lesser extent to east and west. The lowest course of the wall was 4.69m in length, the upper course mainly of headers was a maximum of about 680mm thick except at the north-east angle where it was 1.32m thick. The stone revetment extended 1.48m along the face of the temenos wall to the south of the gate at the level of its first course. There was no projecting jamb against which the gate could close. Traces of white plaster may indicate that the wall was rendered although this may relate to the original use of the stones.

The north passageway wall was also replaced with a wall of similar construction to that to the south but without a projecting lowermost course. This was only visible largely in plan as the Period 6 modifications were not removed during excavation. By the time of its construction the primary wall must have been reduced almost to the ground level and the highest course was in a very poor state, being very friable and heavily eroded. The gate passage was 5.1m wide above the footings and its east end increasing to 5.4m wide to the west.

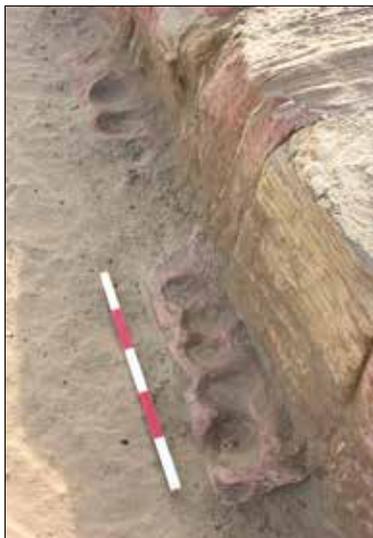
Plate 7.5. Circular, bowl-shaped depressions cut into the stones of the Period 4 gateway's first course – scale bar 500mm.

Abutting the new south wall was a further levelling layer of compact sand with some pottery and bone [(TG5)29]. Cut into the upper surface of the projecting first course of the south wall was a series of circular bowl-shaped depressions (Plate 7.5). At least one of these was cut through by a Period 5 post-hole. They may have been small grinding hollows or part of a game; the depressions are similar to those used in *mancala* although the arrangement with only a single row is very different.

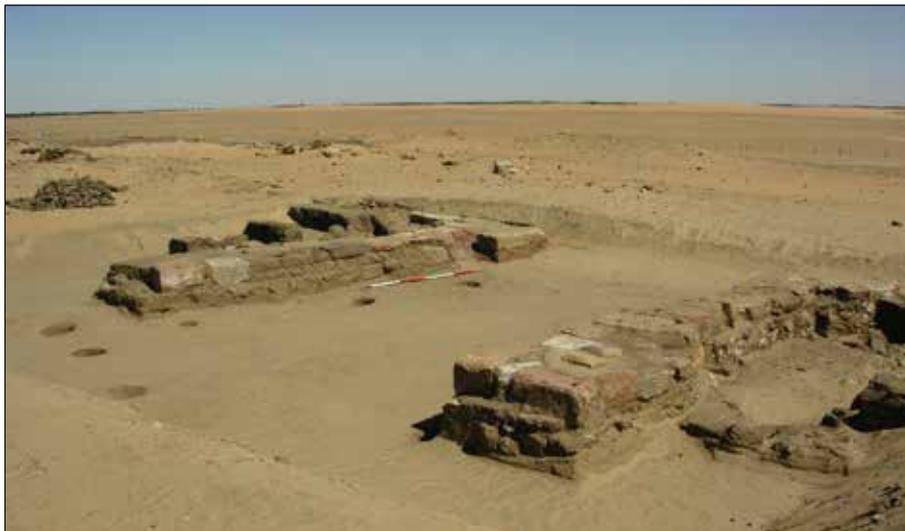
Plate 7.8. Period 6, reuse of the Period 4 stone gateway and extension of the gate passage at its west end – scale bar 2m.

The south wall of the gate passage was extended by approximately 1.77m to the west by a wall faced with large stone blocks and with a mud core (Figure 7.8, Plate 7.8). It abutted against the Period 4 wall and was in line with its north face. The wall was about 1.17m thick and projected west of the inturn of the temenos wall. It survived to a height of two courses, 660mm. This appears to be contemporary with a more extensive refurbishment of the north side of the gateway. Here the Period 3/4 wall was extended to the west by a wall mainly constructed of mud bricks arranged in a mixture of headers and stretchers in each course but

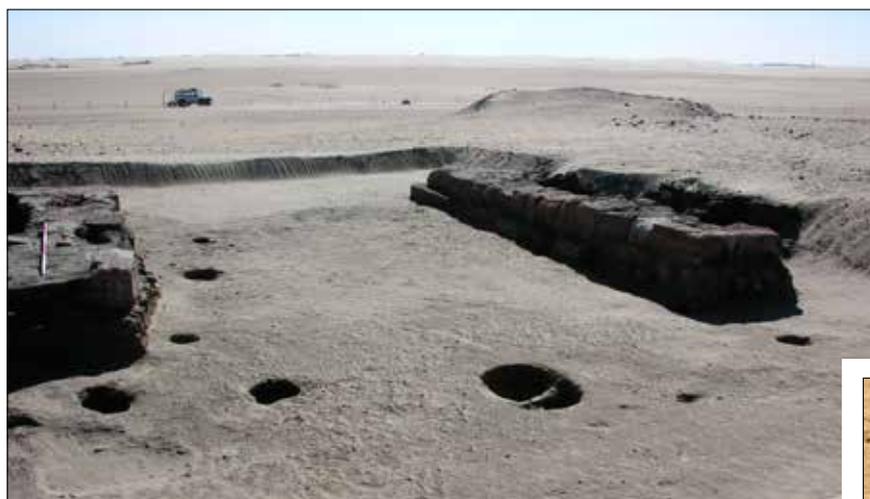
Plate 7.6. Post-holes of the Period 5 gateway looking east – scale bar 2m.

This substantial gateway must have been in poor condition when it was rebuilt or strengthened in timber. Massive posts formed the two sides of the gate passage (Plate 7.6) while a central triple post-hole (Plate 7.7) presumably supported the timbers against which the two leaf gate closed at the inner end of the passageway (Figure 7.7). Most of the timbers were set in substantial, but shallow post-holes (for example post-hole (TG5)28 at 300mm in diameter and 190mm deep)

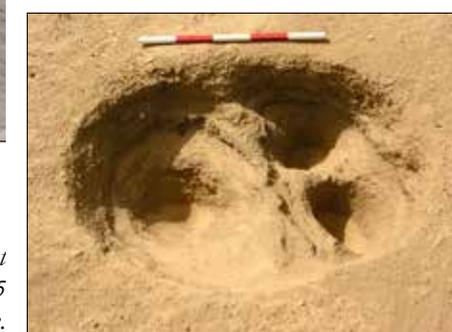
Plate 7.7. Triple post-holes at the inner end of the Period 5 gateway – scale bar 500mm.

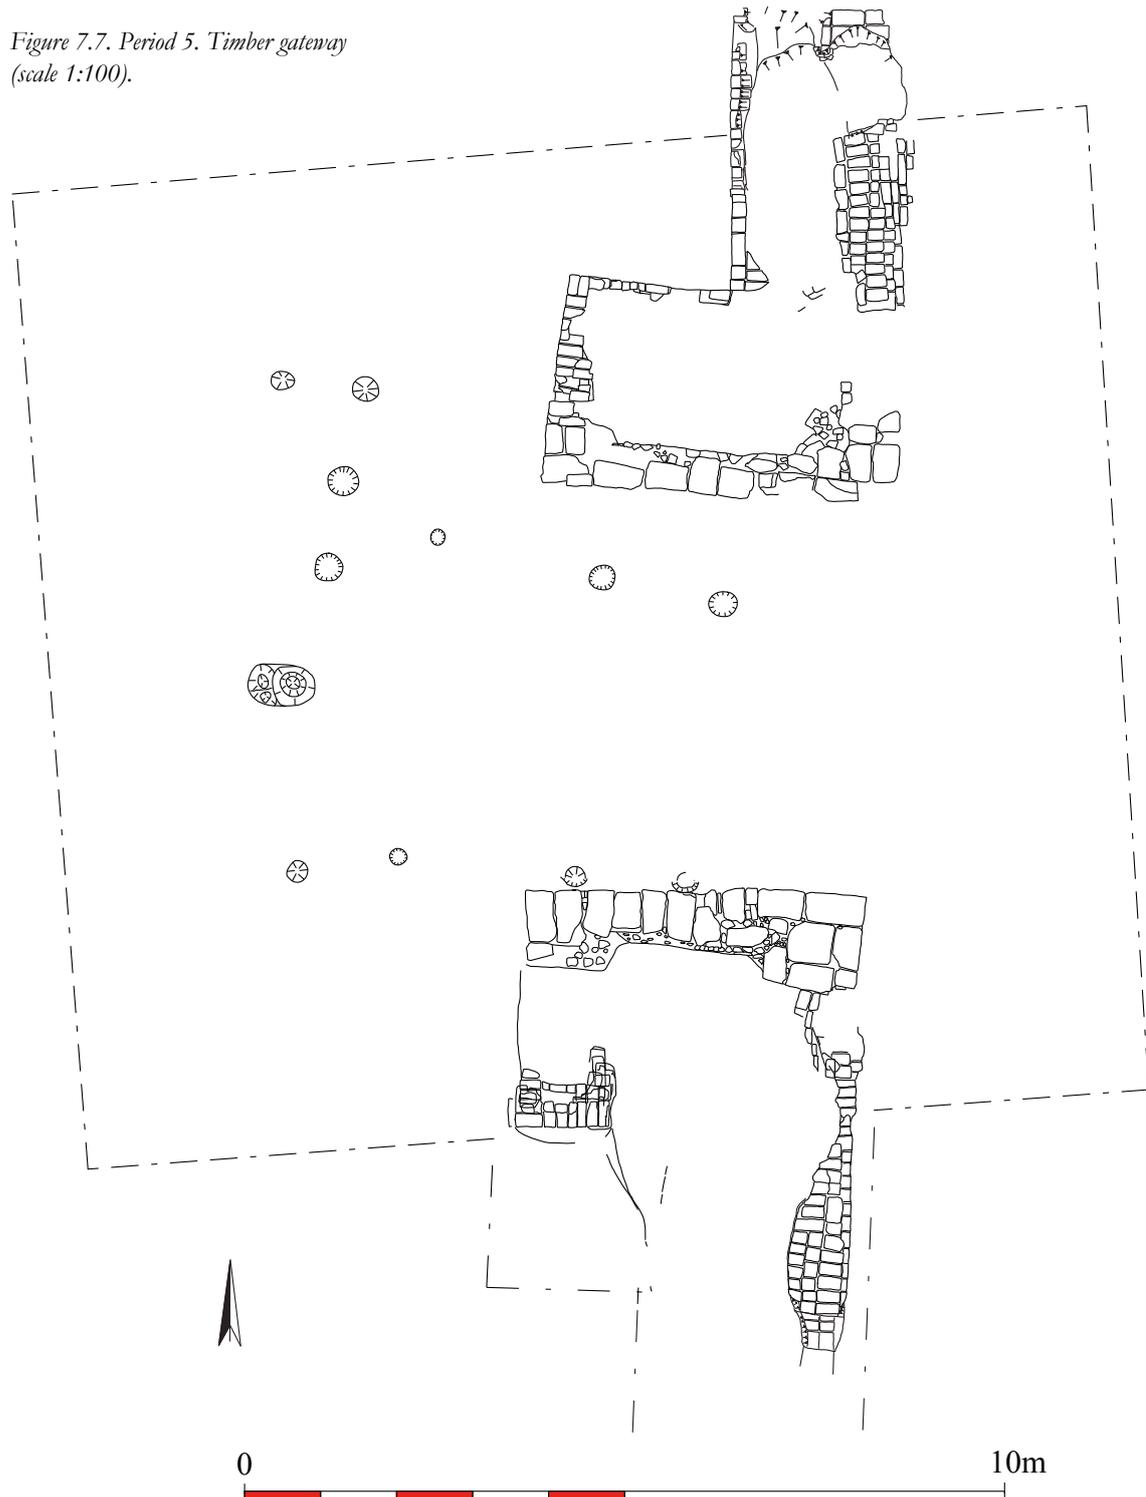
Figure 7.7. Period 5. Timber gateway
(scale 1:100).

apart from the two on the south side of the gate, which were partly cut through the first projecting course of the Period 4 stone facing which presumably was already covered by deposits and thus invisible. The westernmost of these post-holes was extremely deep, at 950mm. The alignment of the gate is a little different from that of its predecessor with a gap of about 1.25m between its north side and the earlier north side of the gate passage. The passageway was approximately 3.5m wide at its east end. To the west the layout is unclear as the arrangement of the post-holes is difficult to interpret.

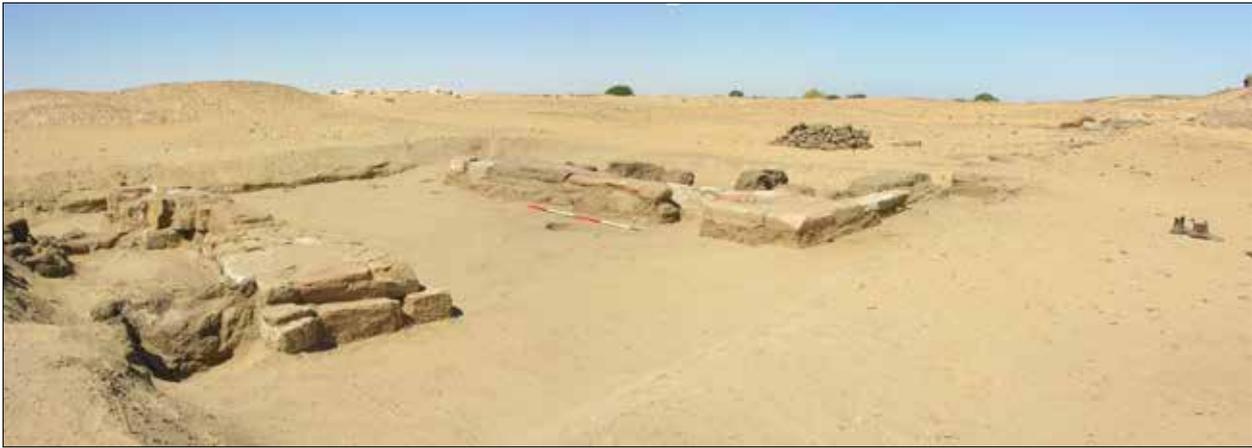
Plate 7.9. The Period 6, gateway from the exterior – scale bar 2m.

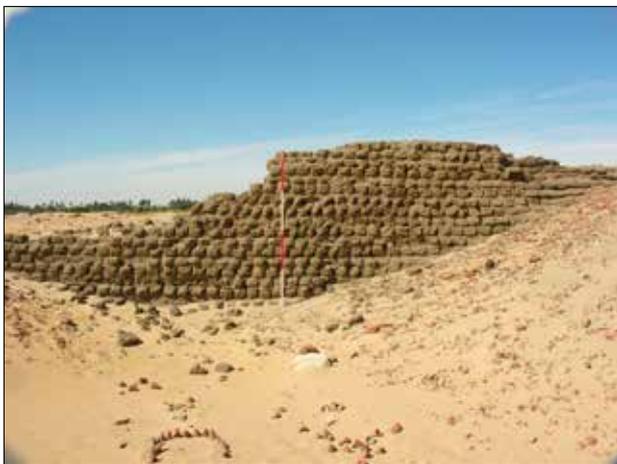
Plate 7.10. The temenos wall by the north-east angle showing construction technique. This was uncovered during the 1929-36 excavations – scale bar 2m.

From the gateway to the north-east angle of the temenos the wall is visible, and towards its northern end, as a result of the 1929-1936 excavations it is an upstanding monument. There 17 courses can still be seen all of headers with a number of the bricks in some courses set at an angle (Plate 7.10). By the gate the surface of the wall was cleaned for a distance of 15m to the north of the passageway wall (Plate 7.11). A number of different phases were visible but their

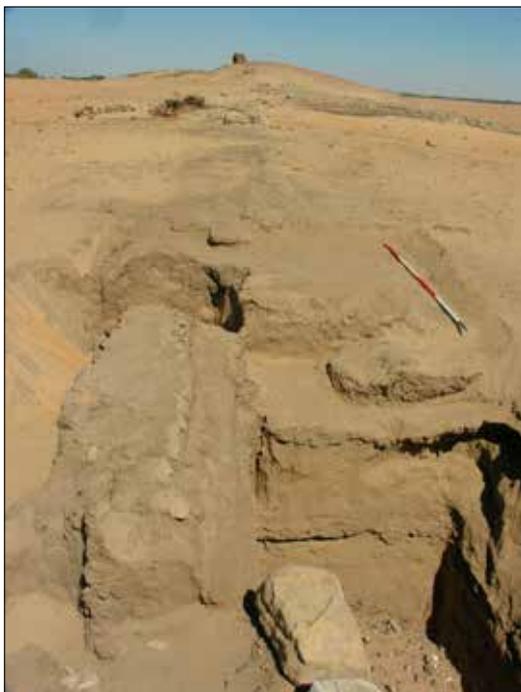
Plate 7.11. The temenos wall immediately to the north of the gateway looking north – scale bar 2m.

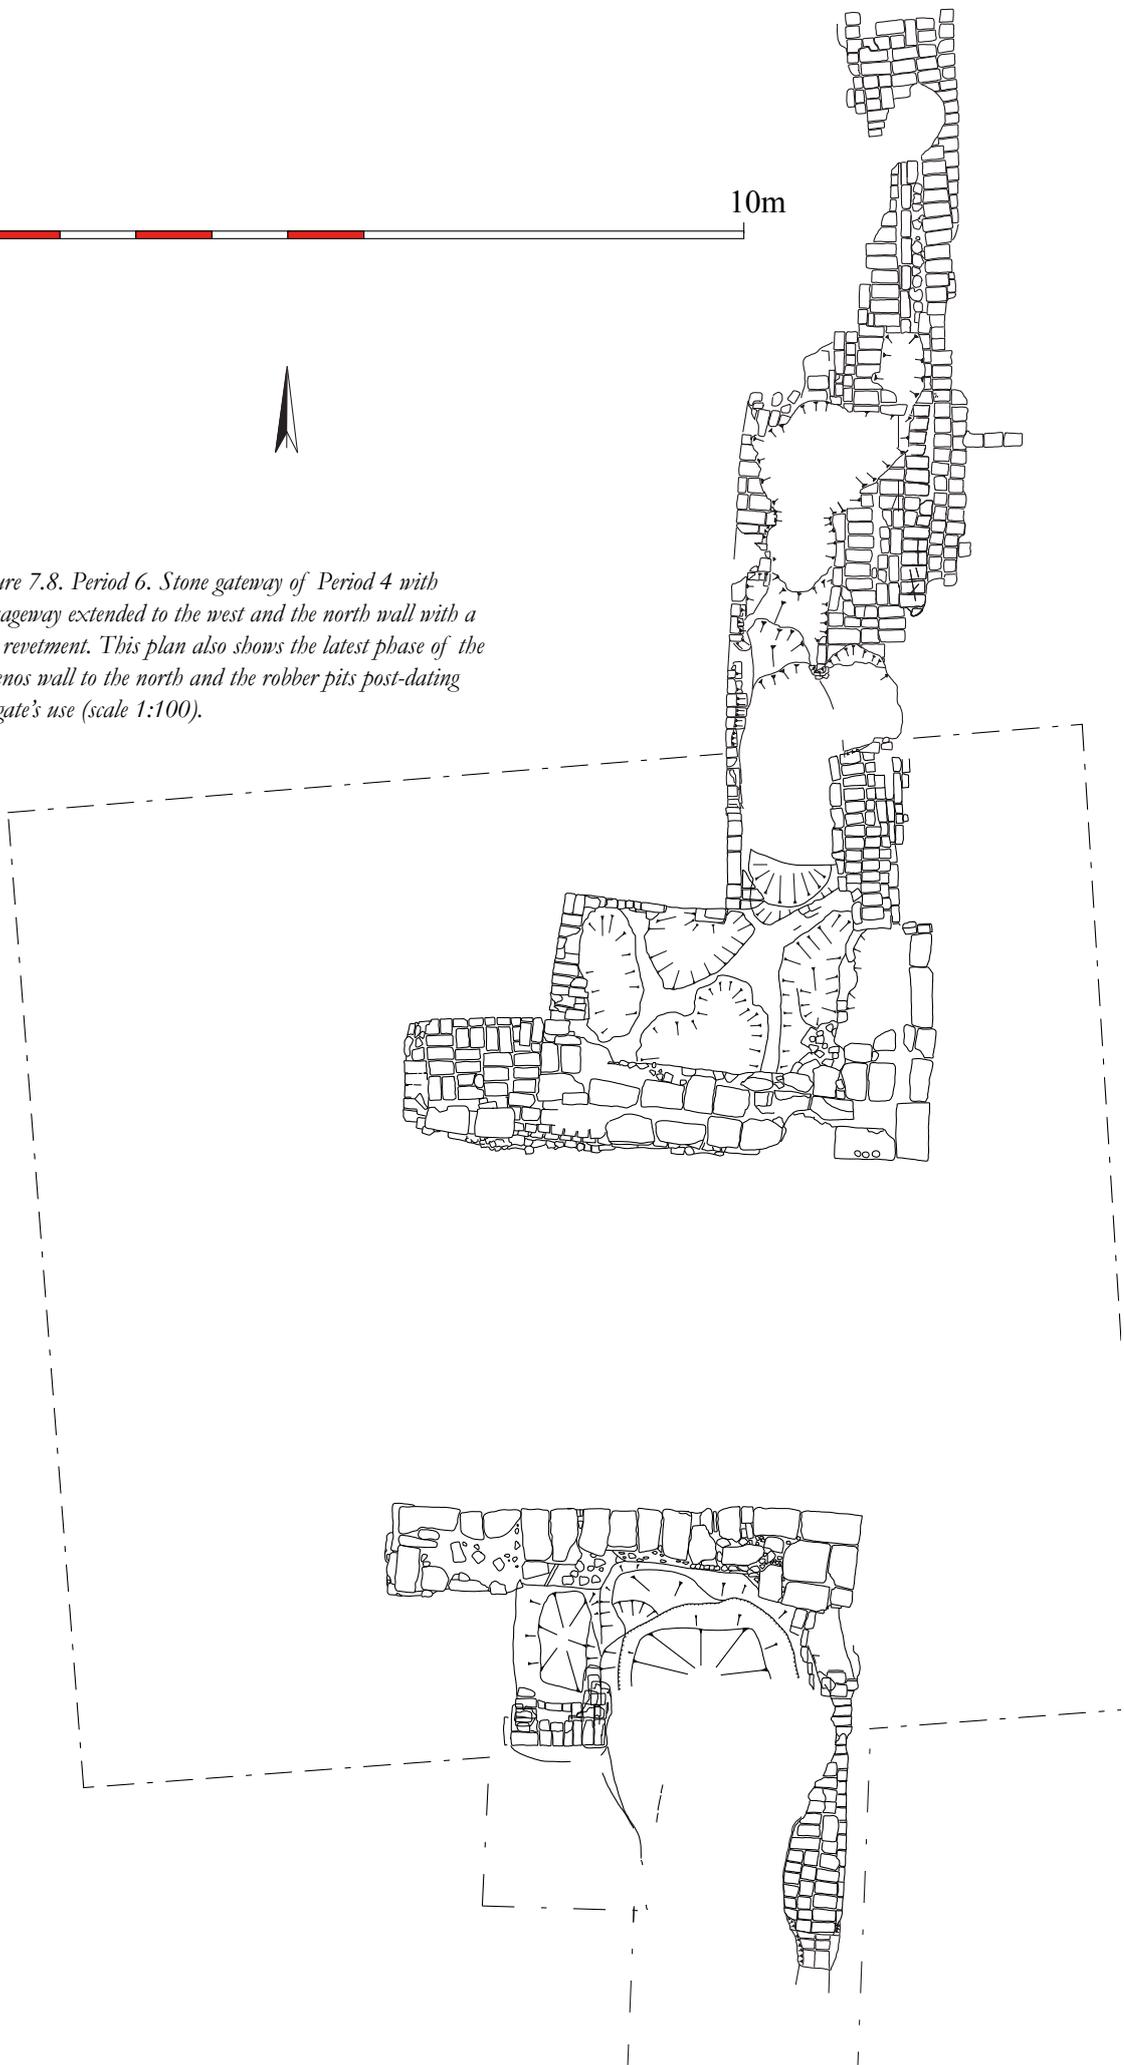
Figure 7.8. Period 6. Stone gateway of Period 4 with passageway extended to the west and the north wall with a new revetment. This plan also shows the latest phase of the temenos wall to the north and the robber pits post-dating the gate's use (scale 1:100).

Period 6. Re-use of the Period 4 gateway and extension of the gate passage to the west. The north face of the passage was revetted in mud brick and stone, some of it reused and this was carried around onto the exterior face of the temenos wall immediately north of the gate. The temenos wall was rebuilt to the north and offset a little to the east where it rested on wind-blown sand.

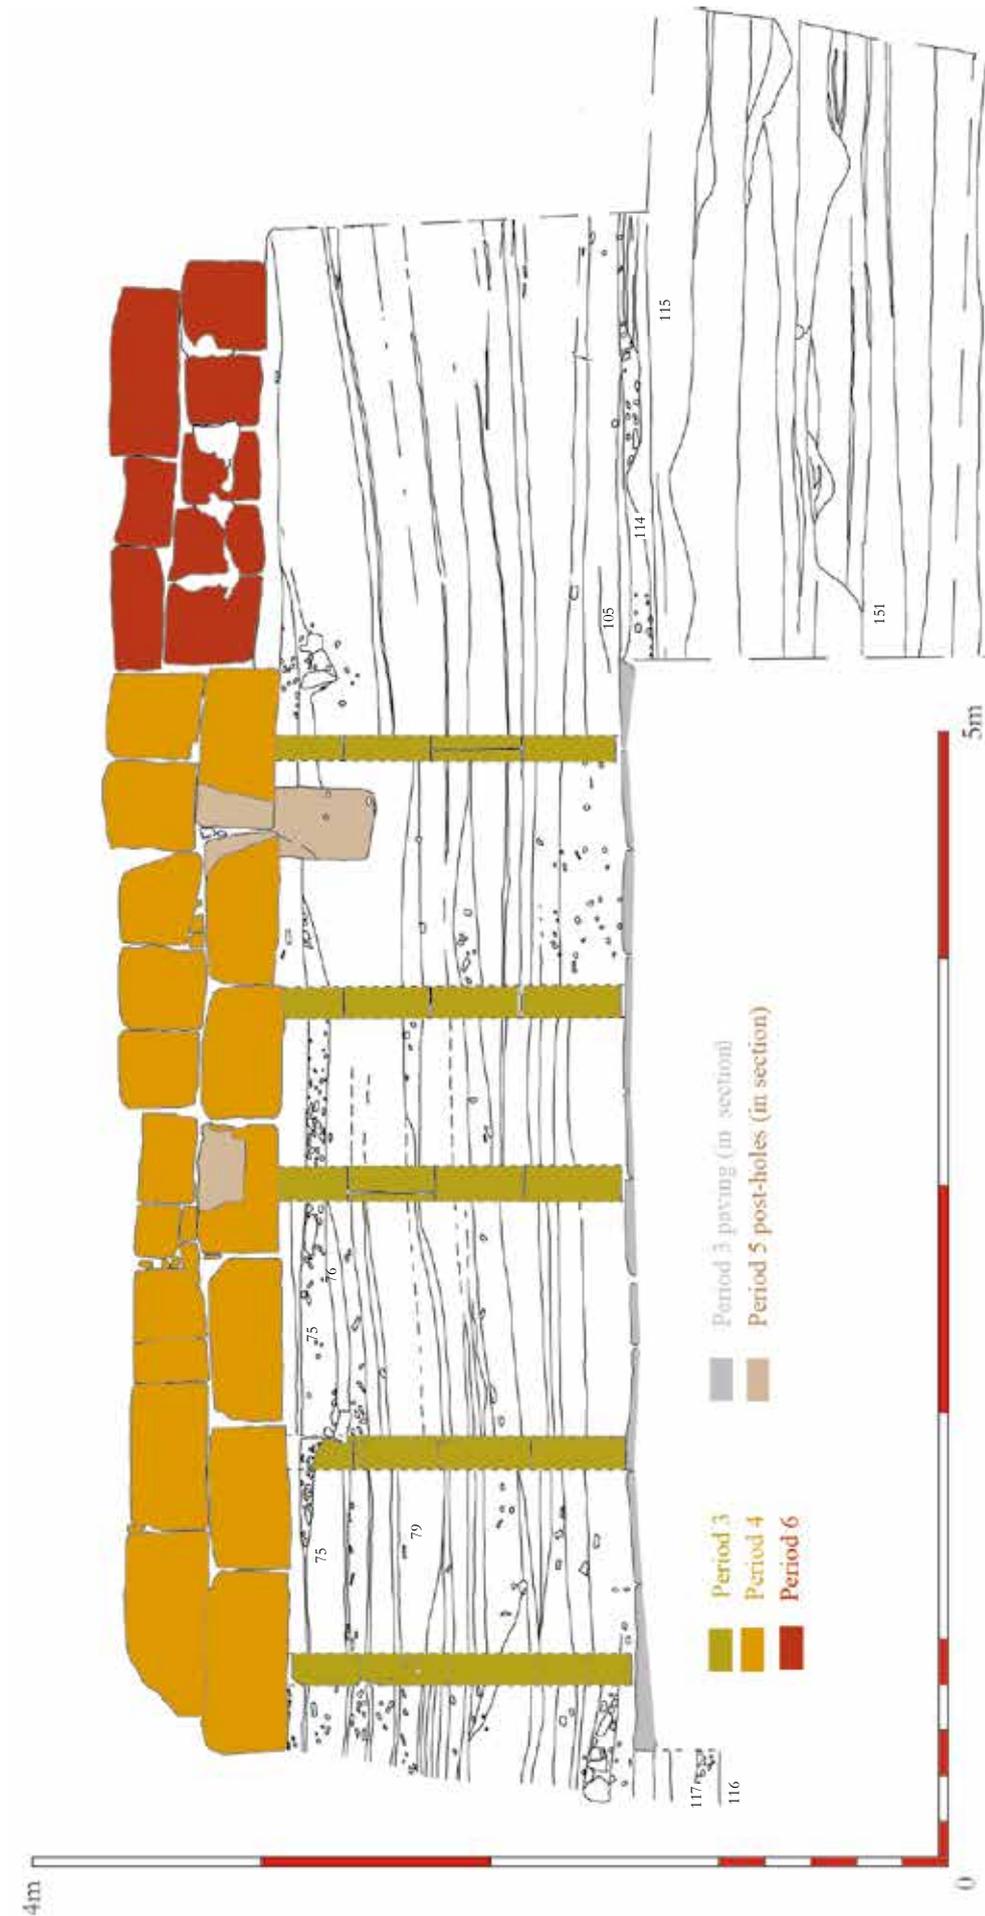
Figure 7.9. North-facing section through the gateway with elevations of the Period 3, 4 and 6 passageway walls.
