SUDAN & NUBIA

Bulletin No. 6

The Kushite Town and Cemetery at Kawa, the 2001-2002 season *Survey and excavations*

Stabilisation and Investigation of the Wall Paintings

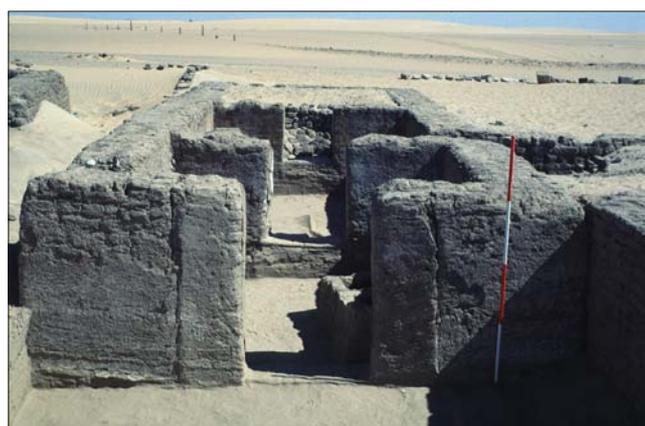
Plate 1. Building A1 at the end of excavation.

Plate 1 (p. 32) shows the layout of the building looking east. The room in the foreground is Room III, which had whitewashed walls. Adjacent to this is Room II, where the majority of the paintings survive up to a high of 1m. The farthest room had been excavated early in 2001 and the paintings on the walls conserved and then back-filled.

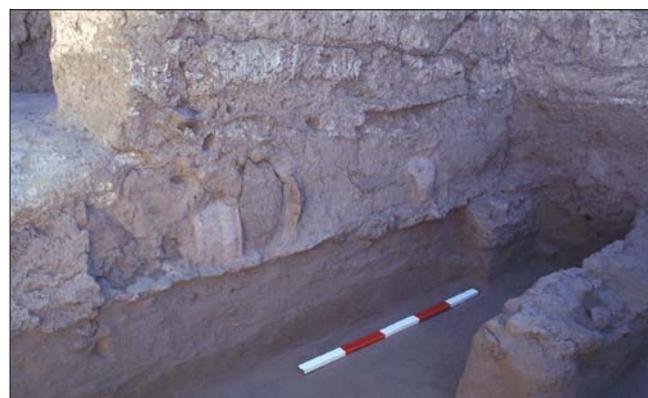
Plate 3. The west face of the wall between rooms II and III. Pottery sherds incorporated in its foundation are clearly visible.

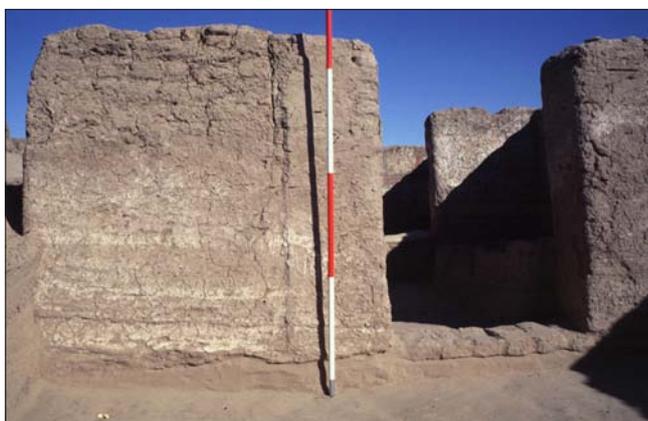
Plate 2. The west wall of Building A1.

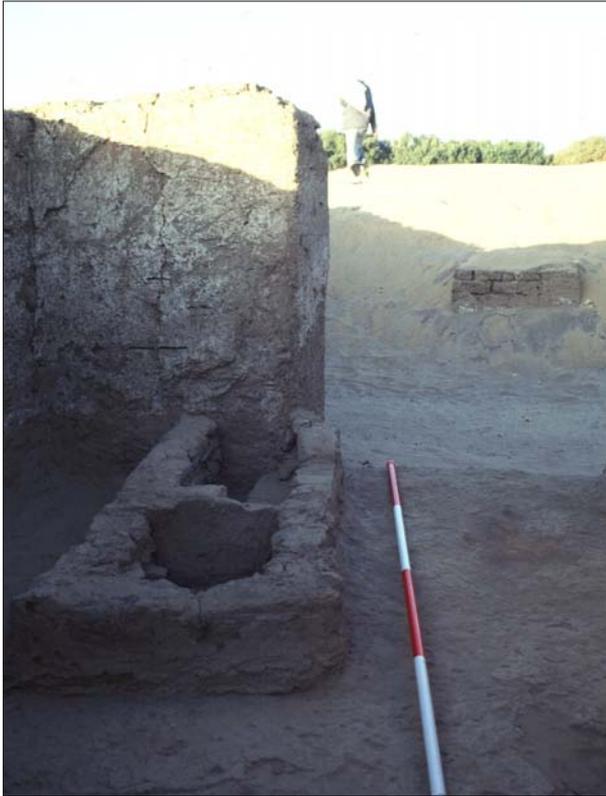
Plate 4. Mud bins within room III looking west.

As the levels of sand built up outside the building, additional patches of mud floor were laid immediately inside the doorway to produce a ramp leading down into the room. It was on this ramp that a mud-brick feature was built. It consisted of two square 'bins' (Plate 4) with sides standing to a maximum height of three courses (260mm) and it was probably originally one course higher. It extended into the room from the west wall, which it abutted, but was angled a little towards the centre line of the building and partially impeded progress from the exterior through room III into room II. Its function is unclear. Both bins were filled with sand.

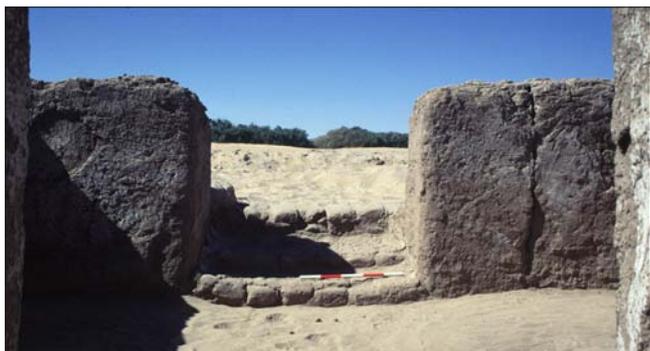
Plate 5. Steps giving access down into the building.

As already noted in room III a ramp of mud allowed access down into the building as the sand built up on the exterior. Set on the sand and clay deposit which contained the mud sealings was a hearth, which had heavily burnt the adjacent walls and much discoloured the painted plaster surfaces of the walls. When the level of the sand outside the building had reached a height of about 790mm above the primary floor surface, a flight of three steps (Plate 5) was constructed giving access down into the building and a new floor was laid in room III approximately 260mm above that of the primary phase. Contemporary with this, a new mud-brick threshold was constructed over the stone threshold between rooms III and II. The upper course of the mud

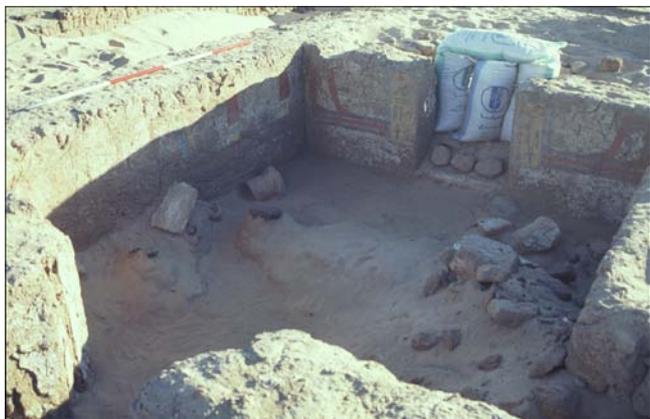
Plate 6. A column shaft with capital lying among the sand fill in room II.

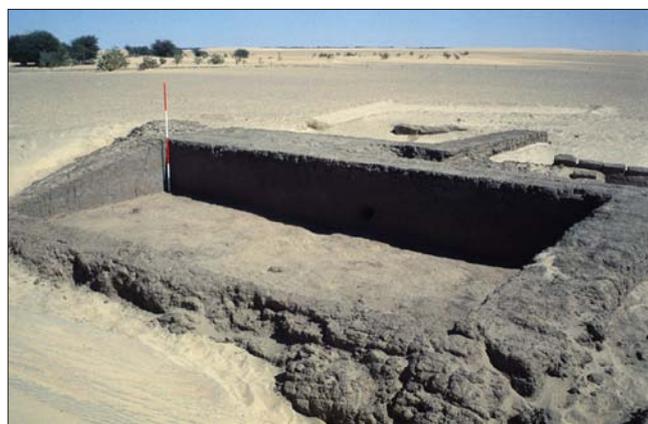
Plate 7. General view of Building Z1 looking north east.

the room was a floor of mud preserved towards the southern end where there seems to have been a number of repairs. A little to the south of the centre of the room was a post-hole in line with a horizontal hole in the east wall only a little above the floor level. These two features were presumably related but their function is obscure. How the wall running off from the stairway to the east fits in with the plan of the building is unclear. It terminates as though on one side of a doorway, yet there is no continuation of the wall nor any other features which in combination with it may have enclosed an area, be it a room or courtyard.

The western wall has slipped down the slope. An attempt to counter this had been made during the life of the building by the construction of two phases of buttresses at the south-west corner, while a stepped buttress was built up against the middle of the south wall. Adjacent to this buttress was found a deposit of mud sealings with impressions.

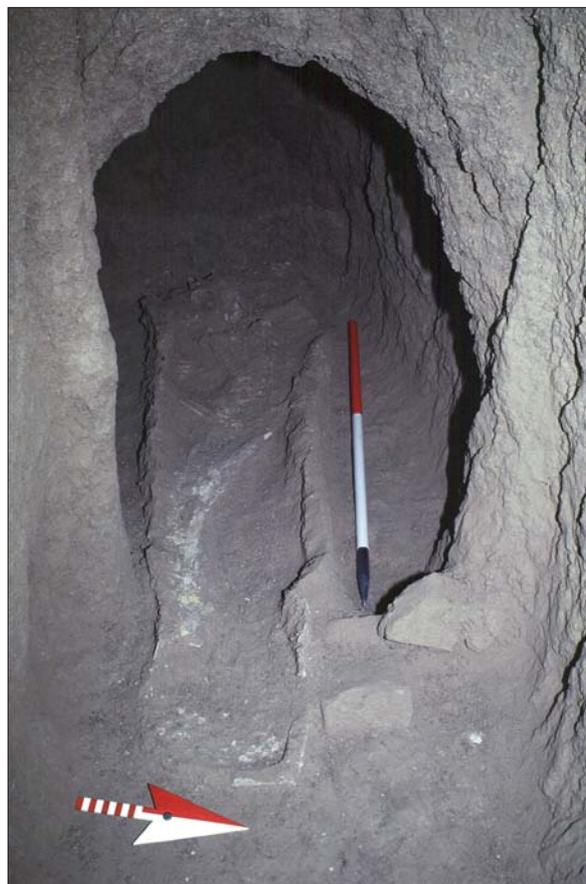
Plate 9. Individual buried in a cartonnage coffin in Tomb [HA2]100 looking west.

None of the large tombs has been entered. Their considerable depth below the surface and the very friable nature of the overlying alluvium make it too dangerous to enter the tombs through the doorways and it will be necessary to dig down through the alluvium to remove the roof of the chambers to allow access. Only one chambered tomb, which was quite close to the surface and extended only a short distance into the alluvium, was excavated. It contained the body of an extended individual in a cartonnage coffin (Plate 9), which

had very poorly preserved painted decoration in red, black and yellow on its sides. This is presumably a secondary burial, or at least the grave was not dug for the burial of the individual subsequently interred in it, as the coffin is much too long to fit within the chamber and extended out into the descender, the blocking wall being built over it. In an adjacent grave an extended inhumation in another cartonnage coffin was buried high in the fill of the descender. Immediately underneath the coffin was a shallow bowl of a type which is very common in the rubbish deposits associated with Building A1.

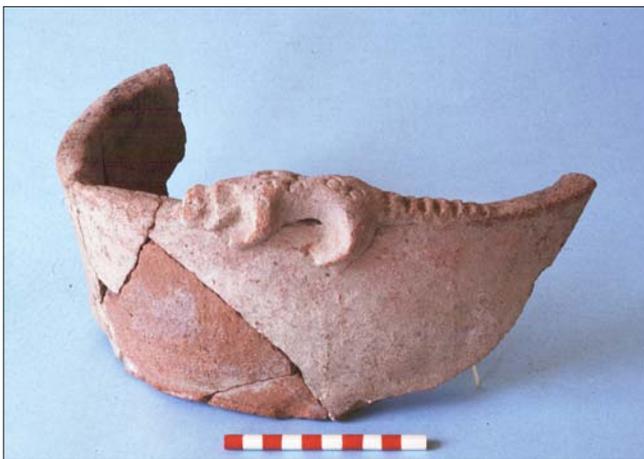
Plate 10. Pottery basin with an appliqué crocodile on the rim.

The finds. Among the finds are large quantities of pottery from within a rubble and rubbish deposit in room I of Building Z1, which includes one bowl with a moulded animal, probably a crocodile, on the rim (Plate 10); two others had been found in Buildings A1 and A2. Quantities of jewellery were recovered from the floor surfaces in room II of Building A1. These include bead necklaces, some still articulated,

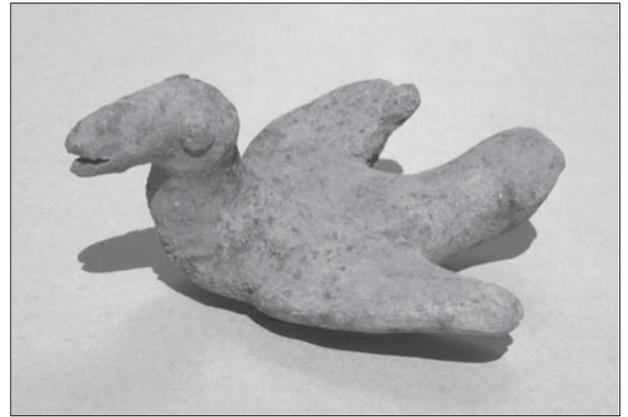
Plate 11. Ceramic bird from room II in Building A1.

and amulets of faience. Also found in this room was a small clay human figurine and a ceramic bird with outstretched wings (Plate 11). The seals from Building A1 room III have yet to be studied in detail. Some, however, appear to bear the throne name of the Kushite ruler Piye (Figure 4) and suggest a date in the later 8th century for the use of the building. The sealings from within the building are very different from the large numbers found in the rubbish deposits outside it which were found in previous seasons. The sealings from Building Z1 are very different yet again. The limited number of types appear not to bear inscriptions. One very large seal type has the oval ground divided into four by horizontal lines. At the top and mirrored at the bottom is a hippopotamus, while in the middle are mirror images of a crocodile (Figure 5). Immediately outside the west wall of Building A2 was

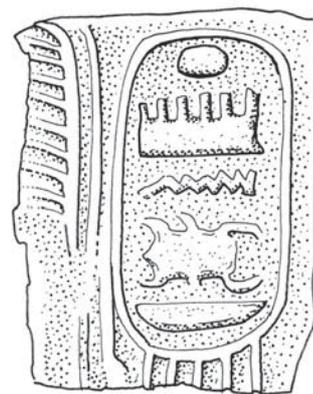
Figure 4. Mud sealing bearing the name Men-kheper-Ra, from Building A1 (Scale 1:1).

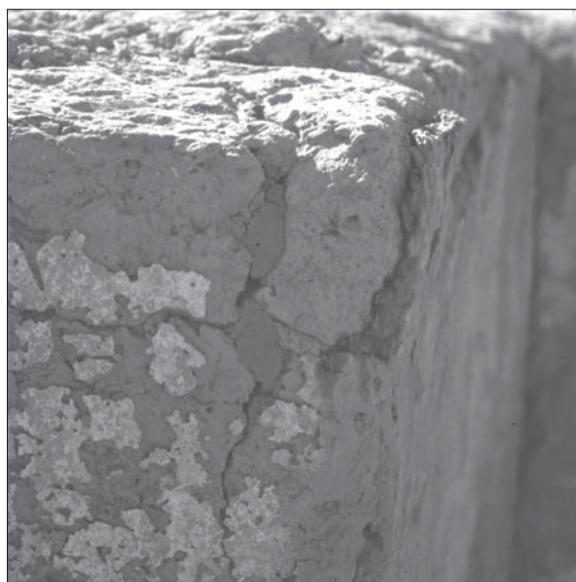
Plate 12. Poor plaster to wall contact.

Failing contact between the wall plaster and the support wall

In order to support the very weak upper areas of the walls, a mud mortar was used to fill any obvious gaps around the loose plaster. A mud slurry was applied behind the plaster to fill the void and ensure the contact between the plaster and the wall was maintained (Plate 12). The slurry was a combination of crushed silty clay in 20% Paraloid B72, and an

Once the paintings were completely exposed, the silty-clay wall plaster dried out at an ever increasing rate, causing the plaster to continue to separate from the mud-brick wall. Large areas, therefore, required a mud support to ensure that the plaster maintained contact with the wall. Ultimately it became necessary to check the condition of the paintings on a daily basis. Whenever movement was detected a high concentration of Paraloid B72, 20% in acetone was injected into the walls to keep the painted plaster in contact with its support wall.

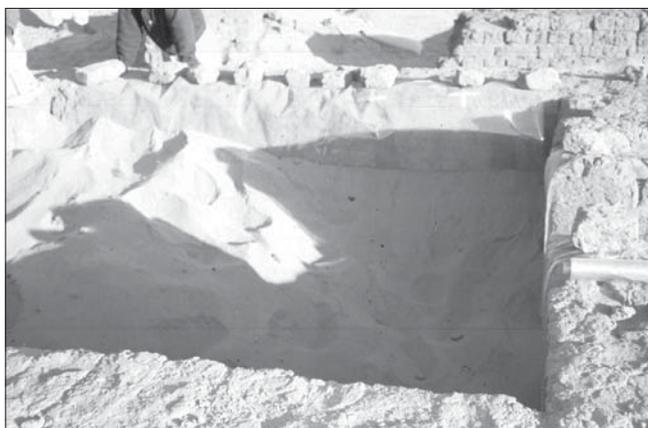
Plate 13. Protecting the wall paintings with melinex during the backfilling

At the end of the excavation the conservation work was completed and the process of back-filling with sand began. There is no intention to reveal and display the paintings again, and their reburial will improve the wall paintings' chances of long-term survival. For the wall paintings this was a high risk activity and it was necessary to protect them from the worst of this abrasive process. The walls were temporarily covered with Melinex (Plate 13), chosen for its strength and slip (low surface friction). The Melinex was placed against the painted surface to protect it as the sand was poured into place. As

the sand level rose the Melinex was gradually raised. Once the sand reached the top of the surviving walls, the Melinex was completely removed. The back-filling of the building was complete in three days (Plate 14 - the building back-filled is visible in the foreground; the exposed rooms in the background belong to Building A2).

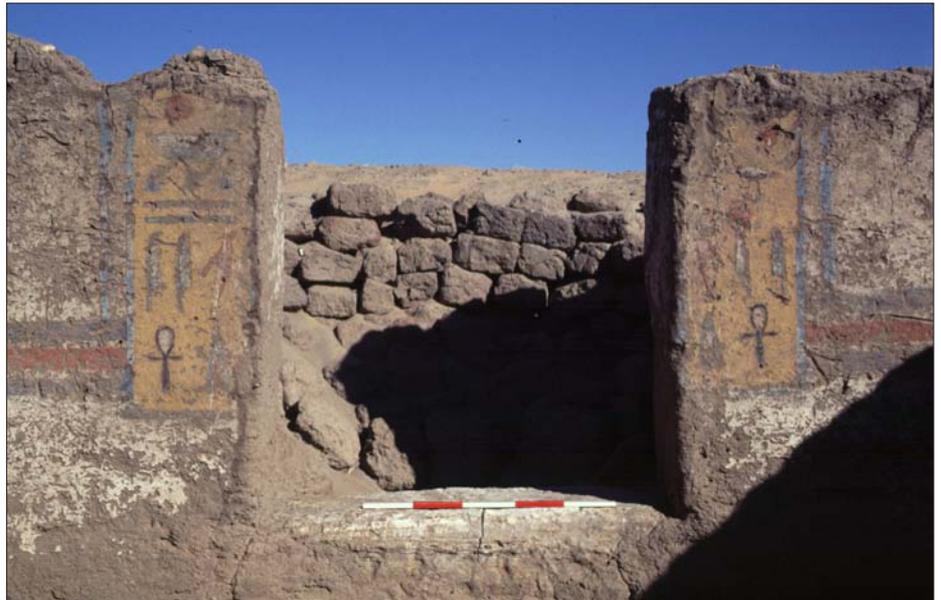
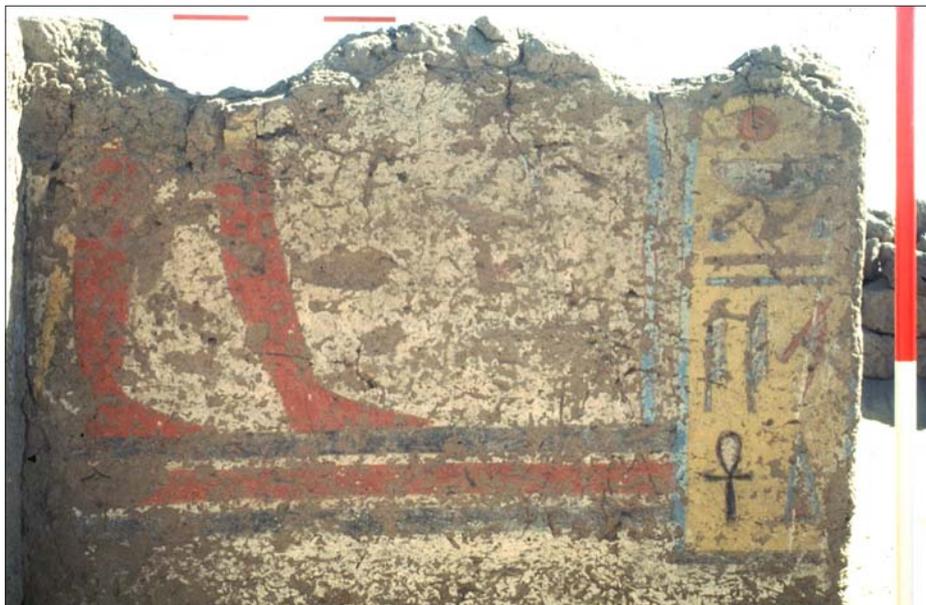
Plate XX. Kawa, Building A1. The east wall of room II with the painted inscriptions flanking the doorway through into room I.

Plate XXI. Kawa, Building A1. The east wall of room II to the north of the doorway through into room I.

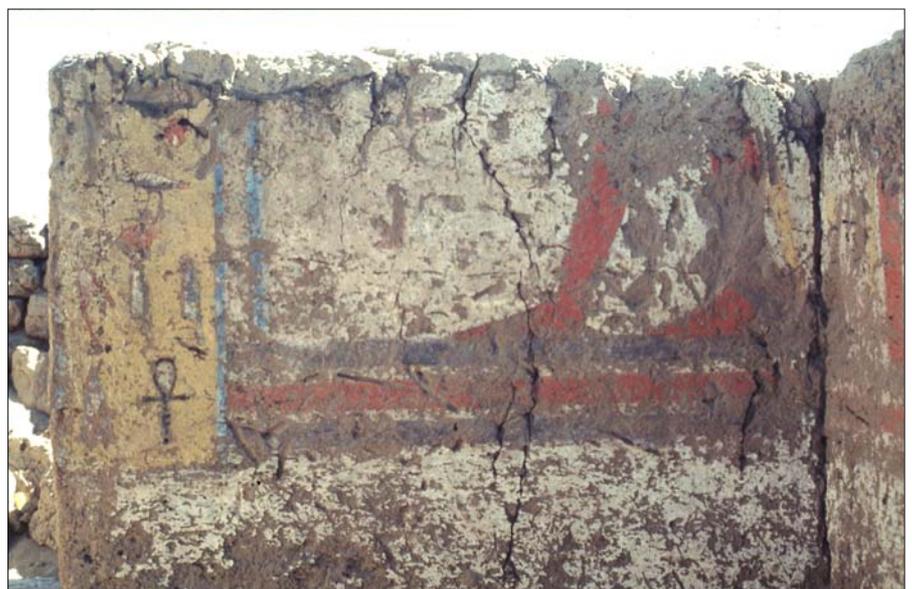
Plate XXII. Kawa, Building A1. The east wall of room II to the south of the doorway through into room I.

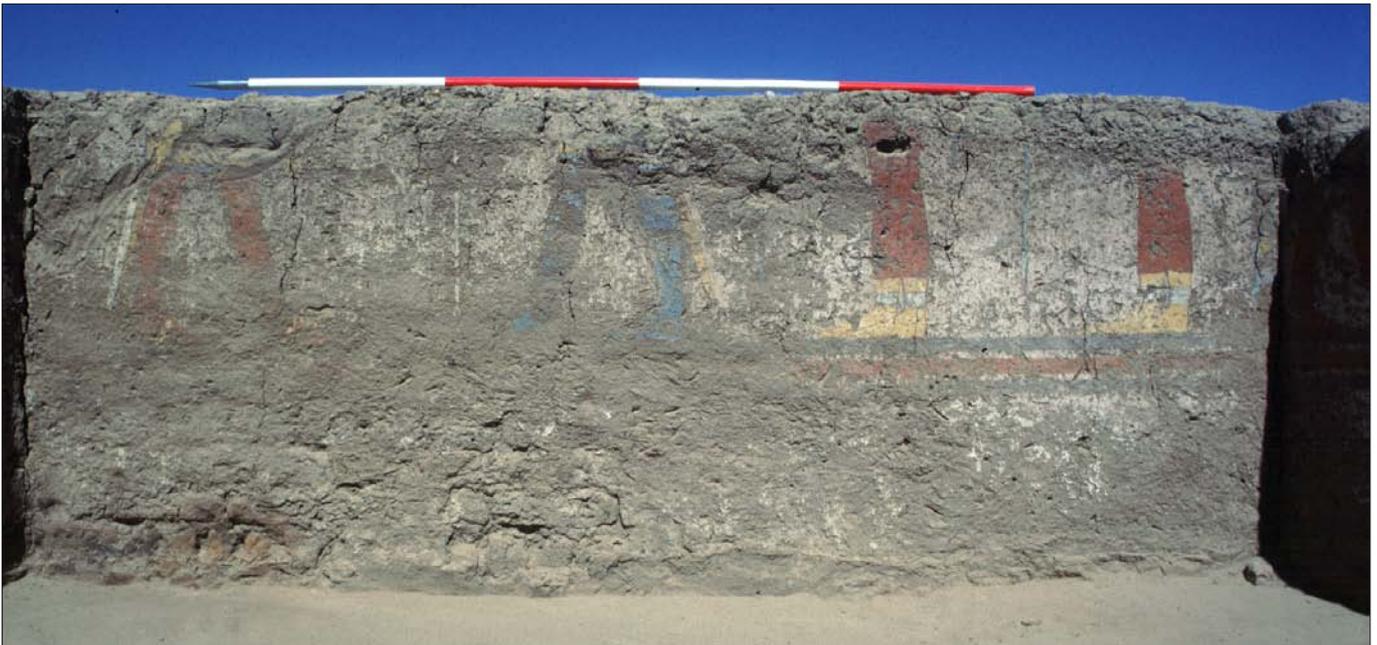
Plate XXIV. Kawa, Building A1. The north wall of room II after conservation. On the left the king, wearing golden sandals, processes towards Amun in the centre behind whom stand two goddesses.

The north wall of room II has four figures (Colour plates XXIII-XXIV), what is presumably a king on the left wearing gold sandals (as in room I in a corresponding position on the north wall) processing towards a blue painted god (Amun) and two female figures (Colour plates XXV-XXVI). The scene on the south wall (Colour plate XXVII) appears to have been similar but is much less well preserved and the king was totally removed when a doorway was cut through the western end of the wall to give access to room IV. Whereas the west wall of room I was whitewashed but had the painted dado of blue/black and red bands (Welsby 2001a, Col. pls XLIII and XLIV), the west wall of room II was only whitewashed.

The individuals on the north (Colour plates XXIII-XXVI) and south (Colour plate XXVII) walls, wearing red garments with cream-yellow legs and feet, were painted in slightly different ways. The ground in all cases is the whitewash, except for the feet in the middle of the south wall. The lower section of the yellow feet probably had a thin layer of red as a ground colour. This was probably done to emphasise the 'golden' colour of the foot as it is unlikely that the whole lower legs and feet were completely in-filled in red, prior to the yellow feet being painted. This theory is supported by the absence of red beneath the yellow on the upper ankles and the blue section around the mid-ankle.

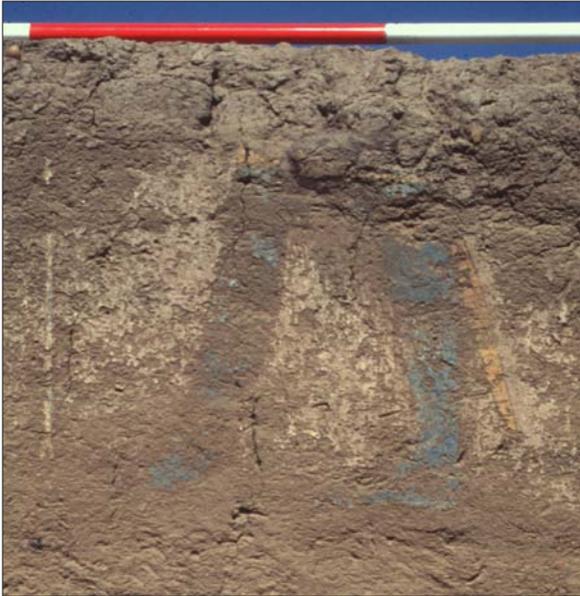
Plate XXV. Kawa, Building A1. Detail of Amun in the middle of the north wall of room II.

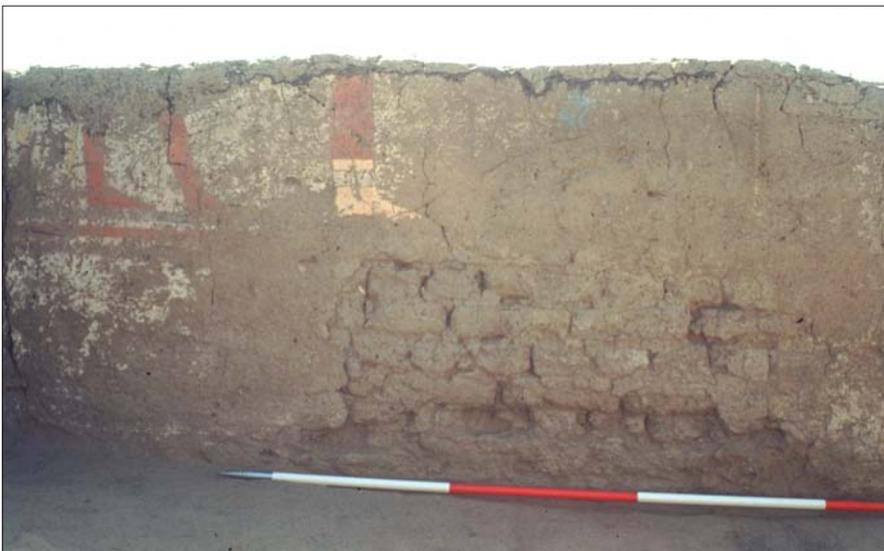
Plate XXVII. Kawa, Building A1. The south wall of room II after conservation.

The pigments for the 'golden' feet on the north and south walls were applied in a different order. On the south wall the outline was made in red and then emphasised in black. On the north wall, all the outline was made in red and then infilled before the black outline was applied. Also, the feet on the north wall overlap the black borders in an untidy fashion, whereas the feet on the south wall are very neat and within the outline borders. The tear-drop shapes within the legs on the north wall have a yellow border but no remaining infill pigment, though the pinkish hue would suggest that it was originally red. However, red pigment survives on all the other walls and no explanation can be given as to why the red in these tear-drop motifs has not survived. The south wall tear-drop motif is infilled in blue.

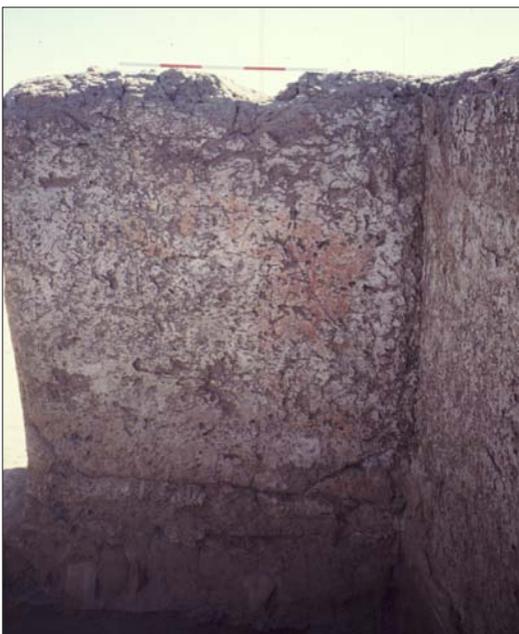
Plate XXVIII. Kawa, Building A1. The east wall of room III south of the doorway.

The back-fill from the previous season's investigations in Rooms II and III was removed. In Room II the upper 30cm of the wall paintings had been successfully and effectively consolidated by Pippa Pearce using 2% Klucel G, a hydroxypropyl cellulose, in IMS (Industrial Methylated Spirits, a polar solvent, made of 96% ethanol, 2% methanol and 2% water). During a close inspection in Room III faint coloured patches were identified, suggesting that wall paintings may survive beneath the whitewash. The coloured patches were only visible within the upper quarter of the surviving wall, where areas of red were visible in places through the whitewash layer (Colour plate XXVIII).

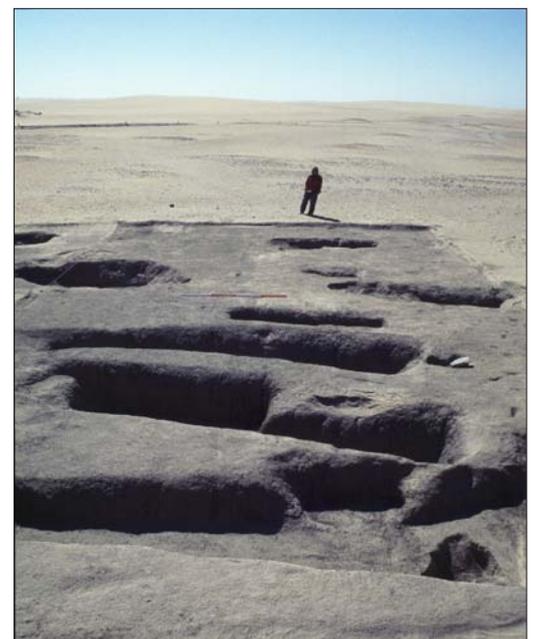
Plate XXIX. Kawa, Site R18, the eastern cemetery: Descendants of tombs arranged in north-south rows

Graves with long descendaries are arranged roughly in north–south rows (Colour plate XXIX), some of the descendaries attaining a maximum depth of over 2.5m. Mud-brick blocking walls are visible in the doorways into the grave chambers and some of these suggest multiple use of the tombs. Although the large descendaries respect each other, a number of smaller descendaries have been inserted in the narrow space between them, presumably in an attempt to associate the burials interred in their tombs as closely as possible with the main burials (Plate 8). One of these contained the crouched inhumation of an infant with a Bastet amulet around the neck in glazed composition (Figure 3).
