# SUDAN & NUBIA

*Bulletin No. 11*

# The Taharqo wall painting rescue project

Eric Miller, Pamela Rose and David Singleton

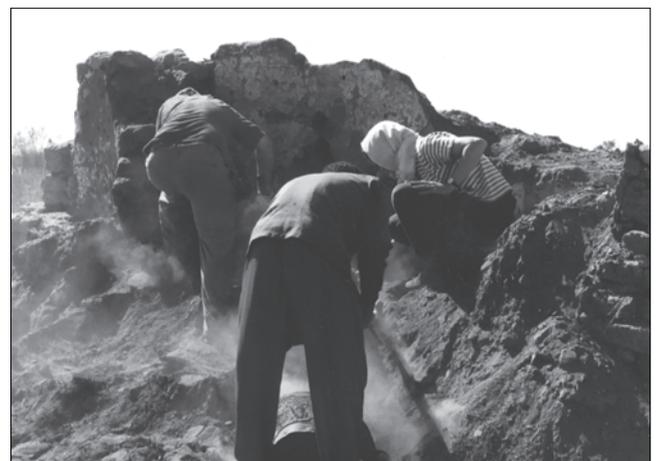
Removal of the apse unexpectedly revealed more painted plaster, protected by the end of the apse, but it was regrettably not possible to include this newly discovered part in the rescue, since precise calculations of materials needed were based on the 2001 measurements. Accordingly, a vertical cut had to be made through the plaster 2.72m from the end, to isolate the section for detachment. The remaining fragment was covered over and awaits removal at a future date (Plate 1).

*Plate 1. Clearing the backfill. More of the painting was revealed when the apse was dismantled.*

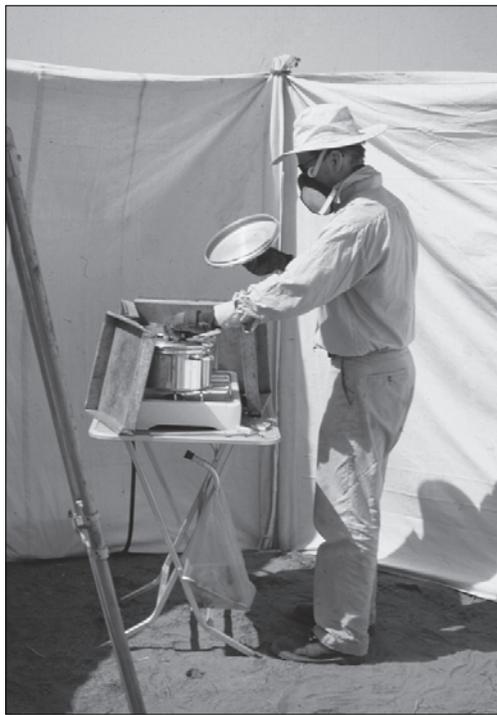
*Plate 2. David Singleton heating CDD and petroleum spirit in a double boiler.*

for safety purposes (Plate 2), and solutions of equal quantities by weight of CDD in petroleum spirit (boiling range 100-120° C) were heated to 80° C to allow a margin of cooling time, while it found its way into the plaster. Wind has a strong cooling effect on the process and the mixing and heating operation was enclosed within a canvas wind-break and a wind-break was also erected to maintain still air at the wall painting surface. Two-and-a-half litres per square meter were applied to the surface by brush,<sup>1</sup> 14 litres in total, calculated to consolidate the 3mm fine plaster layer on which the painting was executed; this is a light brown layer which contains clay, fine sand and a variety of chopped vegetable matter.

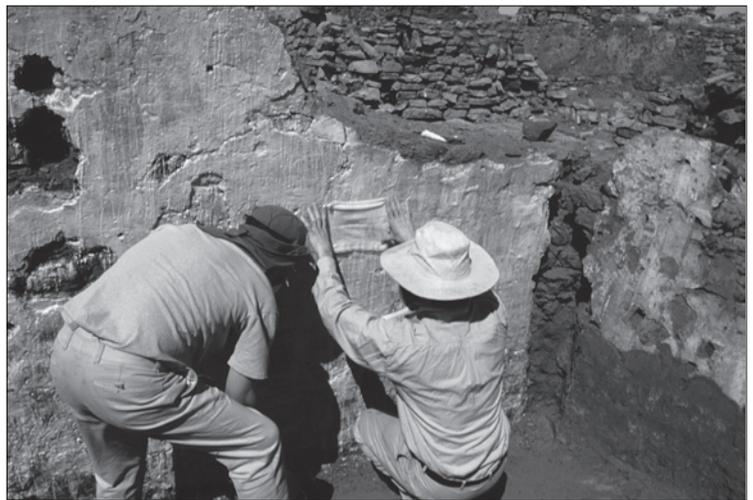
time to create a protective layer over the surface. For this application nine parts of CDD were heated to 80° C with one part of petroleum spirit. At this concentration the CDD rapidly solidified to produce a dense white film on the surface. In a second application using the same proportions, gauze bandage was incorporated to cover holes in the plaster. The protective layer was intended to keep a polyurethane foam (PUF) facing, to be applied later, off the painting (Plate 3).

*Plate 3. Gauze was used as a scrim over holes in the plaster.*

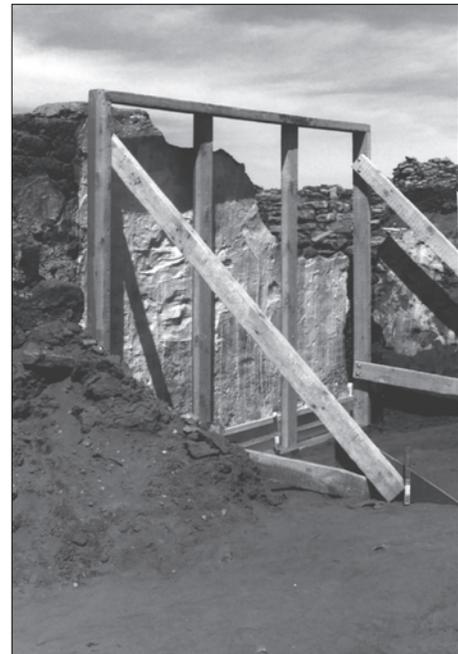
*Plate 4. A frame was set in place and anchored to the ground.*

A frame was constructed using 100mm by 50mm timber (Plate 4). It was made to the precise overall dimensions of the painting, enlarged by 20mm, all round, to allow for a mould (required later) to be constructed on the back. Two vertical timbers divided the space within the frame equally

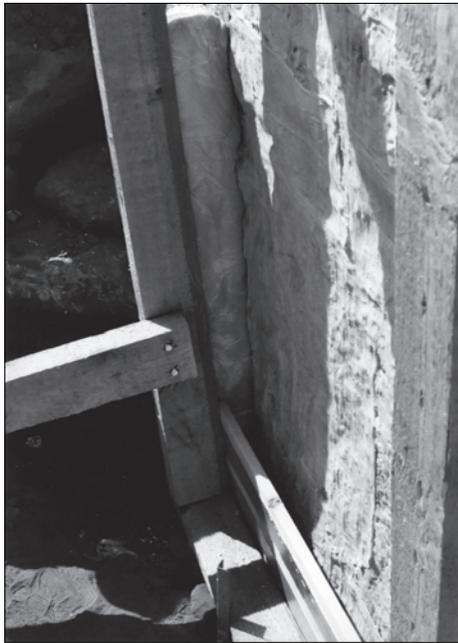
*Plate 5. Shuttering created a space to be filled with polyurethane foam. Note the soft foam wrapped in cling film sealing the gap.*

easily separate from the polyurethane. Twenty-millimetre gauge shuttering was put in place, leaving a space 30mm deep,<sup>3</sup> to be filled with polyurethane foam (Plate 5). The shuttering consisted of 30mm timber battens and 70mm polyurethane foam battens, fixed in pairs to the top of the frame and extending across the whole width. Fixing was by means of screws, inserted through the frame into the timber battens, which also held the polyurethane foam battens by friction and in this way the whole frame assembly was locked together (Plate 6).

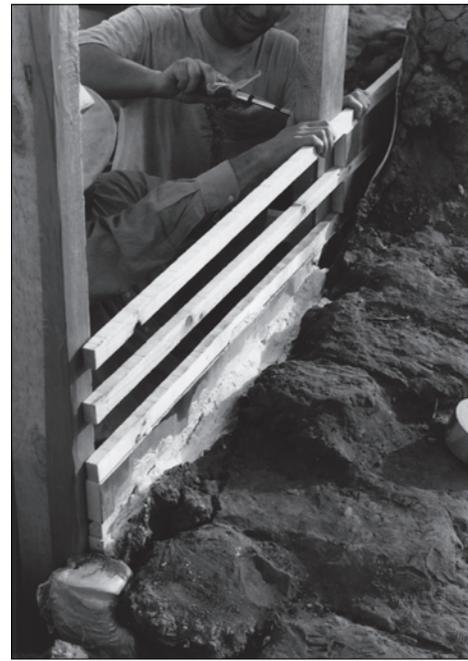
*Plate 6. The shuttering was screwed to the frame.*

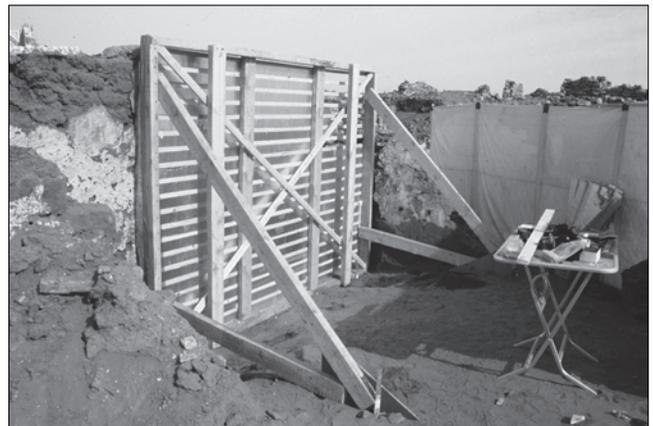
*Plate 7. The frame was cross-braced and timbers were added to rest it on the ground.*

stiffen it against distortion during handling, and timbers were attached for it to rest safely on the ground (Plate 7). Now face down, preparations were made for casting PUF on the back, to provide firm, intimate contact that would protect it from any shocks and vibration that might occur during transportation (Plate 8). For this, a mould was constructed on

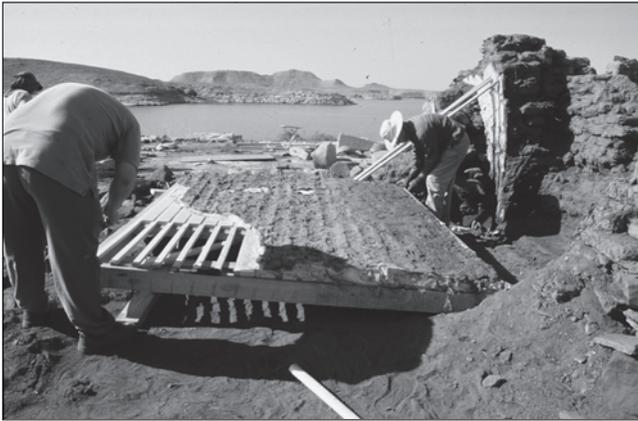
*Plate 8. Laying the painting face-down. Note the section of the wall painting left behind.*

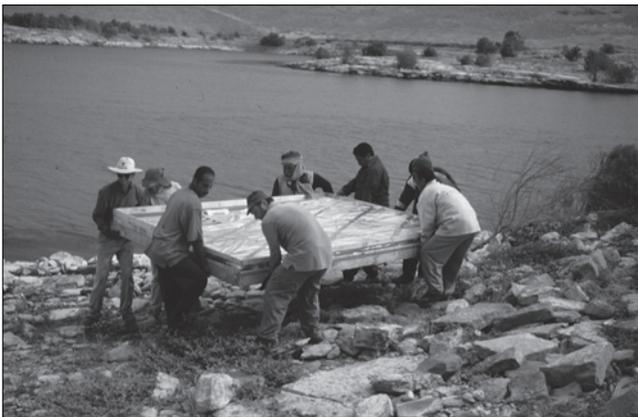
*Plate 9. Carrying the painting to the dock.*

At this point we feared that the weight of the assembly was close to the combined maximum carrying capacity of the ten people available to move it. Consequently, it was taken to the dock area before more weight was added (Plate 9). After casting the backing (Plate 10), the lid was finally fixed in place and the painting was ready for transportation. The Skanska tug-boat returned on the last day (Plate 11) to take the painting to Toshka, together with the team, the

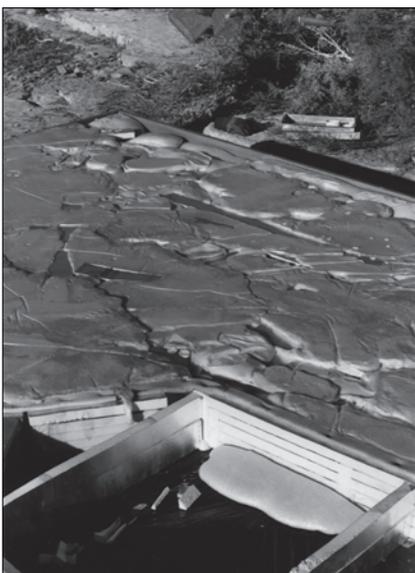
*Plate 10. A polyurethane foam backing protected the painting during transportation*

the back of the frame and aluminium foil was laid over the mud plaster. A lid for the mould was made from plywood, and polythene sheeting was attached to it to act as a means of release from the foam.

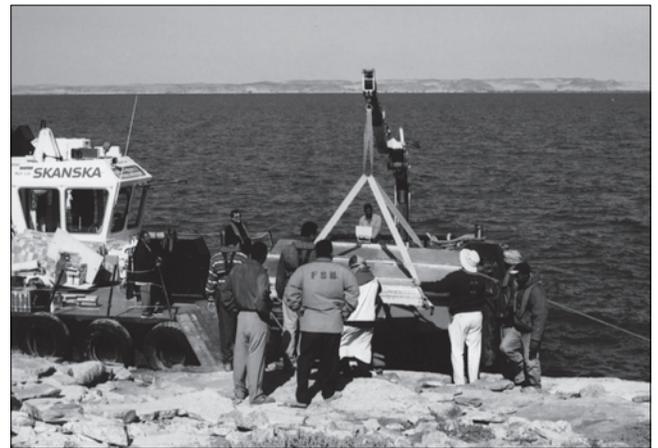
*Plate 11. The painting being loaded on board the Skanska tug.*

equipment and all waste created during the project. At Toshka the painting was transferred to a lorry for its journey to Aswan, in convoy with the team and delivered to the Nubian Museum.

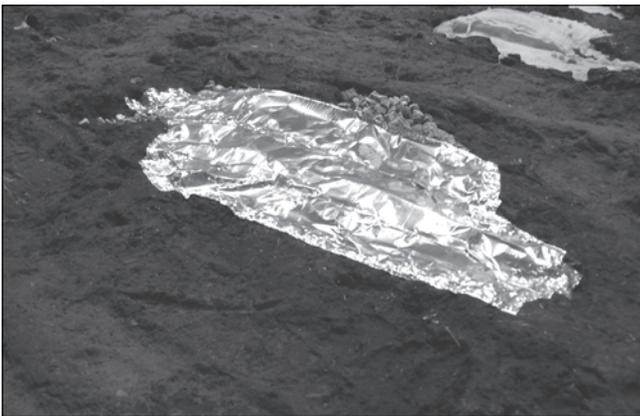
the fabric and create a strongly consolidated outer-crust that could conceivably separate from an untreated substrate at some future date, leaving the painting unsupported. A concentration of less than 1% of Mowital B30H<sup>6</sup> in a solvent mixture of acetone and ethanol was used. Attention was then turned to holes bored through the plaster, possibly by the larval form of insects. Epoxy resin would constitute a highly destructive presence if it seeped onto the front. Pathways through the plaster, therefore, were blocked and insect holes were crammed with cotton wool and sealed with 20% B30H. Larger holes had been sealed, on site, with gauze bandage and CDD. These were now filled to the depth of the plaster with vermiculite granules<sup>7</sup> and sealed with aluminium foil tape. The seal was completed by burnishing the tape onto the edges of the holes, which had been hardened for the purpose with 20% B30H (Plate 12). The missing plaster at the top of the painting was represented in the mould with soft plastic foam, cut to shape and covered with polythene (Plate 13). Vermiculite was used to fill the void around the edges of the painting and covered with aluminium foil tape. Tape edges were burnished onto mud plaster, on one side of the vermiculite fill and onto the mould wall on the other to complete the seal.

*Plate 12. Holes were filled with vermiculite granules and sealed with aluminium foil tape.*

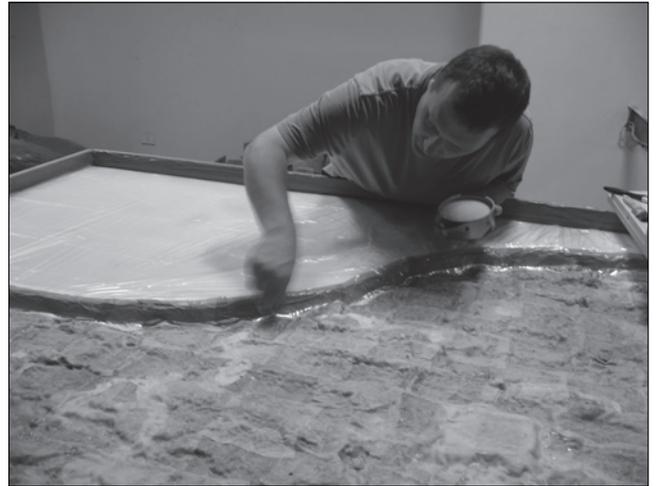
ering the 'black' squares and in the second the 'white' ones. Additionally, the height of the mould walls had to be increased to accommodate the new backing system and all the mould surfaces, including the aluminium foil tape, were covered with parcel tape and coated with wax, to present a surface that would easily separate from the epoxy resin (Plate 13).

*Plate 13. Applying wax as a release-agent.*

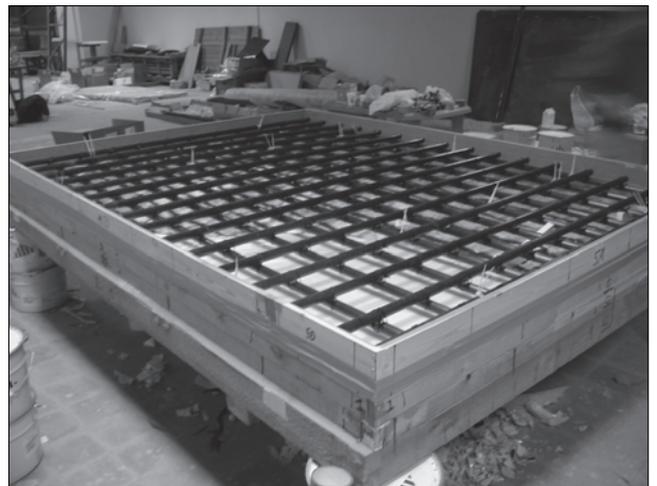
By itself an epoxy backing of such dimensions flexes if subjected to a bending stress. For this reason it needed an embedded stiffening structure, fulfilled here by a grid of 30mm carbon fibre tubing arranged in a series of horizon-

*Plate 14. The grid was laid in the mould.*

tal and vertical members at 175mm centres, and fastened at each crossing with epoxy adhesive.<sup>9</sup> During assembly, cable-ties held the grid together while the epoxy hardened. The completed grid was laid in the mould and its orientation was adjusted with wedges (Plate 14).

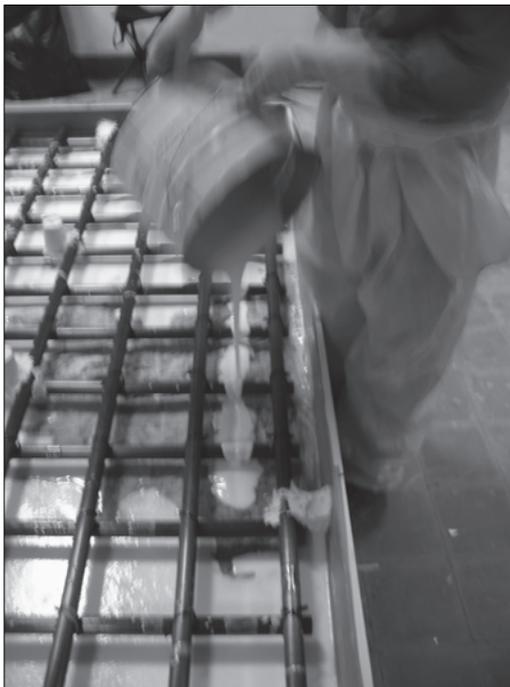
The epoxy resin<sup>10</sup> for the backing was supplied in 5kg tubs, premixed with the foaming agent. The bottles of hardener as supplied by the manufacturer contain the right quantity for a tub of resin, but casting the epoxy foam was not without its problems, since the polymerisation reaction is exothermic. The heat generated is proportional to the mass of the resin and a pour exceeding a depth of 10mm may heat up enough to distort or rupture the casting. Moreover heat could be transmitted through the plaster and cause damage to the painting. The volume was increased during

Plate 15. Foamed epoxy resin was poured into the mould.

the foaming phase by a factor of four, so that a 10mm layer produced a 40mm layer of foam. The reaction took approximately six hours to go to completion. Over a five day period, 22 tubs were mixed and poured to fill the 245mm

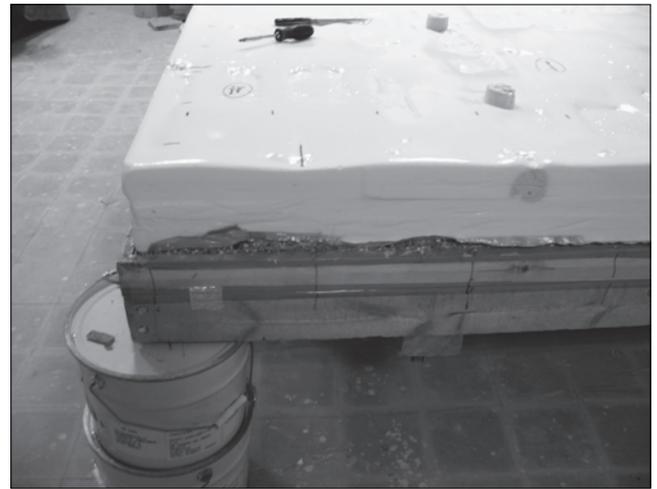
Plate 16. When the foam had hardened the mould was removed.

After the polymerisation of the final pour the mould was taken off; the waxed surfaces allowed it to come apart easily (Plate 16). At the end of the session the painting was wrapped in polythene to ensure retention of the CDD. It was needed to hold the painting firmly and protect it for the 2006 session when the PUF facing was to be cut away (Plate 17).

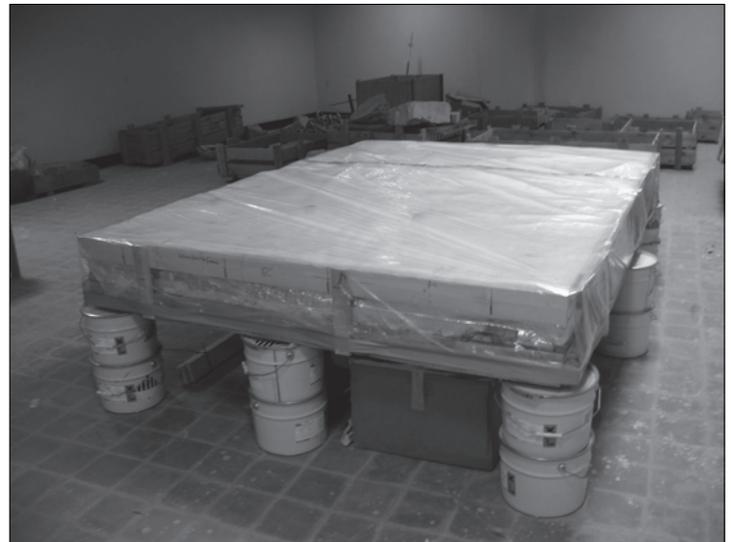
Plate 17. The painting was wrapped in polythene to retain the cyclododecane.

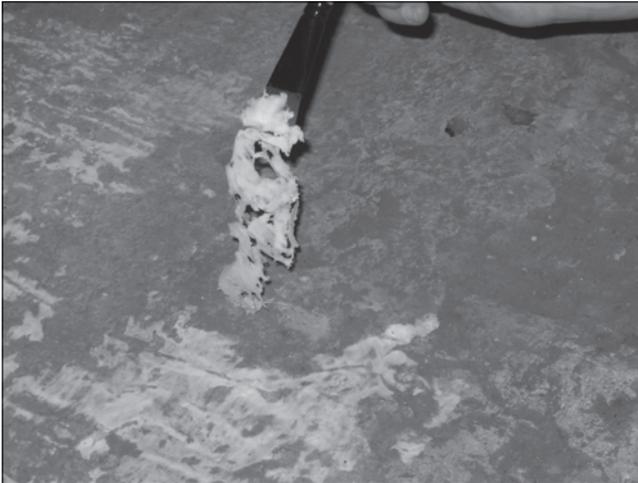
Plate 18. Polyurethane traces are all that was left of the facing.

Thin traces of polyurethane remained intact after the facing had been cut away and these were left lying loosely on the surface once the CDD had evaporated. They were collected together by brush and a vacuum cleaner used to remove them (Plate 18).

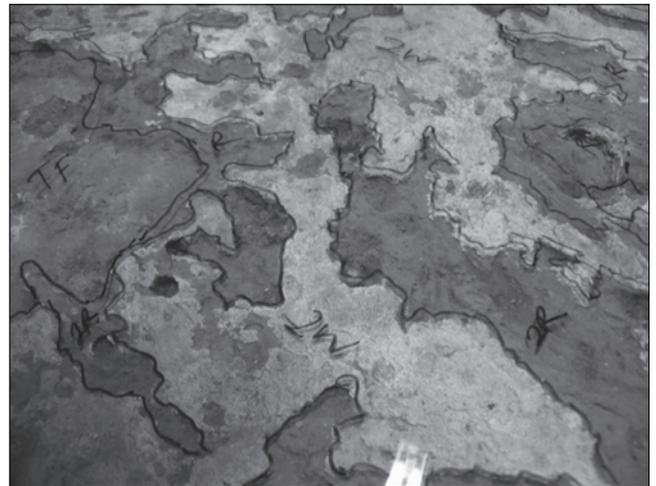
Until now, there had been no opportunity to examine the painting and so its condition was now assessed. The repairs carried out in the Meroitic period were examined in detail. Two Meroitic repair campaigns were identified and a record was made of them by mapping and coding them on Melinex sheet (Plate 19), prior to removing material that obscured the original painting. The outlines of painted detail were also recorded.

Plate 19. Meroitic repairs were mapped and coded on Melinex sheet.

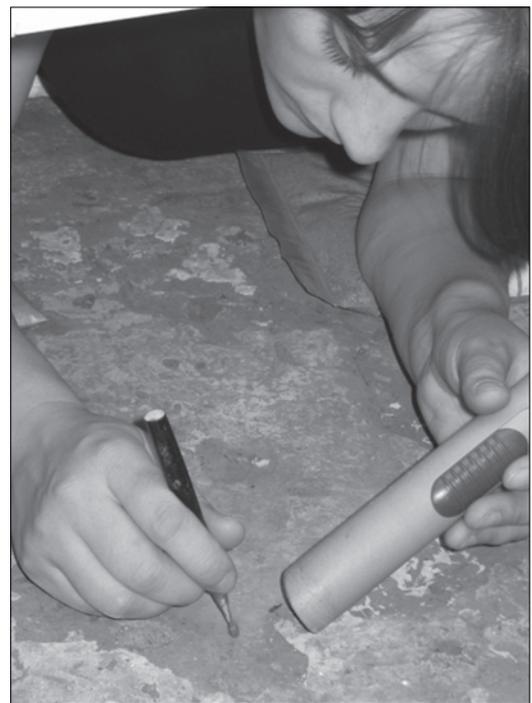
The removal of the remaining Meroitic paint (Plate 20) uncovered a figure at the far left of the scene, possibly to be identified as Horus (Colour plate XXXIII). Very little paint remained under the rest of the Meroitic layers but enough information could be gleaned from what was found

Plate 20. Leonie Saltzmann removing Meroitic paint.

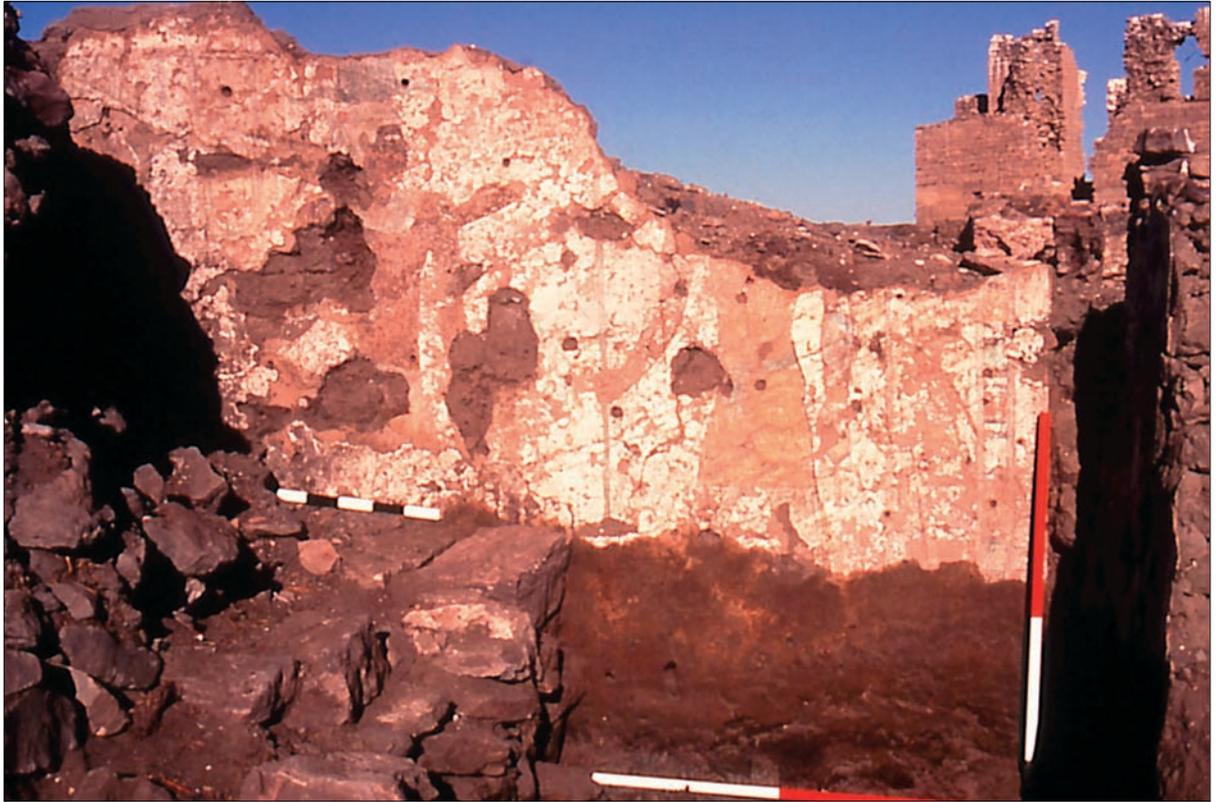
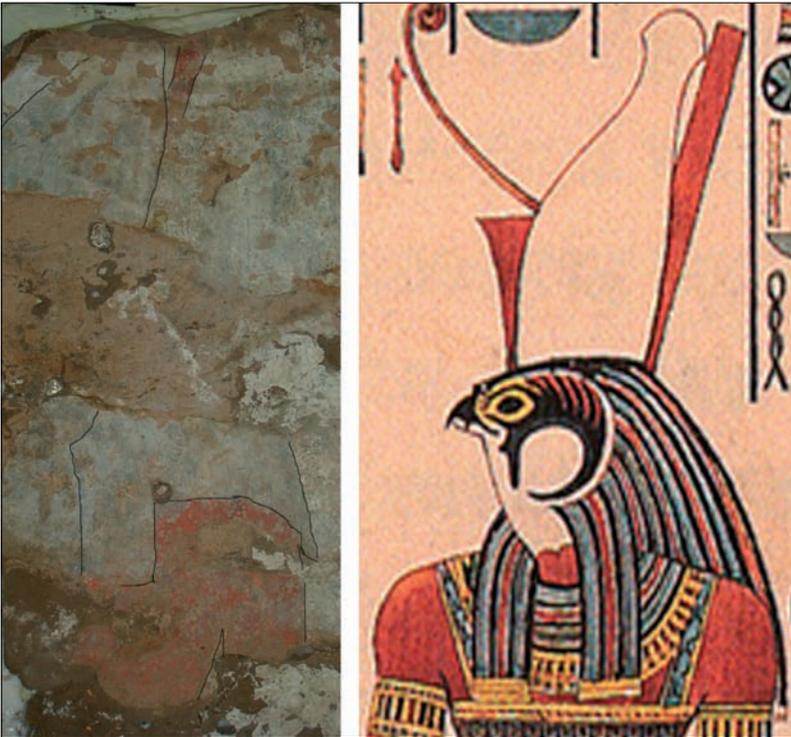
An exploratory visit was made to Qasr Ibrim in 2001 and some of the backfill was temporarily removed to investigate the condition of the painting and to take measurements (Colour plate XXXII). The paint layer and the fine plaster layer on which it was executed appeared to be in good condition. Only the top edge of the coarse mud-plaster layer applied to the wall that supported the fine layer was visible; it was crumbly and it was decided not to include it as part of the rescue. The painting's dimensions were approximated and later accurately measured as 2.72m from the apse to the end, and 2.08m at its highest point. In the course of the following year, Eric Miller consulted Hans Hangleiter regarding the use of cyclododecane and his method for removing wall paintings (Hangleiter 2000), before drawing up a detailed plan for the rescue. Equip-

*Colour plate XXXII. Qasr Ibrim. This photograph of the painting was taken in 2000. A height dimension was taken from it for the rescue plan. (The structure in the background is the 8<sup>th</sup> century cathedral.)*
