# SUDAN & NUBIA

*Bulletin No. 15*

## Dangeil 2010: Meroitic wall paintings unearthed and conservation strategies considered

*Julie Anderson and Salah eldin Mohamed Ahmed*

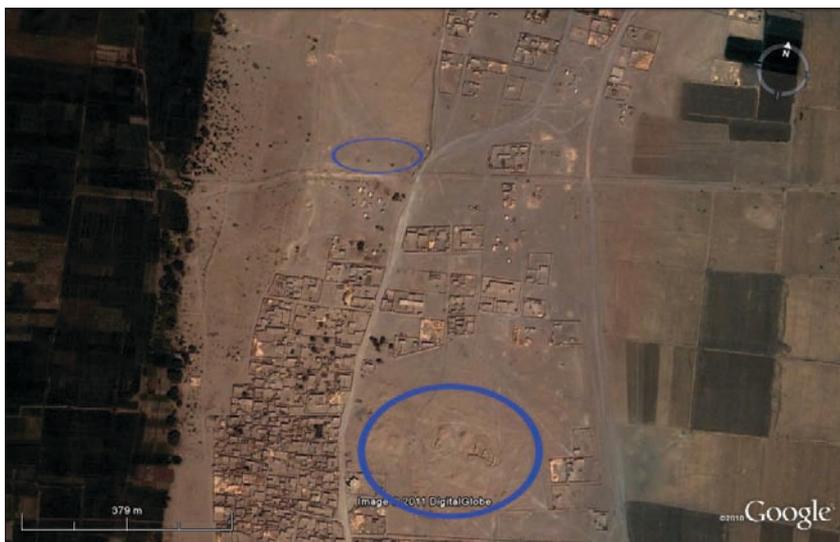
*Plate 1. Google Earth image with the sites of Dangeil and the associated WTC cemetery encircled.*

The 2010 field season of the National Corporation for Antiquities and Museums, Sudan, at Dangeil ran from mid October until the beginning of December.<sup>1</sup> Dangeil is a Kushite site situated south of the Fifth Cataract, just north of the city of Berber. This season excavations were conducted in two areas, the first being in the 1<sup>st</sup> century AD Amun temple, a building which dominates the site and is situated in the centre of a large temenos enclosure, and the second in the associated Kushite cemetery, designated WTC, which dates between the 1<sup>st</sup> century BC and 1<sup>st</sup> century AD (Plate 1).

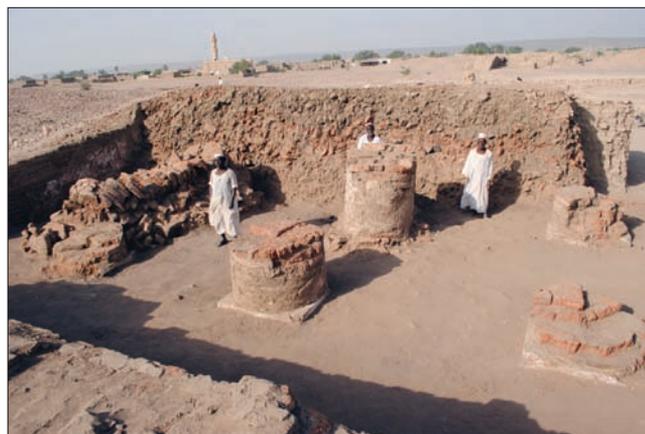
*Plate 2. Southern half of the first court of the Amun temple at the end of excavation.*

The first court is a substantial room with its interior measuring 10.8m east-west by 27m north-south. A doorway (1.58m wide), leading to the temple exterior, was located in the south-east corner of the room and again a similarly situated entrance was located in the northern half of the court. The columns were distributed in two rows. The drums were constructed of red-brick quarter-circles mortared together with mud and then plastered on the exterior with mud and lime plaster to form columns 1.25m in diameter that rested on square foundations. This technique was used elsewhere in the temple; however, the columns in the first court are by far the largest. The various stages in the collapse of the building were clearly visible in the baulk which ran parallel to the east face of the southern entrance pylon (Plate 2).

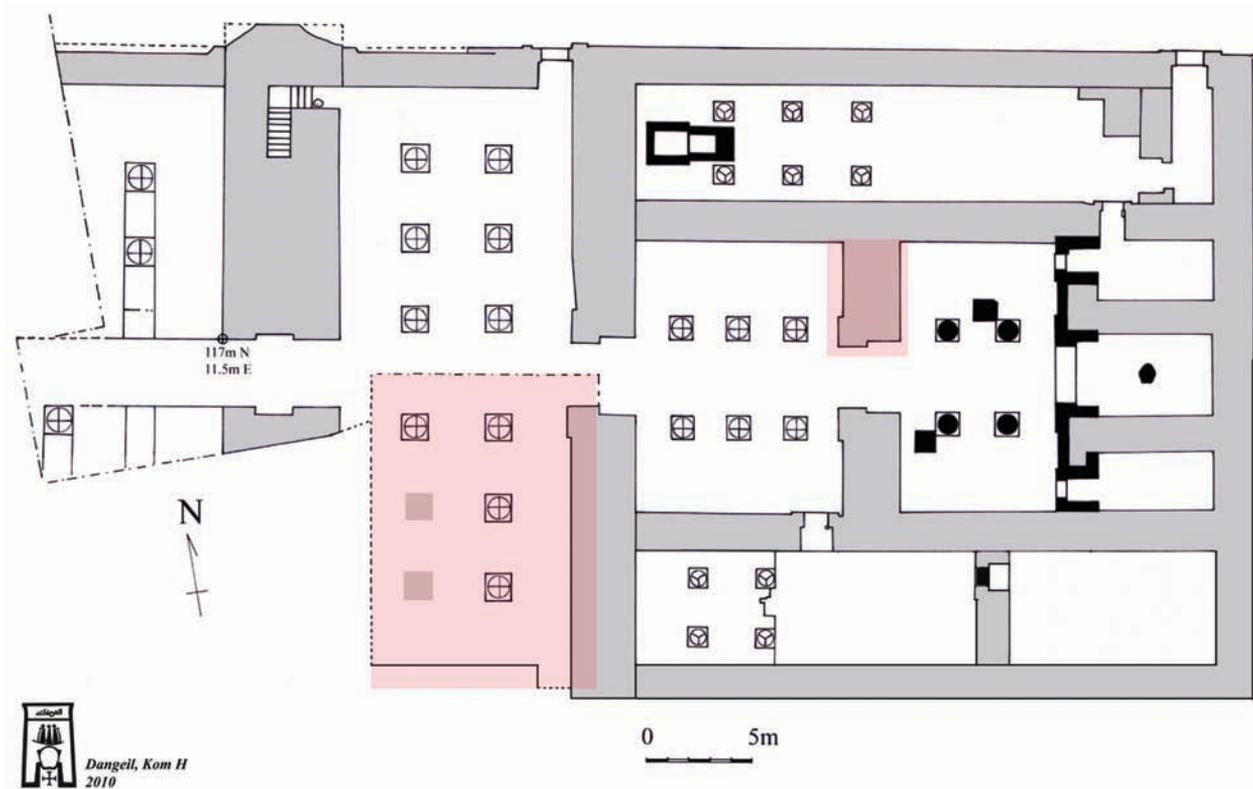
Figure 1. Plan of the Amun temple, Dangeil. Scale 1:1000. Areas of 2010 work shown in red.

Excavations within the Amun temple concentrated on clearing the remaining unexcavated portion of the temple in the south-west part of the building (Figure 1). The objective was to complete the plan of the complex by uncovering the southern half of the temple's main pylon entrance and the remainder of the first court. The fill of this area was extremely dense and consisted of lime plaster, mud-brick and red-brick rubble which originated from the collapse of the southern half of the pylon and from the columns within the

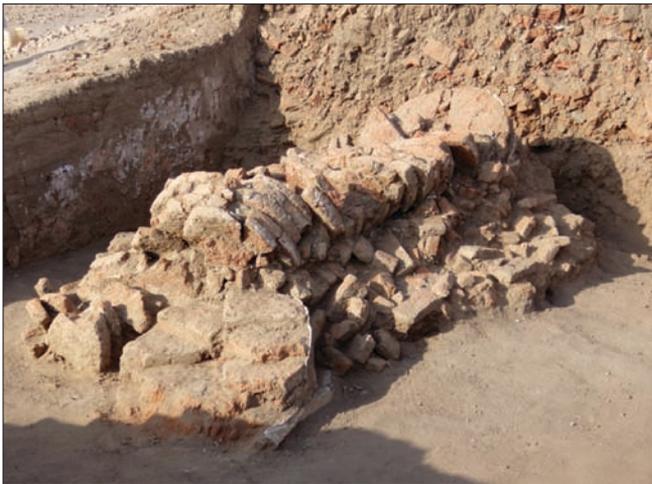
Plate 3. Column collapse.

The two southern columns (H770, 773) had collapsed one on top of the other (Plate 3), likely due to instability resulting from the collapse of the roof and the subsequent infiltration of rainwater following the structure's abandonment. This collapse is sizeable measuring over 3.5m long and ranging in width from 1 to 2.5m. The upper part of the central column in the western row (H761) had slipped and rotated roughly half a metre eastwards during its collapse, yet this upper section remained intact and stood upright with much of its plaster still preserved (Plate 4).

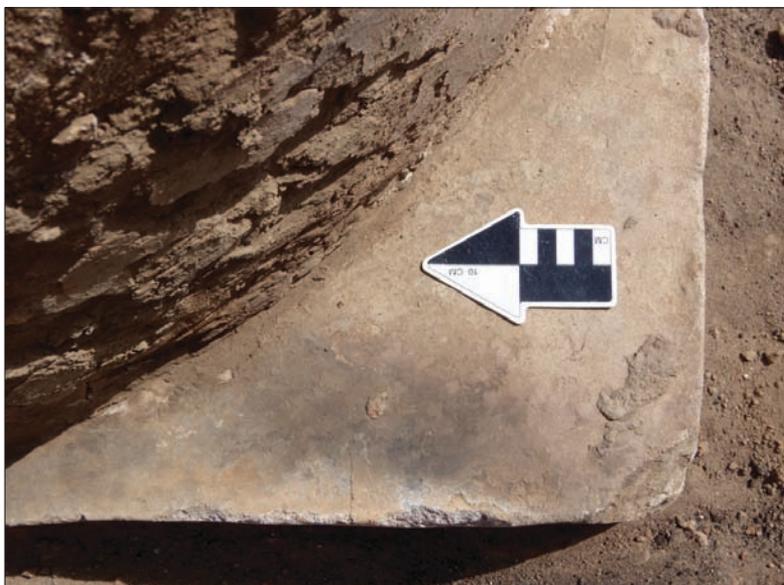
*Plate 5. Burnt column base.*

The lime plaster on the column bases and lower sections of the walls was fire-reddened and charred. Further evidence of

this event has been found elsewhere in the building (Plates 5 and 6).

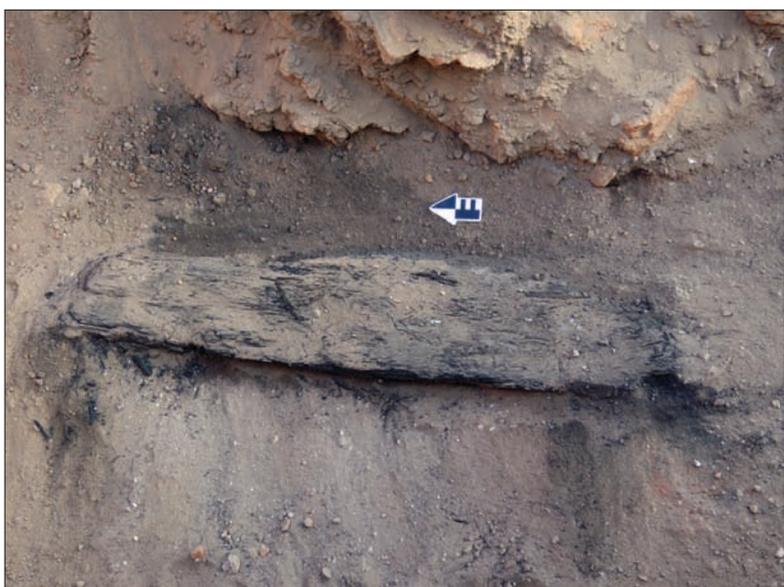
*Plate 6. Charred palm roof beam in situ.*

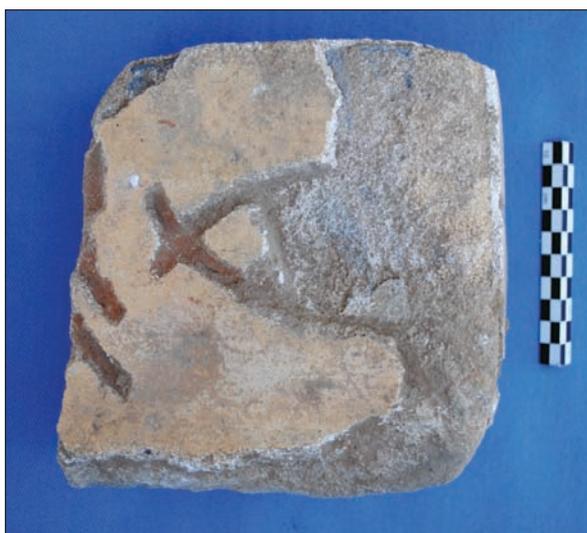
*Plate 7. Abacus (?) face with Meroitic hieroglyphs.*

The few objects that were found during excavation of the court largely were confined to grinding stones, ceramic drain spout fragments and beads; however, a carved and painted sandstone block bearing an ankh on one side and Meroitic hieroglyphs on another face was also recovered (Plates 7 and 8). It may have been part of an abacus that supported the roofing. It is likely that the abaci were stone in order to separate the columns from the wooden roofing as the mud mortar in the columns would have otherwise provided an ideal conduit for termites. A ceramic baboon head (5/10) was found on the site surface to the west of Kom H and

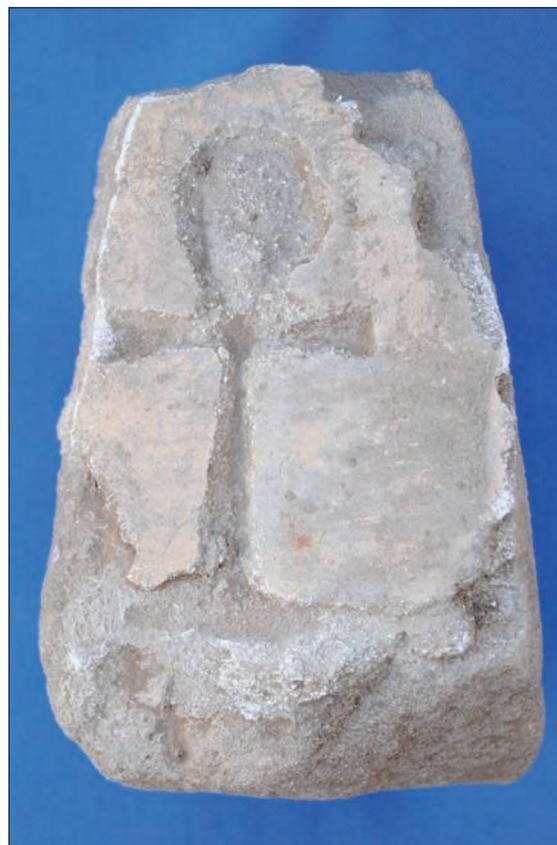
*Plate 8. Abacus (?) face bearing an ankh.*

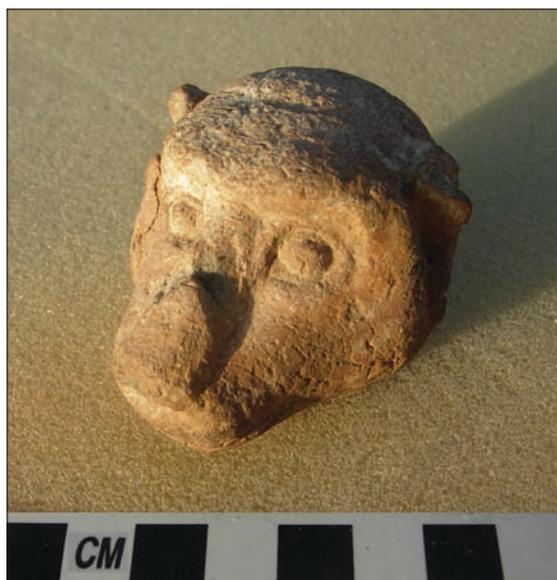
*Plate 9. Ceramic baboon head (5/10).*

so unfortunately lacks a stratified context, but it is rather uncommon and may have been a handle or rim ornament on a large jar (Plate 9).

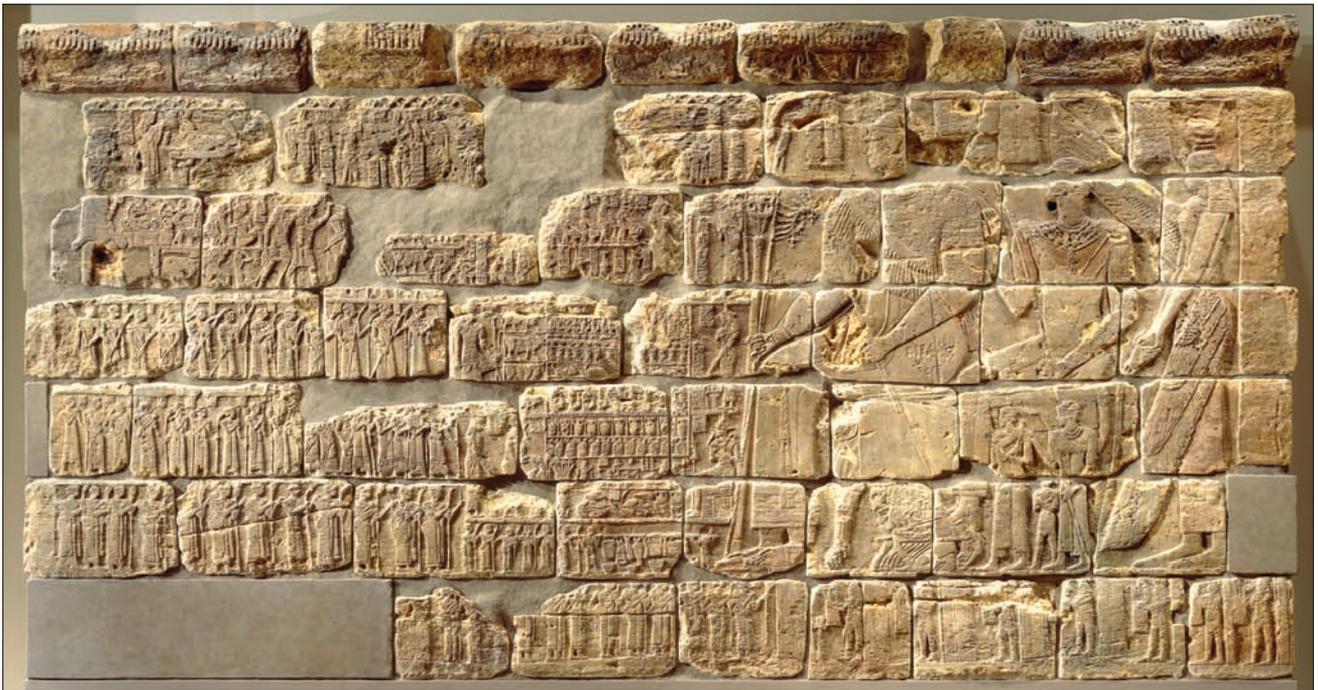
Plate 10. South wall of the tomb chapel of Queen Shanakadakhete (EA 719, © The British Museum).

some material for comparison or analogy but these are less satisfactory as the funerary purpose for which they were created differs from the religious function of an Amun temple. The south wall of the tomb chapel of Queen Shanakadakhete (Beg.N.11) dating to the 2<sup>nd</sup> century BC, now in the British Museum (EA 719), provides one such example for comparison (Plate 10). The queen, who is the tomb owner,<sup>2</sup> is depicted sitting on a lion throne with the prince behind her. Both are protected by the wings of the goddess Isis. Several small registers of attendants bearing palm fronds stand before the larger royal figures.

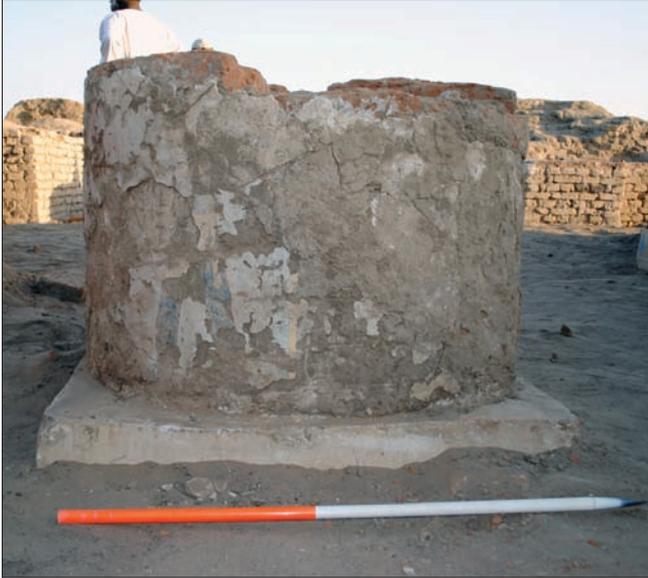
Plate 11. Fecundity god on lower register of column H762.

The lower register of column H762 (Plates 11 and 12) depicts a fecundity god with blue legs,<sup>4</sup> wearing a yellow kilt,

striding forward. The figure was initially outlined in red and then the base paint applied. Details within the painting were defined in red and applied on top secondarily. Thus far, no evidence has been found to suggest that a proportional grid

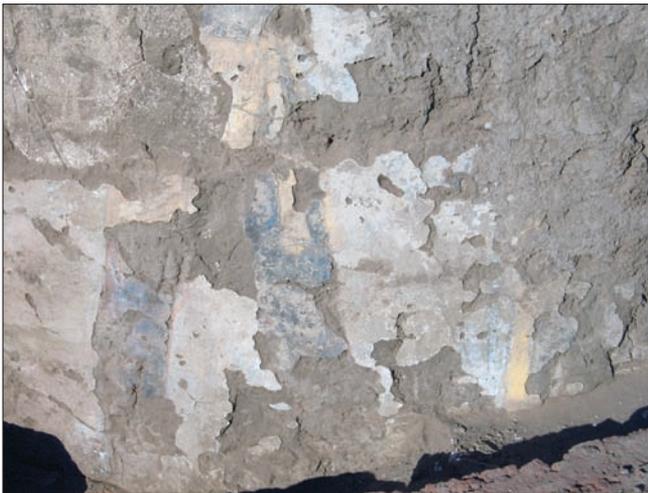
Plate 12. Close-up of painting of the fecundity god on column H762.

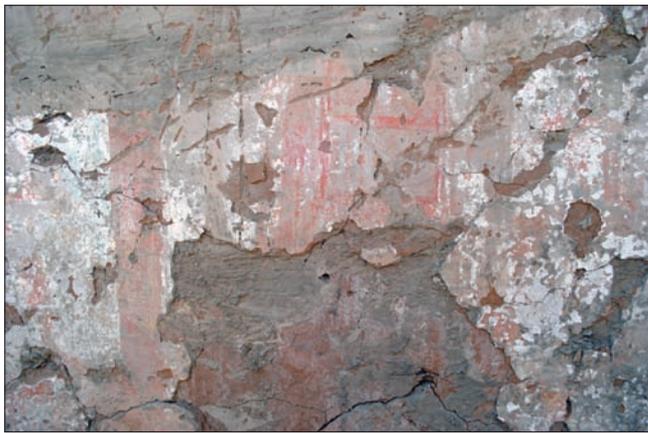
Plate 15. Structure (?) towards which the smaller figures are striding.

Remains of a long painted scene could be seen on the southern wall of the hall (Plate 14). As with the other paintings, it was very poorly preserved and difficult to interpret. Part of this was due to fire reddening and charring of the plaster face. The scene appears to depict a procession of at least three small figures striding westward, possibly through a building or structure, towards perhaps a larger figure. The smaller figures can be distinguished largely by pairs of striding red legs. The individual in the centre appears to be a priest as he is depicted with a tail hanging behind his kilt, while the faint remains of a yellow kilt are visible on the

leading figure. The background is light blue. The left side of the painting is also unclear and may also represent part of a building or some sort of table of offerings. Unfortunately, the longer one looks at these fragments, the more creative the interpretations become.

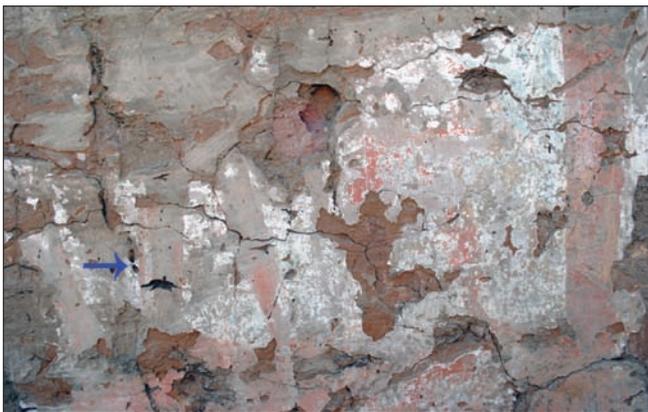
Plate 16. Three small figures with red legs striding westward.  
The priest is the central figure with the tail of his garment indicated by the blue arrow.

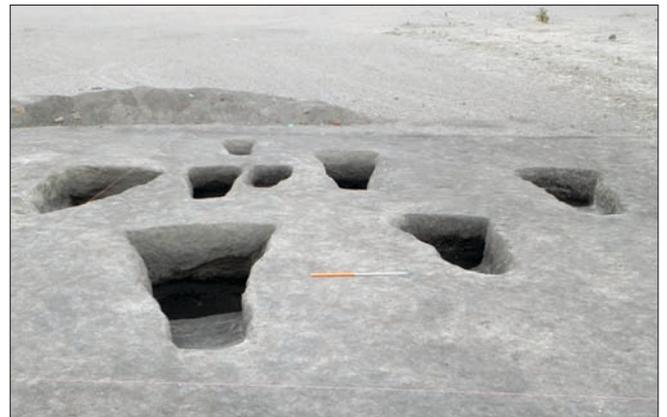
Plate 17. Kushite tombs in WTC 5, facing west.

The Kushite tombs were comprised of east-west orientated shafts that descended into oval, north-south orientated burial chambers (Plate 17). The entrances to these

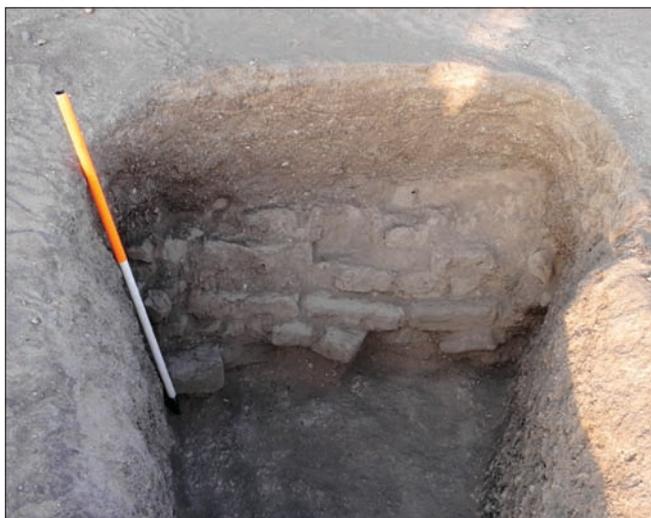
Plate 18. Brick blocking of the tomb chamber.

chambers were sealed with mud bricks or red bricks or a combination thereof (Plate 18). Grave goods recovered included numerous large beer jars (Plate 19), which were usually placed at the tomb entrance just inside the blockage wall, several small, wheel-made red-ware bowls, a painted fine-ware cup from WTC 5, tomb F (Plate 20), beads, and a faience vase which was found nestled up against a beer jar in WTC 8, tomb 1 (Plate 21). A glass flask was found among the poorly preserved skeletal remains in WTC 5, tomb M (Plates 22 and 23). This tomb also contained a small copper-alloy jar (Plate 24). Many of the human remains and organic material from the cemetery were in poor condition due to the presence of salt and water seepage, factors which are exacerbated when tombs have been robbed and disturbed.

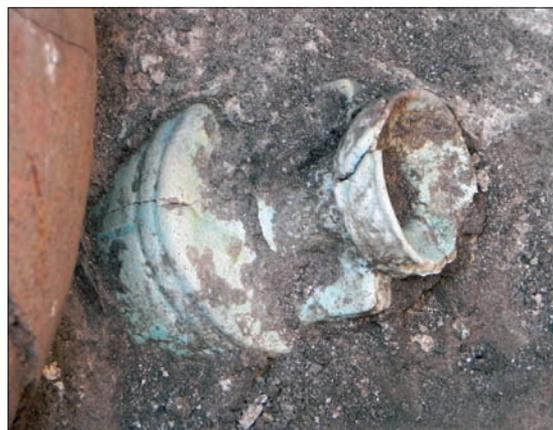
Plate 21. Faience vase from WTC 8, tomb 1.

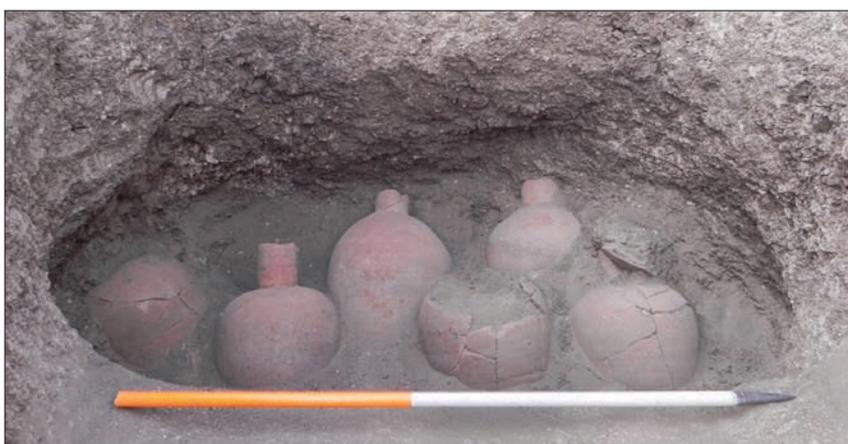
Plate 19. Beer jars situated behind the brick blocking

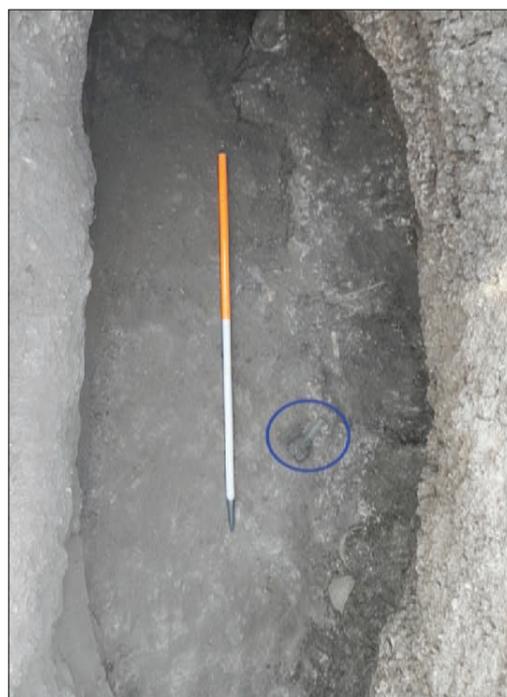
Plate 22. Glass flask among the skeletal remains in WTC 5, tomb M.

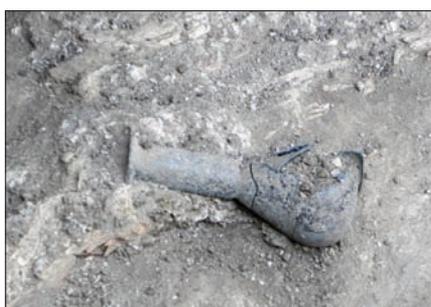
Plate 23. Close-up of glass flask from WTC 5, tomb M.

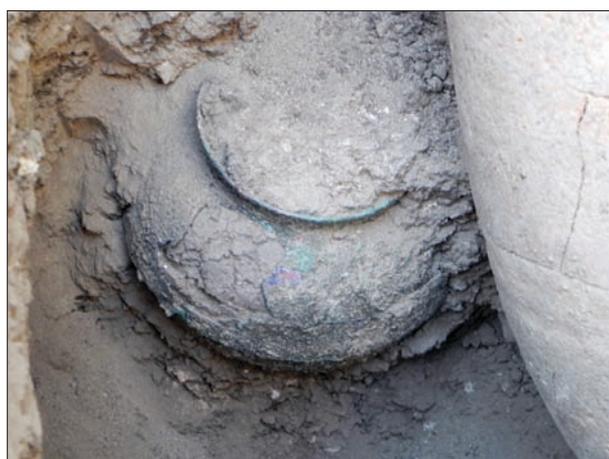
Plate 24. Copper-alloy jar from WTC 5, tomb M.

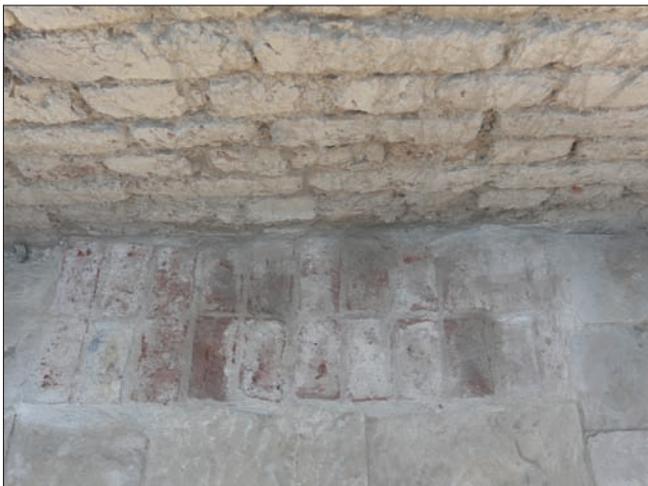
Plate 25. Conservation and consolidation of a sandstone floor.

Consolidation and repairs to the sandstone floors have been quite successful, with missing sections of the floors filled with red bricks and lime mortar after cleaning and preparation of the area (Plate 25). The edges of the ancient flooring are protected. There is a clear, yet non-intrusive dif-

ference between ancient and modern material. The additions are removable, wear well and are locally sourced. Similarly, the application of lime mortar consolidated the ancient bricks in the stairwell of the northern half of the main entrance pylon successfully (Plate 26). Lime rendering applied as a sealant to a column did not work, but subsequent chemical analyses of the various local supposed lime products led to the discovery that some contained no lime whatsoever, and thus the lime rendering initially used on the column actually contained no lime. This problem has since been addressed.

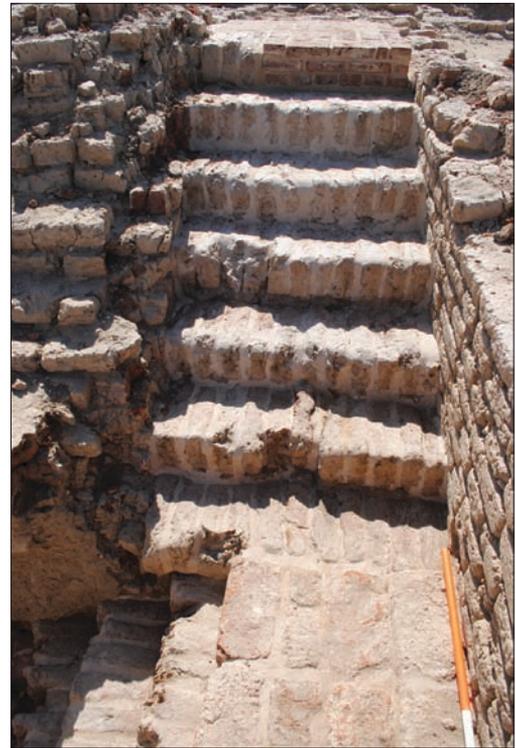
Plate 26. Conservation and consolidation of the staircase in the northern half of the entrance pylon.

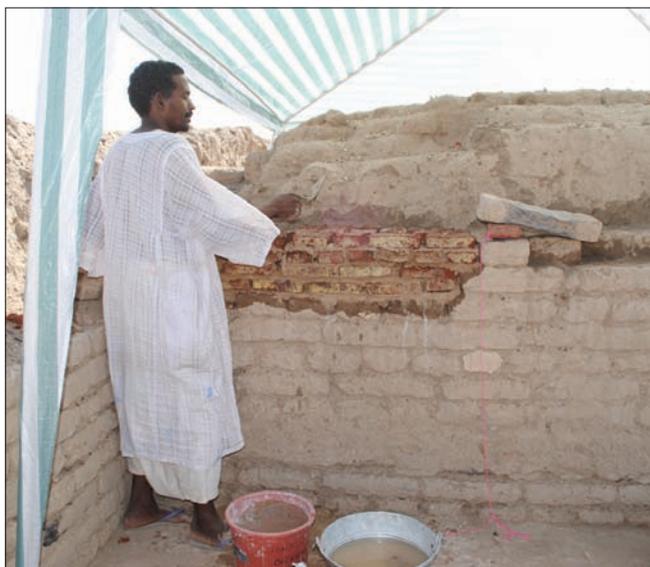
Plate 27. Conservation of red brick wall facing

The greatest challenge faced is the conservation of the temple walls. These walls have red-brick foundations, are faced on the exterior with fired red brick, and have mud-brick cores. The penetration of rain water into the mud-brick masonry leads to the explosion and subsequent collapse of these walls; thus leaving the walls in their original state of discovery would lead to the rapid deterioration of the building. There is an ongoing loss of original material due to environmental and human factors.<sup>5</sup> Various trials using locally sourced material to create a water-proof, protective and sacrificial capping for these walls have been conducted and are ongoing. Currently, the red-brick wall exteriors are reconstituted using modern bricks and lime mortar up to the level of the preserved ancient mud-brick core, then the top of the wall is capped with fired bricks (Plates 27 and 28). The technique of capping

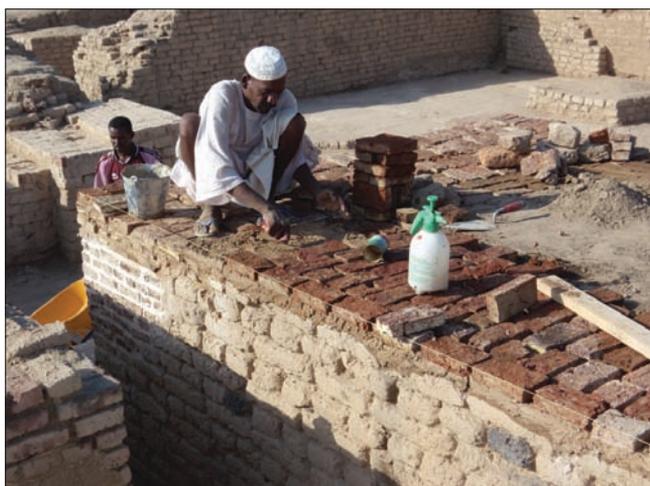
Plate 28. Capping the top of a wall with red bricks

The capping is constructed with a slight slope so that water drains away from the ancient walls. The lime rendering used to seal the columns is similarly inclined along the edges. Depending upon the final dispensation of the temple roofing proposed below, it may be necessary to consider installing a

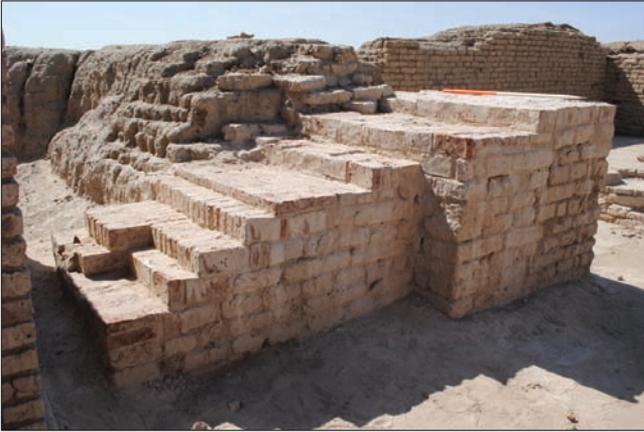
Plate 29. Southern half of the gate into the sanctuary area after initial conservation.
