*Bulletin No. 16* 2012

# Meroitic Building Techniques: a few observations from Dangeil

*Julie Anderson, Salah Mohamed Ahmed and  
Tracey Sweek*

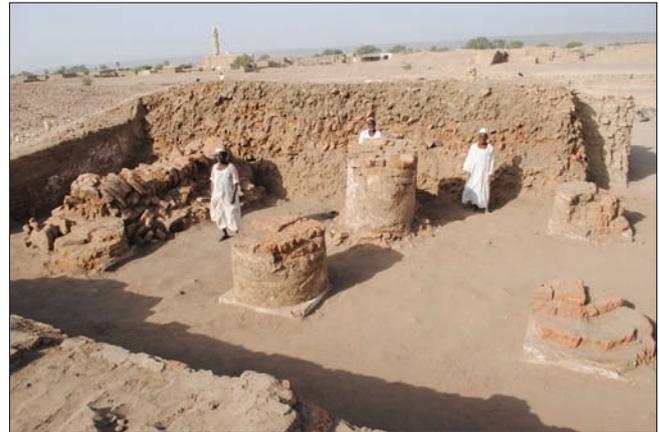
and the substantial collapse of three columns (H770, 773 and 761) remained *in situ* (Plate 1). Removal of the collapsed columns provided an opportunity to examine more closely the building's construction, plastering techniques and brick composition (Plate 2). The temple was constructed of a mixture of materials including mud brick, fired brick, mud and lime mortars, palm wood and sandstone.

Plate 1. South half of the first court with column falls in situ.

Charred palm beams, charcoal and ash from the roof were preserved beneath the columns' tumble. The columns fell after the temple had burnt and the roof collapsed. The roof had been flat, consisting of a framework of palm beams, ribs and probably matting and mud plaster, supported on the columns and walls. The distance spanned by each roof beam would have been approximately 3.5m when the relative position of the walls and columns is taken into consideration. The instability of the columns was caused to a large degree

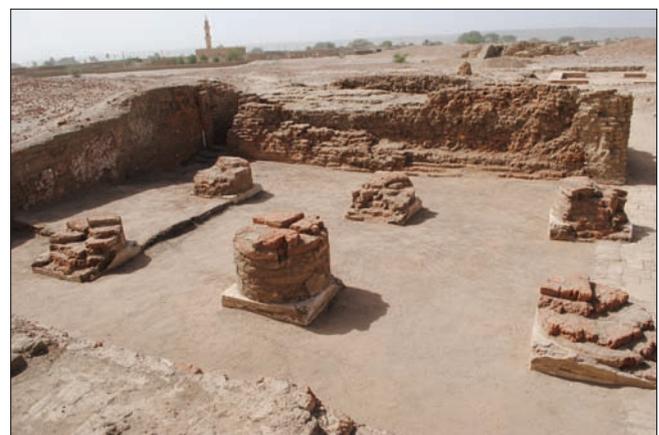
Plate 2. South half of the first court at the end of the 2011 season.

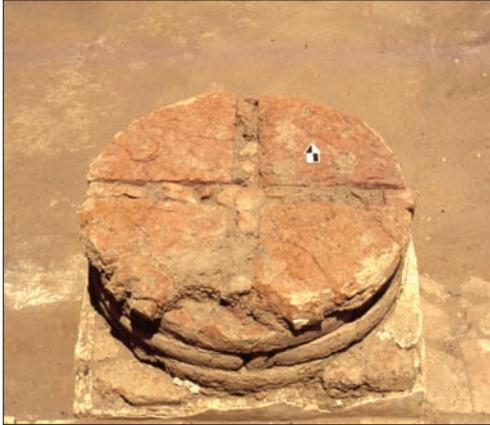
created by varying the size of the gaps between the quadrant bricks in each drum. In addition to mud mortar, galletting was also used in the first court (Plate 3). It largely consisted

Plate 3. Column in the first court with galletting.

of fragments of broken red brick that were inserted into the wet mud mortar between the bricks during the laying of each drum. As the gap to be filled by the mortar was large, c. 200mm, the addition of galletting served to strengthen and reinforce the bond; however, there still remained a larger gap between the bricks comprising the drums of the first court columns than those elsewhere, through which water could percolate. The gap between the bricks in the second court for example, was only c. 40mm.

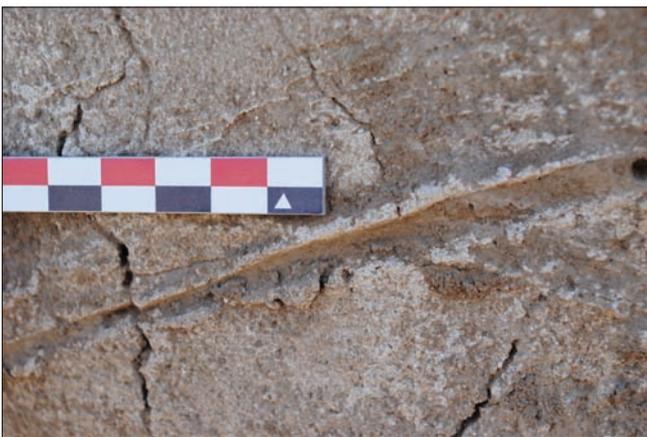
Each column was covered with an unevenly applied 'scratch coat' of lime plaster up to 20mm thick, with spiral lines incised in it which encircled the column. Close examination indicated that the plaster was extremely thick when applied; so thick that folds or rolls were created when the plaster was incised (Plate 4). Mud plaster was applied on top

Plate 4. Lime-plaster scratch coat.

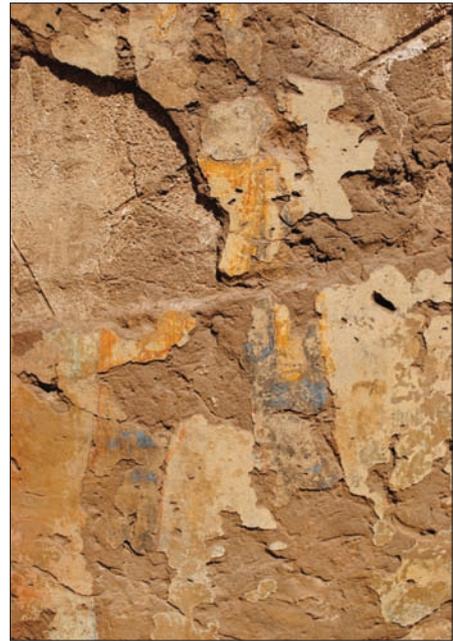
of the scratch coat over which a wash of lime was applied. The mud plaster averaged 8mm thick but the lime wash was under a millimetre. Pigments were applied to the lime wash (Plate 5). The mud plaster was extremely friable and the pigments themselves are fugitive so together this creates a very

Plate 5. Column with a layer of mud plaster overtop of a lime plaster scratch coat. Lime wash and pigments have been applied to the mud plaster.

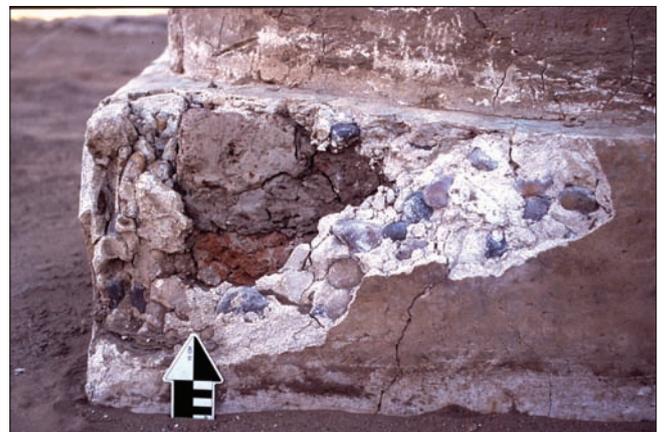
Column bases were covered with cement (30mm in thickness) consisting of rounded desert pebbles (c. 20–30mm in size) mixed with lime (Plate 6). The cement was covered with a thick layer of lime plaster to which the artificial pigment identified as Egyptian blue, a copper silica compound ( $\text{CaCu}(\text{S}_{14}\text{O}_{10})$ ), was applied. Similarly in the kiosk situated in front of the temple straddling the processional way, pigments were applied directly to a lime plaster finishing coat without an intervening layer of mud plaster and lime wash. These colours were less fugitive and better preserved than

Plate 6. Cement consisting of lime and rounded pebbles on a column base in the first court.

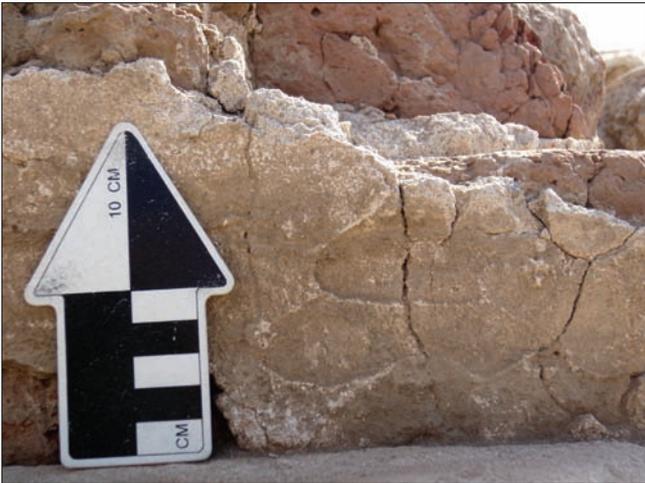
Tool marks were visible in the lime plaster and ridges were created when the plaster was applied and the plaster thickness is irregular (Plate 7). In many cases the shape of the tool marks does not appear to correspond to those produced by a plasterer's float, a tool still used today and which was

Plate 7. Tool marks visible in the lime plaster on a column base.

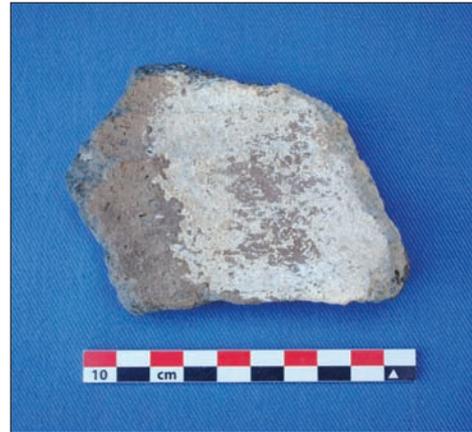
present in ancient Egypt, though not a common find. One such example of a wooden plasterer's float was discovered by W. M. Flinders Petrie at Kahun dating to the 12<sup>th</sup> Dynasty (1985–1795 BC) (Petrie 1917, 42, pl. XLVII; see also David 1986, pl. 18). Reused pot sherds were among the tools used for the application and scoring of lime plaster and cement and several were discovered, though this is not to say that they were the only tools utilized (Plate 8). Mud plaster may also have been applied by hand.

Plate 8. Pot sherd reused as a tool for lime plaster application.

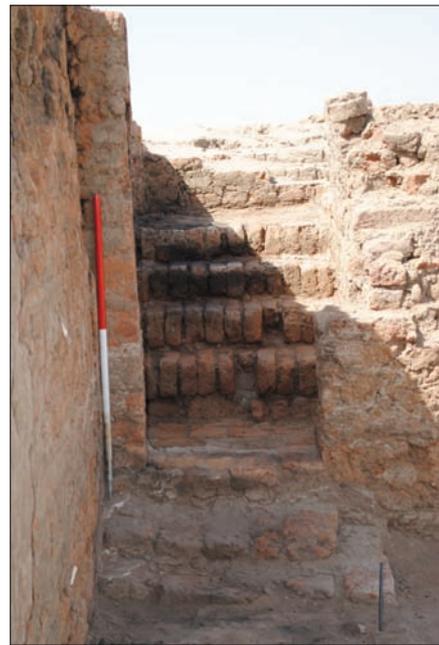
fire-reddened bricks of the south wall of the first court (Plate 9). It seems that the fire which destroyed the temple started inside the south pylon's stairwell, with the stairwell perhaps drawing wind to create a forced draught fire that was thus fanned and spread.

Plate 9. The staircase leading up the south pylon.

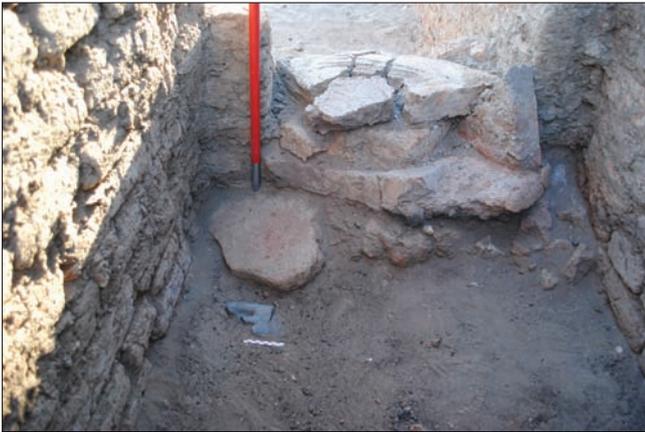
*Plate 10. Interior of the stairwell with the left foot of Tabarqo statue in situ.*

Following the fire, subsequent related structural collapse and the abandonment of the temple as a formal religious building, the stairwell was blocked. Beneath this blockage, mixed with the temple's destruction debris was part of the left foot of a large granite statue (Plate 10). It was part of the statue of the Kushite ruler Taharqo discovered in the temple in 2008 (see Anderson and Salah Mohamed Ahmed 2009). This fragment was found a substantial distance away from the other pieces, the majority of which were discovered in the south-eastern room of the temple, and seems to suggest that statue fragments could be found in the destruction layer anywhere within the temple.

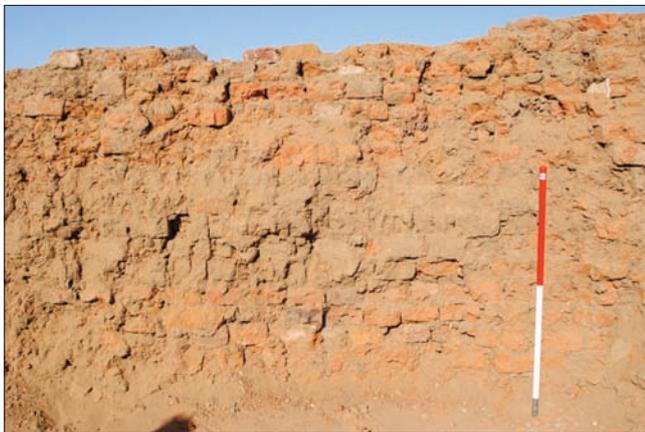
with a red-brick foundation and a mud-brick core faced with red bricks on the exterior sides and the upper courses. There is no evidence to suggest the presence of a red-brick bonding course running through the pylon. The stairwell and its landing were also of red-brick. Evidence for this construction is visible both on the top of the pylon in holes where the red-brick capping had been removed at some point in the past, and on the sides where the red-brick facing has fallen away from the mud-brick core (Plate 11). This construction differs from the north half of the pylon (H13), which as far as can be determined appears to be solidly constructed of red brick.

*Plate 11. South pylon with mud bricks visible in the structure's core.*

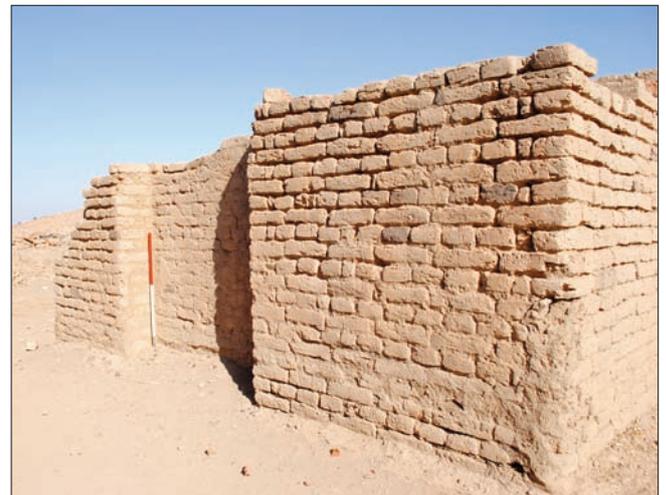
The exterior red-brick facing of the pylon (H109, 13) consisted of headers laid over stretchers, offset by half a header (50mm) each time so that long vertical joints and structural weakness would not be created (Plate 12). The foundations

*Plate 12. Brick work in the north pylon (facing north west).*

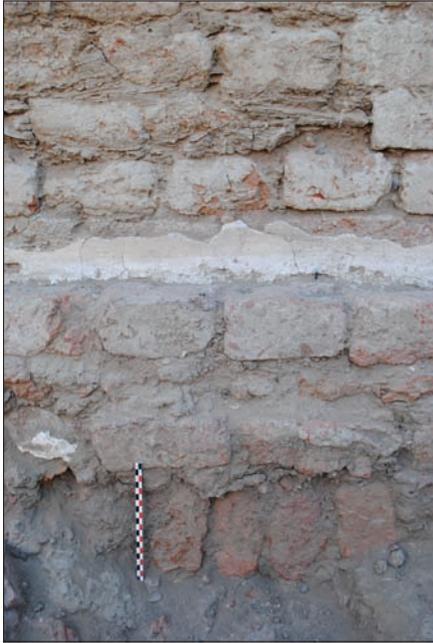
of the walls consisted of a course of red bricks laid on their sides. Throughout the building some of the thicker walls have two or three courses of fired bricks laid as headers on top of this lowest foundation course (Plate 13). These can protrude up to half a brick's length away from the main face of the wall and possibly functioned to inhibit the undercutting of the foundations particularly by environmental factors such as wind and rain. The columns in the first court required a firm base to ensure stability and were constructed on a foundation that consisted of four rows of red bricks laid in a single course of headers on each side and two diagonal rows in the centre (Plate 14). Presumably the columns elsewhere in the temple are similarly founded however their foundations have not been exposed.

Plate 13. Red-brick foundation courses beneath temple wall.

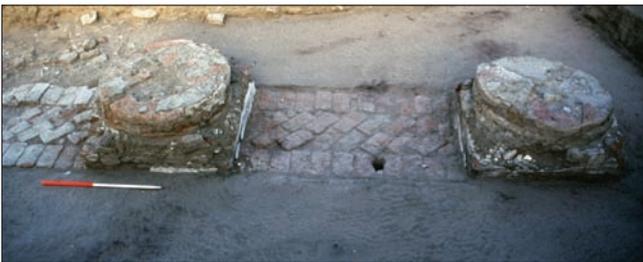
Plate 14. Red-brick foundation courses supporting the columns.

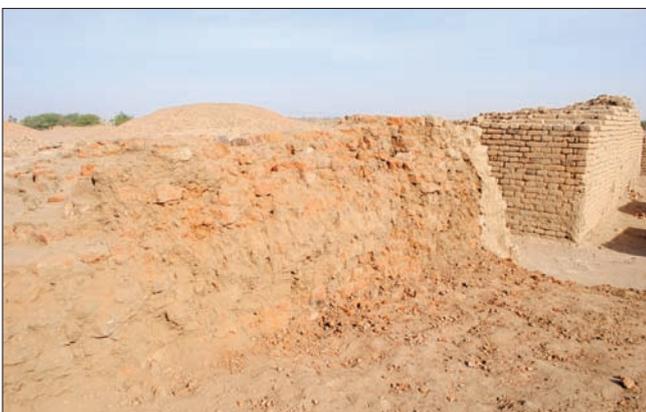
The collapse of much of the east face of the south pylon (H109) can be attributed to its poor construction. Poorly fired red bricks in the exterior broke or were insufficiently bonded to the interior brick structure causing the facing to peel or break away (Plate 15). There appears to be no evidence for the insertion of wooden beams within the brickwork to tie it together. Unlike the exterior facings, bricks laid in the core were arranged in an irregular fashion adapting to whatever anomalous shape of brick that was to be inserted. Any avail-

Plate 15. East face of the south pylon, with outer facing damaged or missing.

able material that remained towards the end of the building works appears to have been used in its construction. Workmen on site also noticed this and referred to the construction as 'Friday's work' (*[shughul youm jum'bi]*, work done on a weekend in haste when one would perhaps rather be elsewhere).

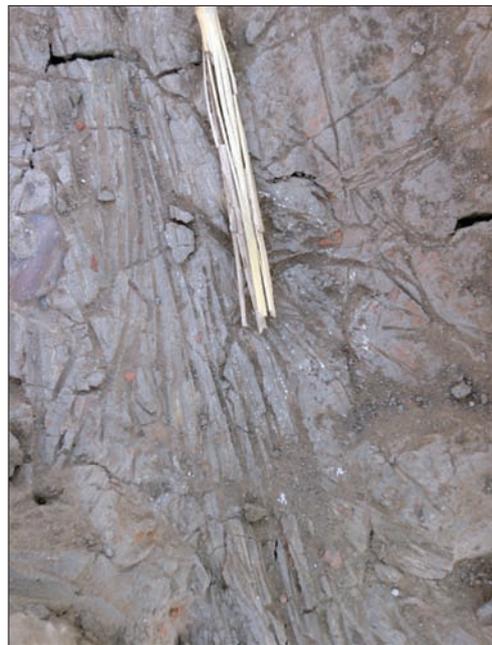
of organic material functioned as additional binding and to keep the mortar and bricks damp as long as possible to limit shrinkage. Though this is good building practice, in this case it may have been a necessity due to the size of the wall and to the variety of material included within. A modern analogy would be the inclusion of horse hair in mortar renders to make them stronger. No actual vegetal material survived in the impressions; however, various straw-like materials and their fragmentation patterns were examined and compared with the mud impressions. This led to the tentative identification of the organic material as likely being chopped stalks of sorghum (Plate 16). This may be further indicative of the widespread

Plate 16. Mud plaster with vegetal impressions and a modern stalk of sorghum for comparison.

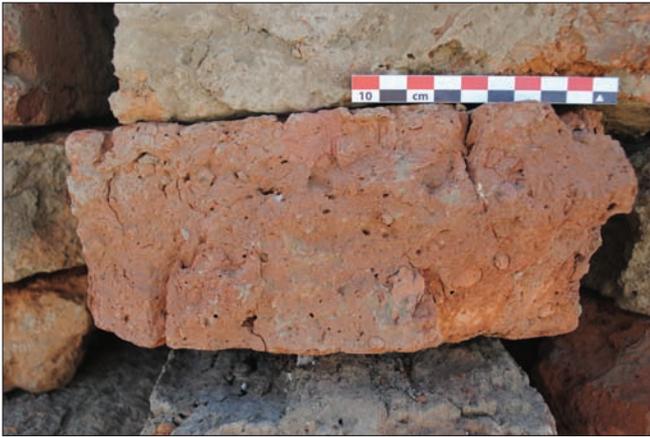
The same vegetal impressions are visible in the red bricks, though more prevalent in the non-rectangular bricks, suggesting that sorghum stalks were used as a temper. The soil used in the rectangular bricks was modified by the addition of coarse aggregates such as pot sherds and pebbles (Plate 17). The alluvial soil in the bricks appears sandy, and the soil may have been modified by the addition of sand however, particle analysis has not yet been conducted to determine the percentages of materials present in the bricks and to ascertain whether this is in fact correct.

Plate 17. Broken red brick with inclusions of pot sherds.

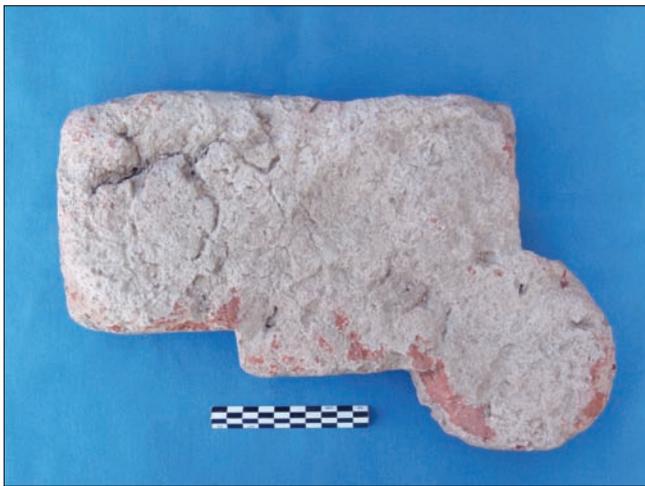
The bricks were made in moulds, some specially shaped to create architectural features more normally found in stone such as torus and cornice mouldings (Plate 18). The dimensions of the regular rectangular bricks, mentioned above, do vary slightly but they are largely homogeneous in size and

Plate 18. Red brick in a torus shape.

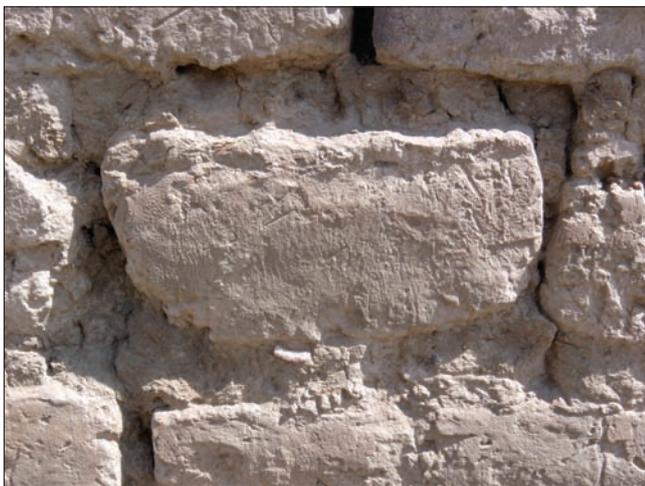
material so it is not unlikely that the bricks used in the temple were all made at the same time. Mud is a plastic substance and as such during manufacture, mud ran over the sides of the mould creating lips which are visible along the edges of the bricks. These lips can appear on both upper and lower edges (Plate 19). The upper face of a brick usually is less

Plate 19. Brick displaying a lip visible along the upper edge.

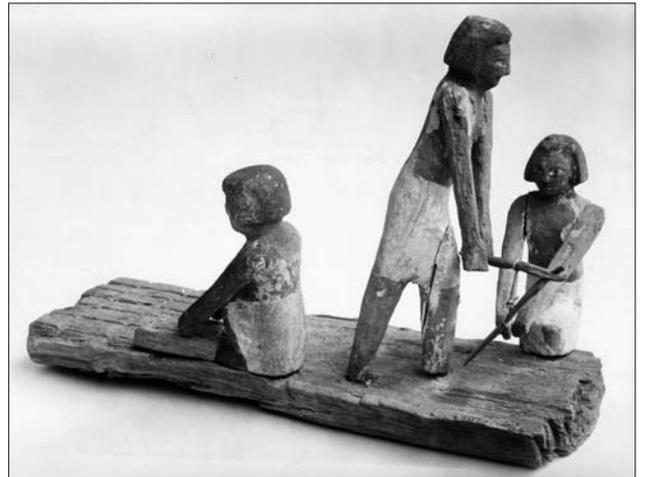
Plate 20. 12<sup>th</sup> Dynasty wooden tomb model of brick makers from Beni Hasan, Egypt (EA 63837). © Trustees of the British Museum.

Bricks are ubiquitous in Kushite and Egyptian architecture but there are few surviving examples of the moulds themselves and sources depicting brick manufacture are limited. Most analogous material comes from Egypt. For example, a wooden tomb model dated to the 12<sup>th</sup> Dynasty (1985–1795 BC) from Beni Hasan Egypt, now in the British Museum (EA 63837), depicts a team of brick makers with the small figure on the left putting the mud in moulds and the figures on the right mixing the mud (Plate 20). A surviving wooden brick

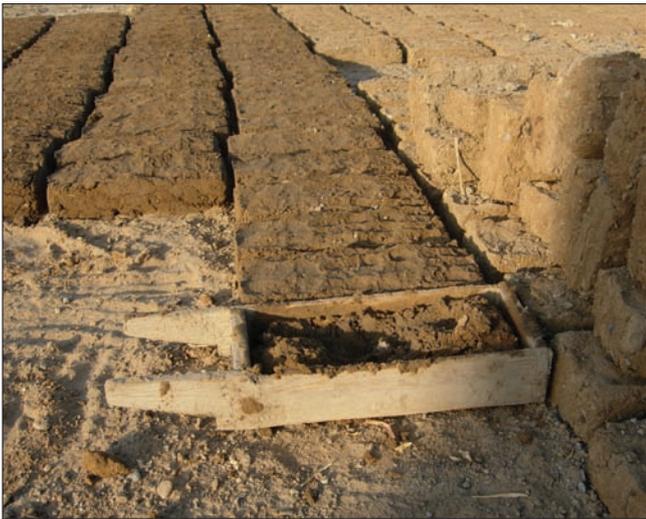
Normally a depression (well) is created in the centre of the earth pile to which the water is added prior to mixing. The mud mixture was transported nearby to a relatively flat area where the bricks produced could be laid out in rows to dry in the sun. Mud selected was rolled in dry earth prior to insertion in an open framework rectangular wooden mould resting on the ground. Finger and hand-marks were made on the upper surface of the mud when it was slapped into the mould. This created a slightly uneven upper surface on the brick to enhance mortar adhesion. Such finger or hand marks are also present on many ancient bricks, particularly in the quadrants used in the columns and in vaulting bricks (Plates 21, 22). Finally, the upper surface of the mud now

*Plate 21. Modern wooden mould used for making mud bricks.*

sitting in the mould was dusted with a sprinkling of dry earth. Any extraneous material present in the dust could adhere to the brick. This technique helps prevent mud from sticking to the mould and the brick-maker. An analogy might be the dusting of surfaces with flour when making bread to stop the dough from sticking. The mould was then removed leaving the newly formed mud brick to dry in the sun and the proc-

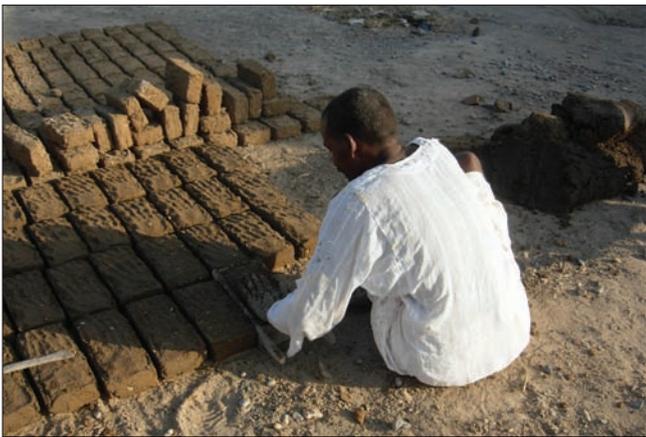
*Plate 22. Modern brick maker at Dangeil, Nigmedin Ahmed, making mud bricks.*

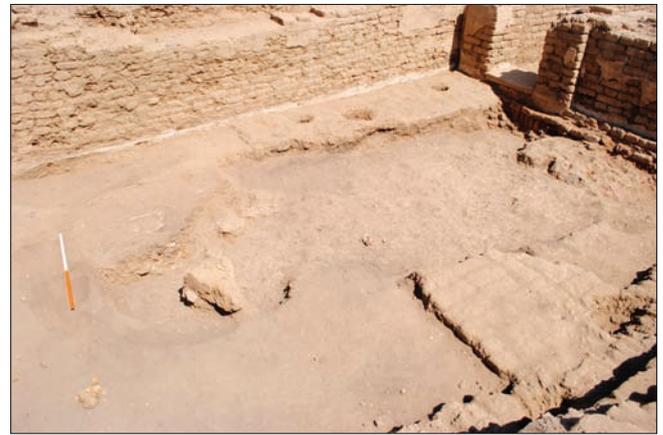
A construction pit was uncovered in the southern room of the temple, just to the south of the second court (Figure 1, Plate 23). The pit had been used to mix mud mortar for the temple construction and interestingly, it was located within the building itself. A pile of dried mortar mixed with broken brick and sandstone remained at the east end of the pit. Upon completion of use, the pit had been filled with rubble remaining from the construction activities and was sealed beneath an earthen floor surface.

It is possible that wooden scaffolding was used during the construction of the upper parts of the walls. A row of large post-holes were found beside the construction pit adjacent to the north wall of this room (Plate 23). Such scaffolding

*Plate 23. Construction pit within the south room of the temple.*

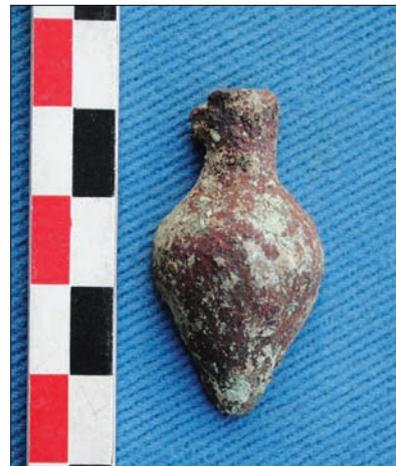
may have been secured to the wall under construction by the insertion of horizontal scaffolding beams; however, no evidence for such holes has yet been found, possibly because the walls are not preserved high enough. If they were used, then the holes may have been filled after completion of work. A copper-alloy plumb-bob (field no. 77/09) was found in the construction pit – an essential tool for an architect (Plate 24). Similar plumb-bobs including some of Greco-Roman date

*Plate 24. Copper-alloy plumb-bob (find no. 77/09).*
