The Qatari Mission for the Pyramids of Sudan. Re-opening the Burial Chambers of Beg. N.9: Preliminary Report

Re-opening of Beg. N 9, work progress and challenges

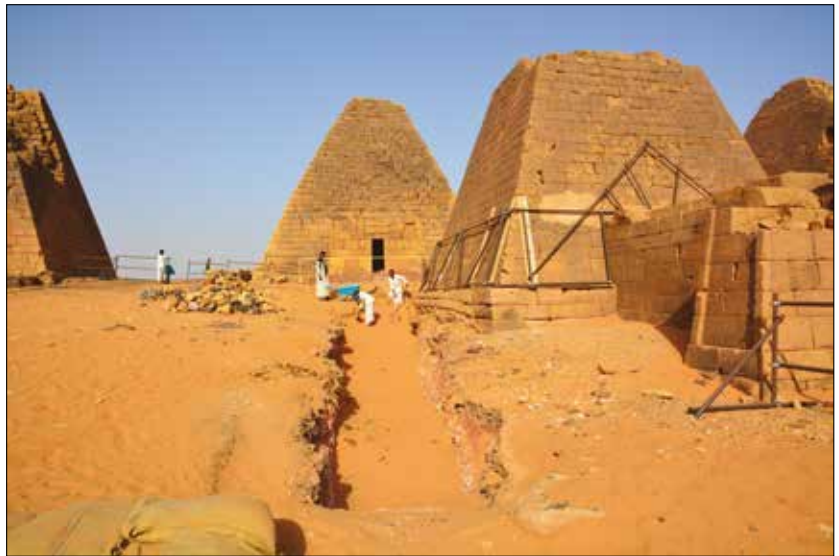
Work began on this pyramid from the first season of QMPS in 2015-2016 by the QMPS-DAI Section with contributions from the QMPS-NCAM Khartoum Section. The work started at the descandary, but at a depth of 3.8m the work stopped due to the discovery of ancient water penetration. This is mostly from the area near the south-west corner of Beg. N.18, that was built close to the descandary, and has exerted pressure on the northern side wall (Plate 1). This problem can be seen in the profile of the northern side of the descandary. Most probably this problem began in antiquity as the descandary of Beg. N.9 was dug into the sloping face of the ridge from east to west. In addition, the later construction

Plate 1. Location of Beg. N.18 beside the descandary of Beg. N.9.

of Beg. N.18, east of Beg. N.9, resulted in the collection of rainwater that penetrated into the descandary.

In the following season, 2016-2017, in order to protect Beg. N.18 and to facilitate the work in the descandary of Beg. N.9, the QMPS-DAI team constructed a concrete ring beam around the upper part all along the descandary. The maximum depth of this revetment is 3.8m in the western part of the descandary.

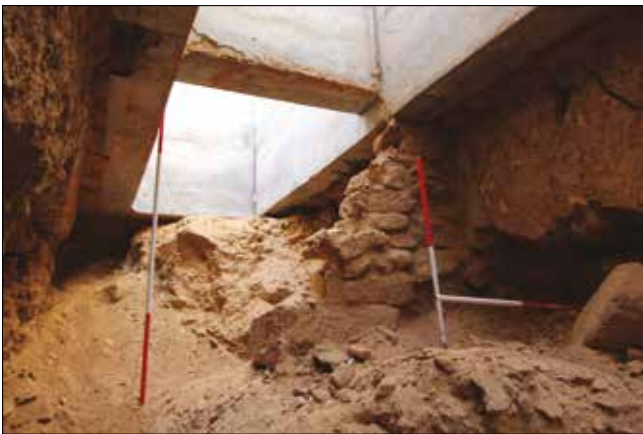
In order to move the work forward, more local workmen were employed and the level of the excavation of last season was reached. At a depth of 200mm below the concrete beam, however, in the area under the south-west corner of Beg. N.18, we faced the same problem as that of the previous season. Part of the descandary sides had collapsed and the walls showed cracks, there were loose flakes of rock, and holes had appeared in the kaolin and white sandstone layers which stretched around the whole descandary (Plate 2).

Plate 2. Cracks and holes on the northern wall of the descandary.

To overcome these challenges, several meetings were held between the NCAM and the DAI teams, in order to secure the site and protect the workers. Metal supporting props (agroprops) were placed to support the concrete wall, and a stone wall was built under it, towards the western end of the descandary. A decision was made to allow only NCAM workmen to work in the descandary and tomb.¹

ern descandary walls have been filled by sandstone fragments and clay and 20 agroprops have been placed to support the concrete wall. This is a temporary solution to facilitate the opening of the tomb and the removal of all the objects put inside by Reisner, as mentioned in his notes.

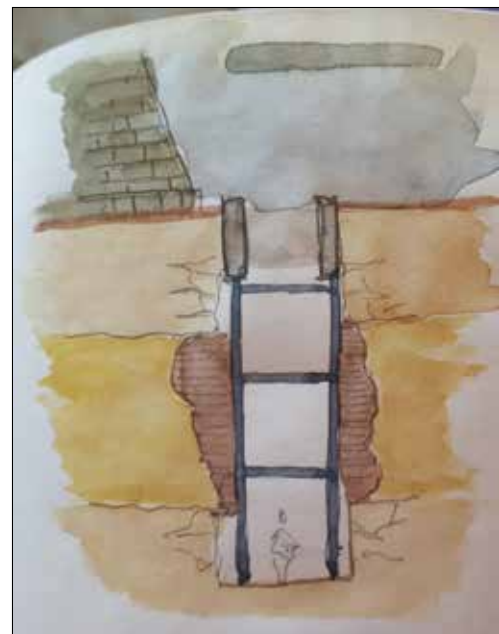
It was requested that Ignacio Forcadell devise a plan to secure the descandary in order that work could continue towards the burial chamber, the main aim being to look inside the chamber and to see if its condition justified the measures necessary to allow safe access. Therefore, to secure the descandary he suggested putting 80 agroprops under the concrete wall starting 300mm from the western side and concentrated in the middle of the descandary. However, to reach the burial chamber's entrance the solution employed was to dig a vertical shaft at the western end of the descandary with wooden shoring to hold back the earth (Plate 3).

Plate 3. Drawing of the proposed shaft by Ignacio Forcadell.

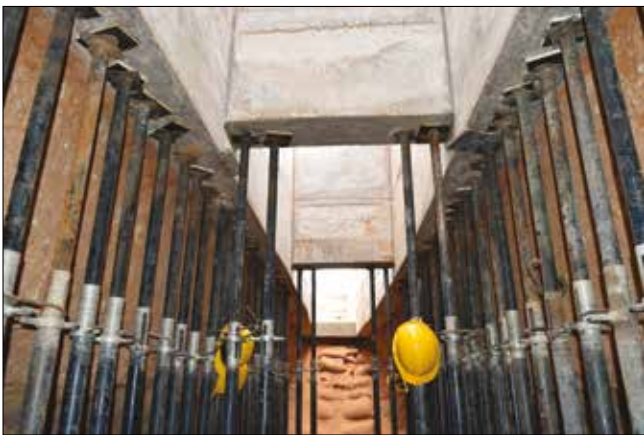
The descendary was cleaned for a length of 8.4m from its eastern end. At a depth of 5.6m is the area of the missing steps in the kaolin layer. The fill in this part consisted of rubble and small sandstone blocks within a matrix of mud. The steps are again preserved below the kaolin layer in the ferricrete and yellow sandstone. In order to secure the descendary work was concentrated only in the western part of the descendary. The agroprops were installed after levelling the descendary fill at a depth of 5.6m (Plate 4).

Plate 4. Installation of agroprops for security in the descendary.

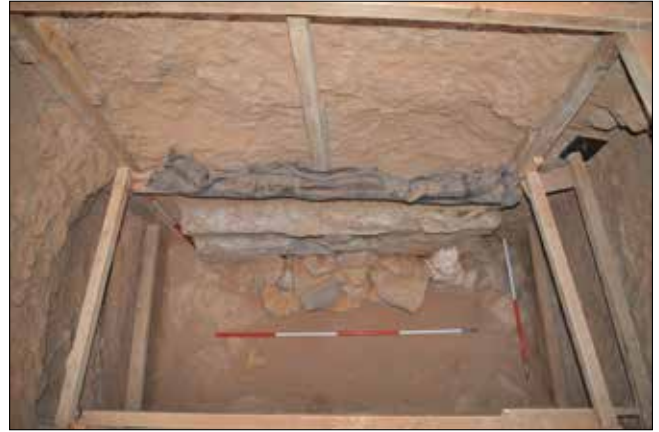
The upper part of the entrance of the burial chambers was revealed at a depth of 9.35m. At a depth of 7.65m the carved door frame appeared (Dunham's type III; 1957, 66). It is a moulded entrance with a cornice and panel in the middle (Plate 5); the lintel with panel measured 2.2 x 0.8m and the northern of the two jambs 1.35 x 0.4m; its lower part was

Plate 5. The vertical shaft and part of the entrance to the burial chambers.

eroded by water penetration. The doorway was sealed by three rows of sandstone blocks between the jambs. Only the upper part was removed to give access to the first chamber.

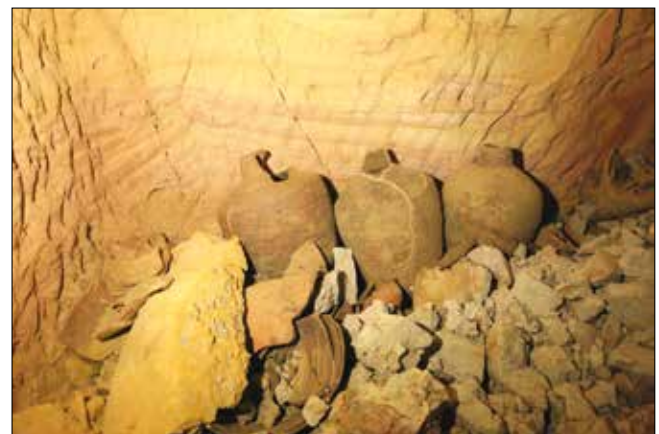
Looking inside the first room after removing part of the blocking wall, we found that the roof, which is cut in the kaolin layer, had partially collapsed, forming a pile in the middle of the room. Pottery objects were visible in the room beside the walls (Plate 6), as was the entrance to the second burial chamber which was sealed by sandstone blocks. The presence of these pottery objects confirmed the entry in Reisner's memoir concerning the storing of archeological objects in the burial chambers beneath this pyramid. This discovery will hopefully reveal enormous archaeological information and knowledge.

Plate 6. Collapsed roof and pottery jars inside the first burial chamber.

and a flattened roof according to Dunham. Unfortunately the pillars and the roof had collapsed most probably because of water penetration. Most of the archaeological objects left by Reisner were buried under the collapsed kaolin from the roof. Only a few complete objects were collected among them small pottery bowls found in small niches in the northern wall, and jars from the north-west corner and by the north wall. Fragmentary and broken jars came from the south-west corner along with a grinding stone and organic material. In front of the entrance leading to the second chamber was a whisky bottle left by Reisner with a paper inside but unfortunately it was not sealed when found and the paper was much decayed. The work was carried out in a hurry as we had been advised to collect as much as we could. This was done by dividing the chamber into grid squares, and removing the material for subsequent analysis. There was no trace of decoration in this chamber; it had not even been plastered.

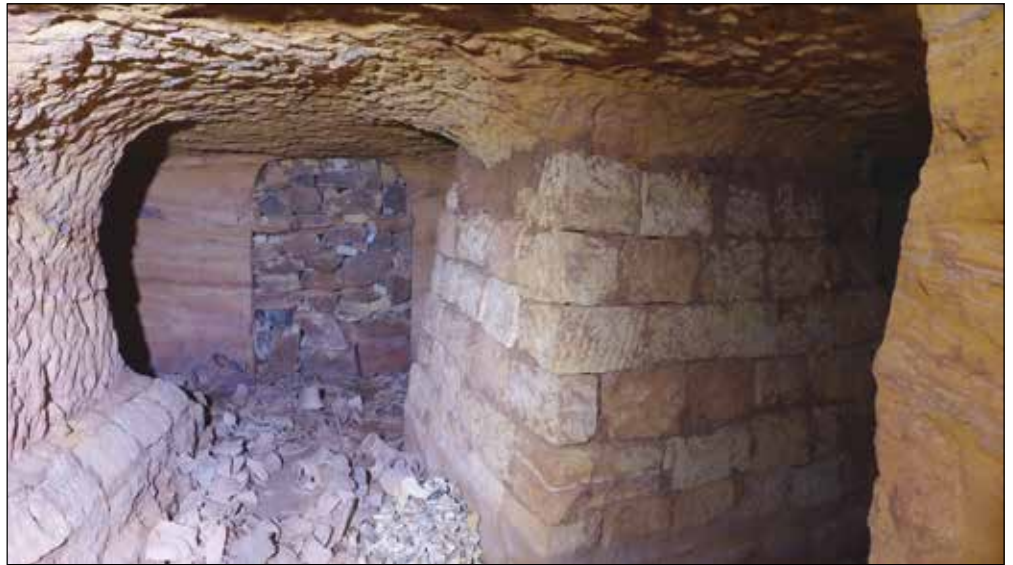
On the chamber's floor were numerous complete and fragmentary ceramic vessels as well as human bone (Plate 7). At the far end an entrance, well sealed with stone, gave access into the third burial chamber.

Chamber B is smaller than A, measuring 4.25 x 7.55m. The northern rock-cut pillar was located 900mm to the west of the east wall. This pillar is encased by seven courses of

Plate 7. View inside the second burial chamber showing the archaeological material and the pillars.

sandstone blocks of different sizes, while the pillar to the south was encased only at the base by three courses. The stones were bonded with a clay mortar. The presence of these pillars only in the second chamber raises the question as to whether it was built at the same time as the first chamber and descendent. Why was only the north pillar revetted to its full height and why were there only pillars in this second room? Had cracks appeared during the tomb's construction or before the burial took place? The pillars are rounded into the roof which is lower than that in the first chamber. There are some cracks in the pillars and in the entrance between chambers A and B, and part of the entrance has collapsed.

The objects, placed in piles, cover the entire floor of this chamber. It is clear that water had entered the chamber and silt covered most of the objects. The bulk of the archaeological objects were removed from this chamber for study.

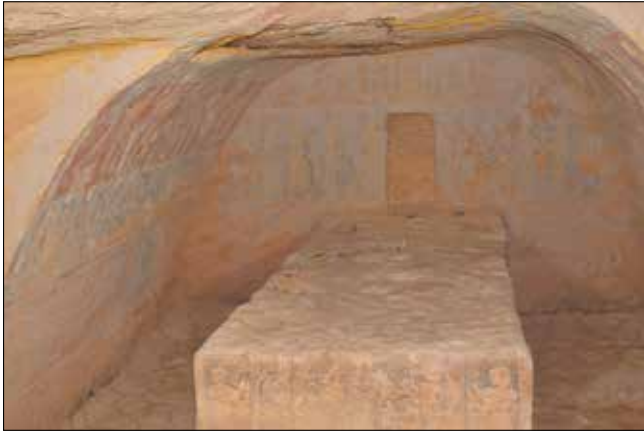
Chamber C is the smallest at 3 x 3.1m with a vault-shaped roof only in the western side of the chamber, mainly in the area over the coffin bench. The north, west and south walls were plastered and painted (Plate 8). The coffin bench, attached to the west wall, was cut from the bedrock and measured 1.77 x 1.12-1.77m and was 660mm high above the debris sealing the floor; at its west end on the top there is a nail probably used by Reisner for drawing. The east face of the coffin bench bore inscriptions in high relief while the north and south sides were decorated with paintings of the king and deities (Plate 9).

Plate 8. View inside the third chamber shows painted walls and coffin bench.

In addition to the coffin bench and small niche cut in the western wall above the coffin, most of the lower part of the painting had been destroyed due to water penetration which reached at least 300mm above the floor of the chamber.

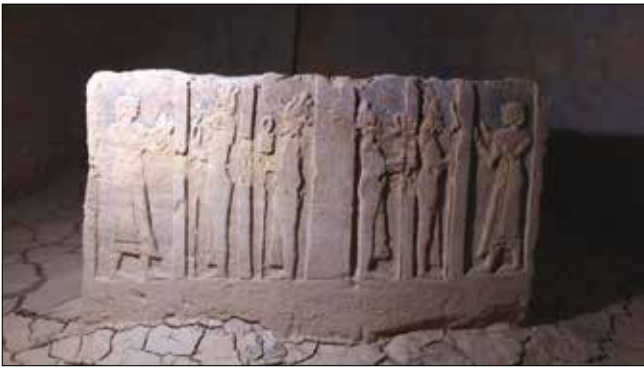
Plate 9. The relief on the eastern face of the coffin bench.
