8. Excavations of Building Z1

Mahmoud Suliman Bashir and Derek A. Welsby

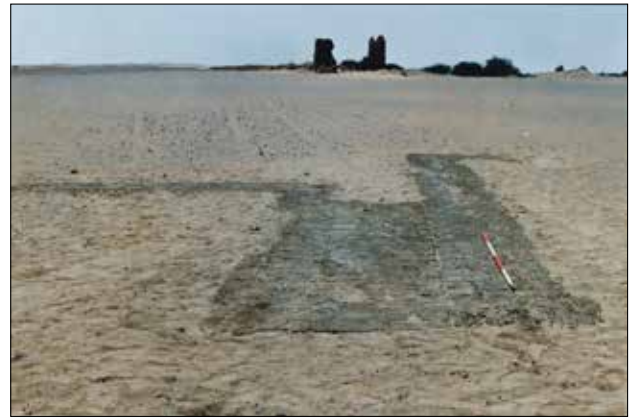
Plate 8.1. The building's walls visible immediately below the surface before excavation began. The ruins in the background are of the dig house constructed by Griffith – scale bar 2m.

Building Z1 is situated towards the northern edge of the site at Kawa. Sections of the building's walls were visible on the ground surface and a plan of these was made in 2000 after brushing of the surface (Plate 8.1). The remains were fully excavated in the winter of 2001-2, the work supervised by Pip Stevenson.

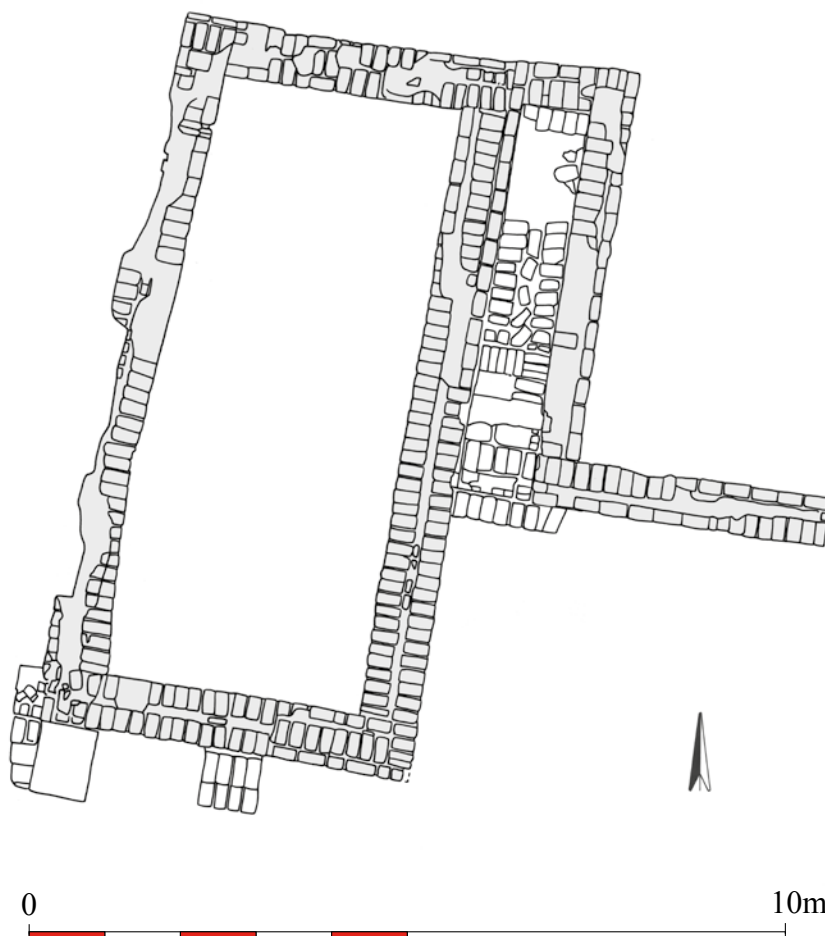
Figure 8.1. Plan of Building Z1 (scale 1:100).

8.05 x 3.18-3.36m internally with a long narrow room containing a stairway (width 1m) against the exterior of its east wall. Extending 3.5m beyond this to the east is a single wall (Figures 8.1 and 8.2). Preservation varies dramatically.

The nature of the original building on this site is uncertain. As it survives the plan of the building appears to be complete but if so its form is very unusual (Figure 8.1). Whether the building was ever more extensive is unclear. The depth of excavation on the west side of room Z1-I within the very

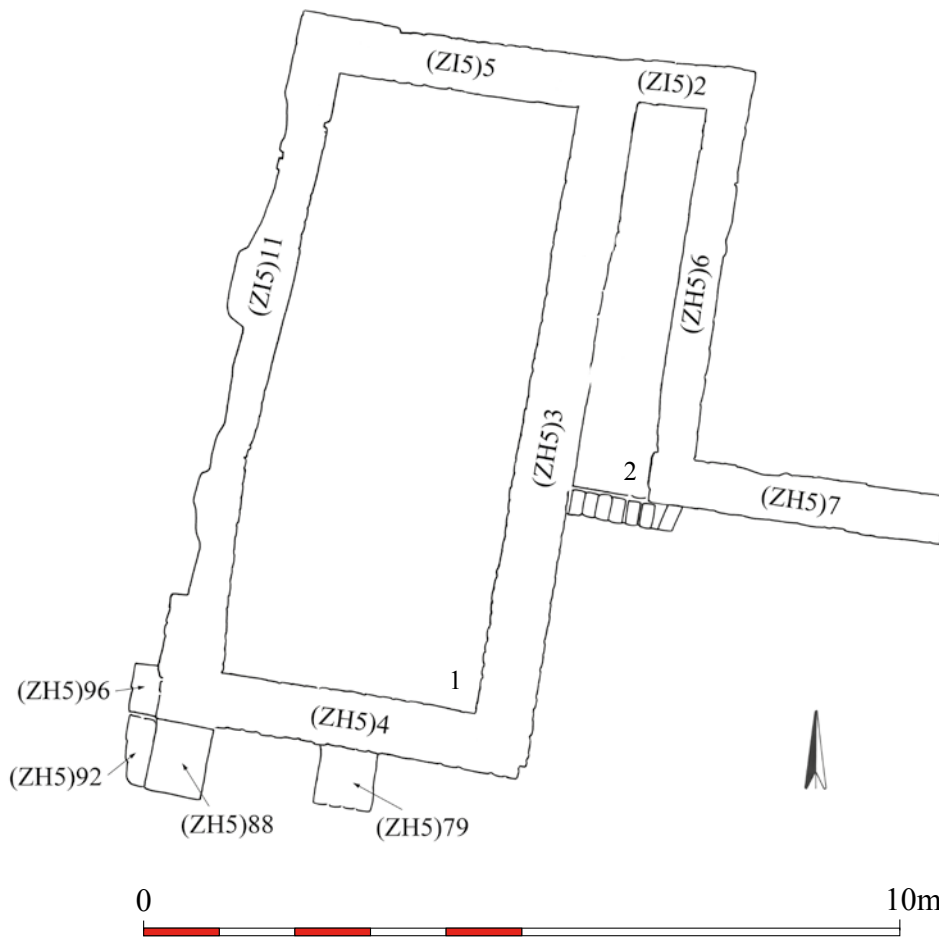
Figure 8.2. Building Z1, context numbers of major structural elements (scale 1:100).

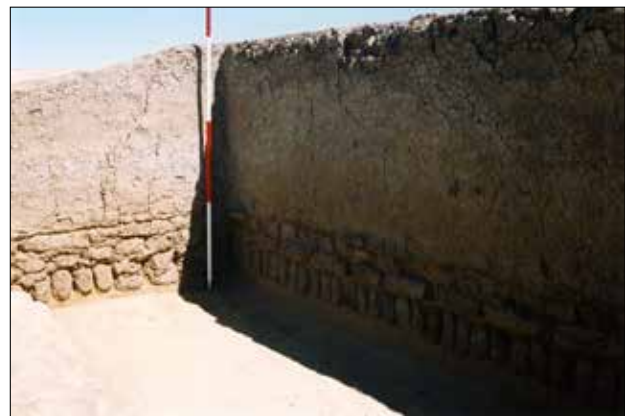
Plate 8.2. The north and east walls of Room I showing foundations and mud mortar render above the primary floor level looking north east – scale bar 2m.

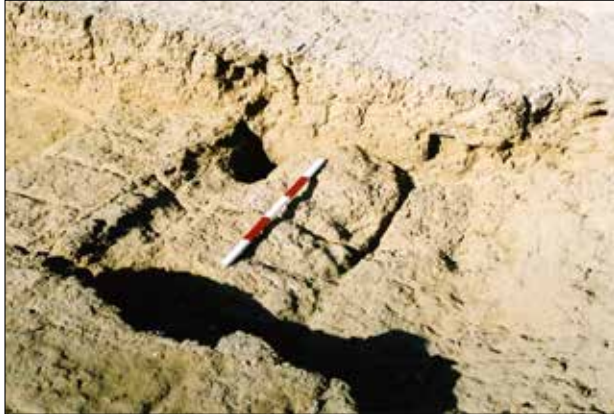
Plate 8.3. Room Z1-II. The threshold, 'pivot' and sockets for the wooden elements of the steps looking south west – scale bar 500mm.

and west and was associated with a shallow post-hole either for a jamb or door pivot at its west end. The function of the shallow depression 380mm in diameter towards the east end of the threshold is unclear. Additional sockets, with thin stone slabs forming their tops, are presumably for the timber front edge of the first step, the core of which is of mud brick (Plate 8.3). The lower part of the socket for

Extending across the doorway into room Z1-II was a single line of up to two ‘courses’ of mud-brick rubble. To the south fine rubble layers on the primary surface are overlain by a row of four mud-brick stretchers over a distance of 1.5m with another set off line to the west (Plate 8.3). The gap between the last brick and wall (ZH5)7 was filled with rubble.

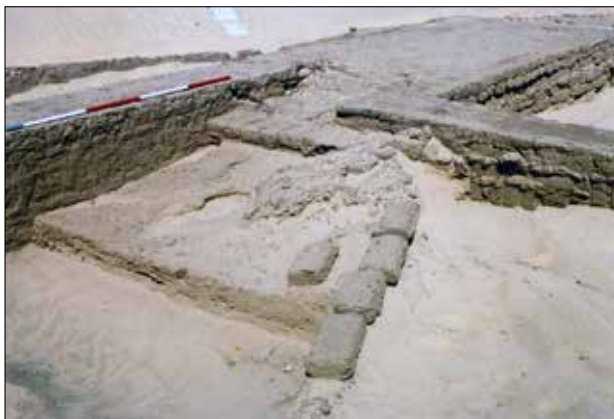
Plate 8.4. Rubble Surface (ZH5)54, wall 19 on deposit 43 and rubble 18 looking north west – scale bar 2m.

In front of the doorway, abutting the north-south wall to the west and the south face of wall (ZH5)7 to the east is a step measuring 1.48m in length constructed of a single course of bricks laid as headers leading up from the sandy surface to the south. To the south the natural sand was overlain by a 200mm thick deposit (ZH5)54 of small fragments of mud-brick rubble upon which the step is laid. The surface of the rubble was then used as a surface contemporary with the use of the staircase in room Z1-II (Plate 8.4).

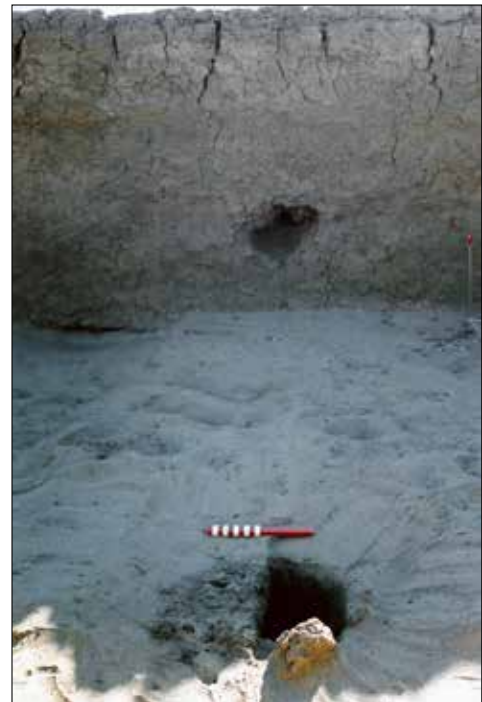
Plate 8.5. Post-hole in the centre of Room 1 and associated beam socket in the west wall – scale bar 500mm.

210mm deep roughly cut into the east wall of the room and only about 220mm above the surface of (ZH5)49 (Plate 8.5). At a comparable level at the north end of the room was an organic deposit [(ZH5)56] containing fibrous material.

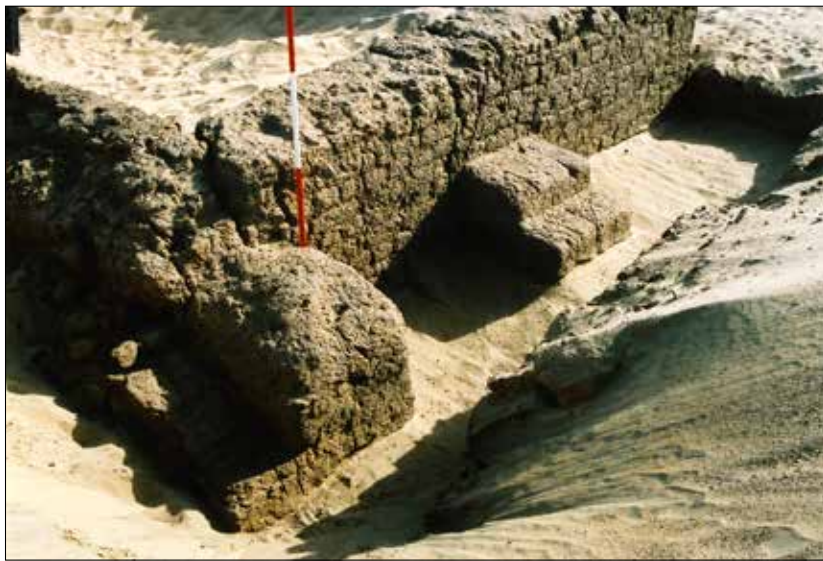
Plate 8.6. The south wall of room Z1-I with buttresses (ZH5)96, 92 and 88 at the angle and (ZH5)79 midway along the wall, looking north east – scale bar 1.5m.

extending 980mm to the south, over 380mm wide and up to 200mm high, the top is stepped. After a build-up of sand against (ZH5)92 another mud-brick buttress (ZH5)88 was constructed partly overlying (ZH5)92 extending 960mm south of the building, 670mm thick and surviving to a height of 700mm (Plate 8.6). The buttress was covered in a mud-mortar render 20-30mm thick. To the east of this buttress 100mm of sand was deposited sealed by a thin layer of ash. On this surface mid-way along the south wall buttress (ZH5)79 was constructed of mud brick and covered in a mud-mortar render. It is 770mm wide, projects from the wall 770mm and is 450mm high and consists of two steps, the lower with a riser of 230mm. Abutting buttresses (ZH5)88 and 79 was a deposit 200mm thick of sand (ZH5)85 containing considerable quantities of lumps

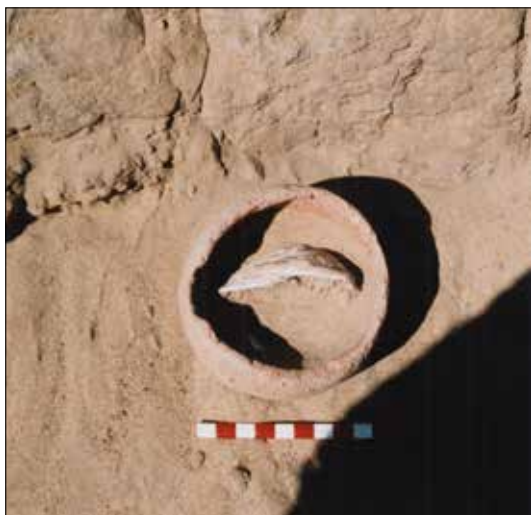
Plate 8.7. Pottery vessel containing an oyster shell – scale bar 100mm.

marked by a thin layer of ash, another had a complete pot (Type 000.00), containing an oyster shell, (Plate 8.7) and rubble on its surface up against the wall. In addition, the excavations in this area revealed a single upright stone and a reused grinder, set at the external angle of walls (ZH5)3 and (ZH5)4.

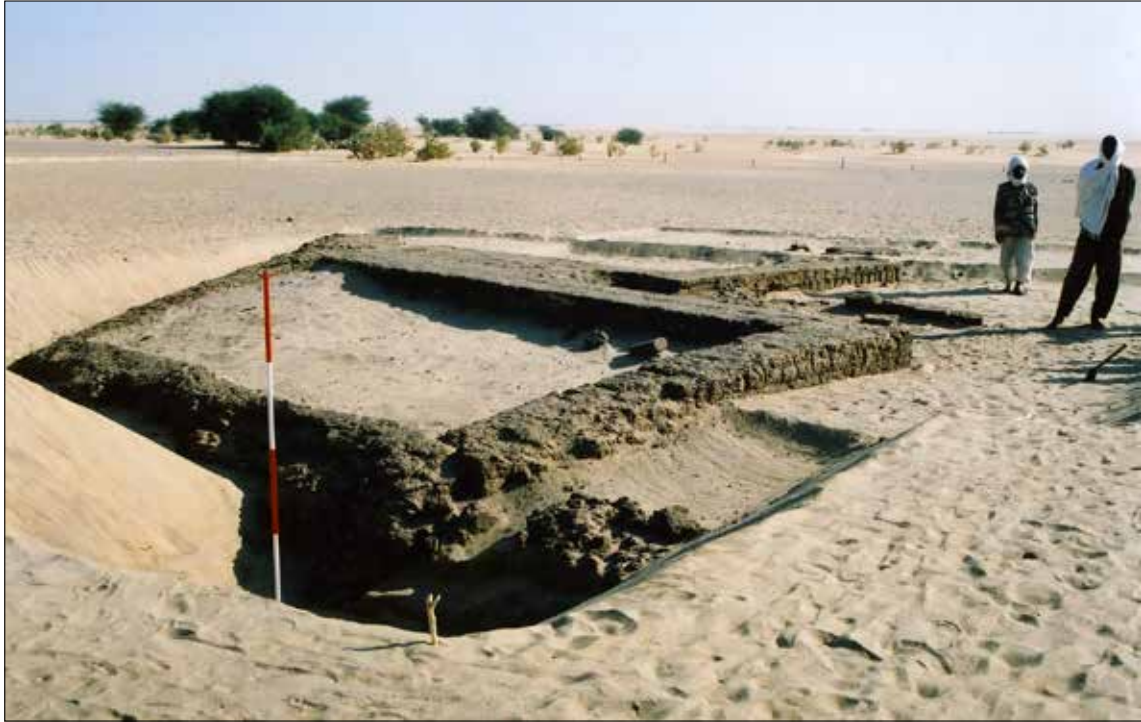
*Plate 8.8. General view over Building Z1 during excavation looking north east.
The relationship of the denuded walls of room Z1-I to the present ground level can be clearly seen – scale bar 2m.*
