### 3. Excavations of the painted shrine and other buildings in Area A

*Derek A. Welsby*

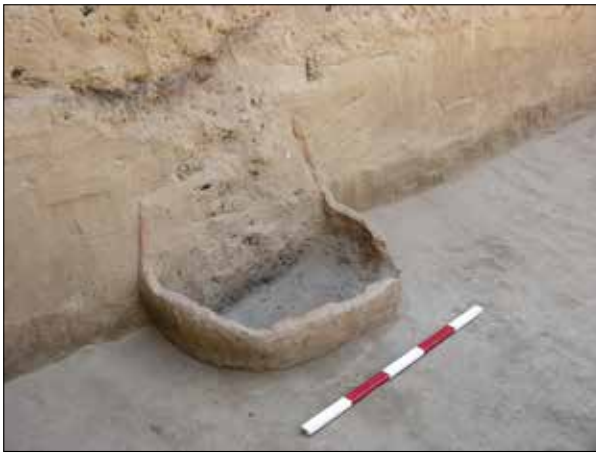
Plate 3.1. The earliest feature excavated in Area A, the ceramic oven (AC5)180 – scale bar 500mm.

to a depth of between 40.46m and 40.49m OSD, that is about 1.7m below the lowest course of the south wall of Building A2. Set 40mm into this deposit was a circular, frustum-shaped, ceramic oven, (AC5)180, 510mm in diameter (Figure 3.2, Plates 3.1 and 3.2). It survived to a height of 370mm and was filled with 30mm of ash and sand and then 150mm of loose sand with pot and ash before going out of use.

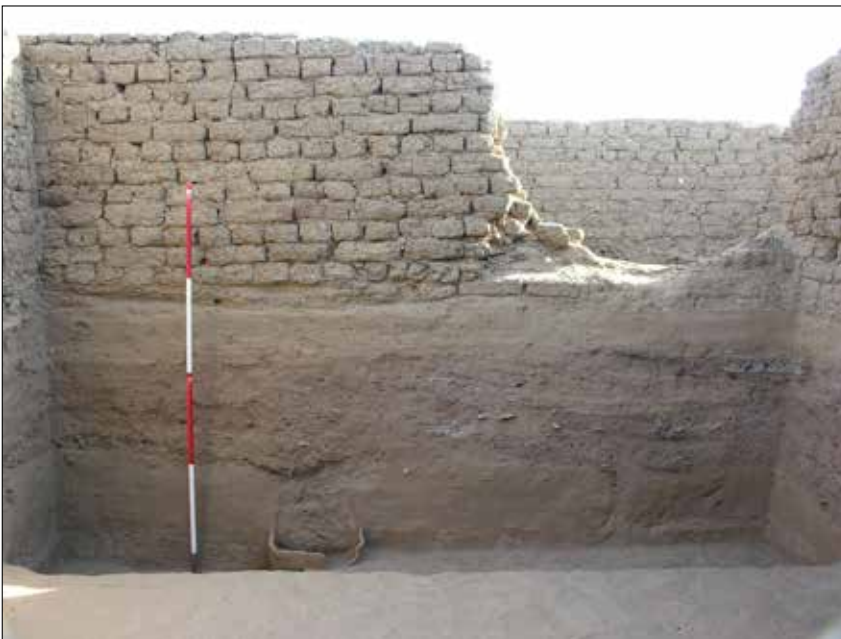
Plate 3.2. The ceramic oven (AC5)180 and occupation deposits below the level of Building A2's walls – scale bar 2m.

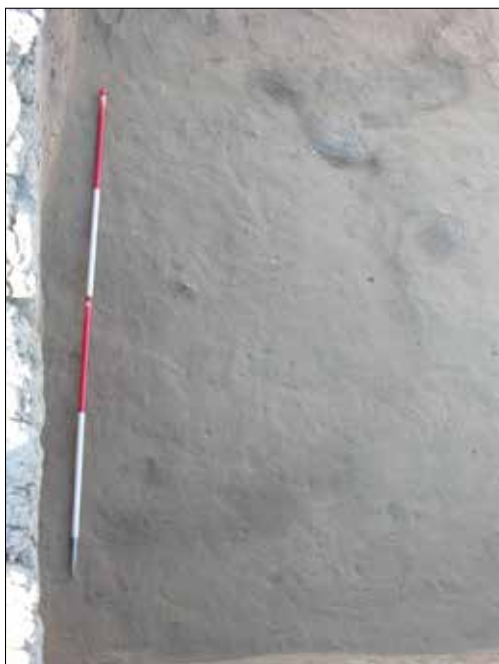
Plate 3.3. The shallow gulley (AC5)150 in surface (AC5)116 looking west – scale bar 2m.

other features at this level (Figure 3.4) are considered as pre-Building A3 they could relate to its primary phases. The eastern was 2.3m in length, a maximum of 250mm wide and 30mm deep. In the bottom was a row of what might be very small stake-holes each about 25mm in diameter and up to 35mm deep. The other feature was more irregular and extended out of the excavation area. To the south was a pit [(AC5)156] 450mm wide directly over the site of the much earlier oven and filled with ashy material. As with the oven in the ‘street’ this suggests that the oven remained in use for a long period as deposits built up around it. This pit may have been the result of removing the upper part of the oven. There were also two small hearths in this area [(AC5)152,160] the former

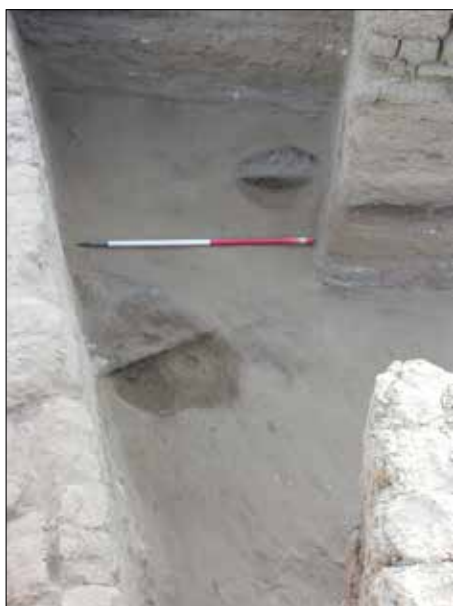
Plate 3.4. Period 1.2. Pits (AD5)305 and 307 cutting surface 308 – scale bar 1m.

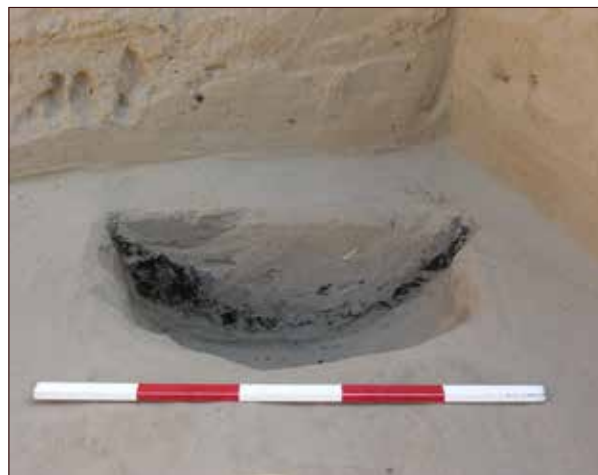
Plate 3.5. Period 1.2. Pit (AC5)142 with fills 141 and 140 cutting surface 144 – scale bar 500mm.

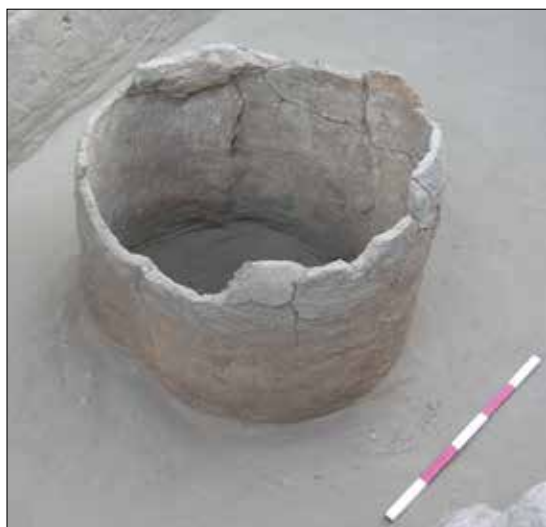
Plate 3.6. The ceramic oven (AC5)130 – scale bar 500mm.

Oven (AC5)130 (Plate 3.6) must have remained a prominent feature in this area over a long time as the sand

gradually built up against its exterior. As in its primary phase there was no evidence for the burning within it discolouring the surrounding sand deposits. It was filled with ashy sandy silt with bone, lots of pottery and four mud bungs. The deposits against it [(AC5)170,163] were of sand with some charcoal flecks. Sat on the surface of (AC5)163 was a complete pottery vessel filled with fine sand and a few substantial pieces of bone, against which was deposited (AC5)162 on the surface of which at the west end of the ‘Street’ was a substantial deposit of mud-brick rubble up to 220mm thick. Both were sealed by another sand deposit with a firm surface [(AC5)158]. In turn this was sealed by (AC5)145 a similar surface but with occasional pieces of mud-brick rubble within it and flecks of charcoal. All these sandy deposits are probably multiple very thin surface however, whether each was laid by the occupants of the area or they were naturally forming deposits is impossible to tell – they were probably a combination of both. The primary walls of Building A3 were constructed on this surface.

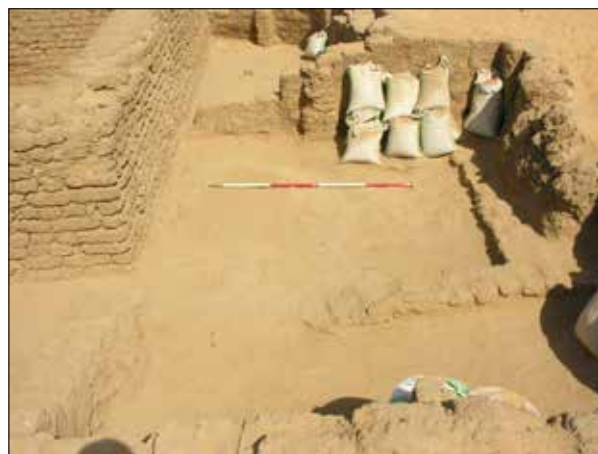
Plate 3.7. Building A5. The east and south walls (AC5)68 are clearly visible while wall (AC6)74 to the west is much less so – scale bar 2m.

Two new walls were constructed one of which appears to abut wall (AC6)74 delimiting a probably rectilinear space 2.93m wide by at least 3.44m, designated Building A5 (Figure 3.5, Plate 3.7). The walls were built from bricks 340 x 170mm in size and were one header thick. There may have been a doorway in the south wall 1.1m wide. After a build-up of 200mm of sandy silt with mud-brick fragments within it a stone pivot slab (Plate 3.8) was placed at the north end of the Period 2 wall, a

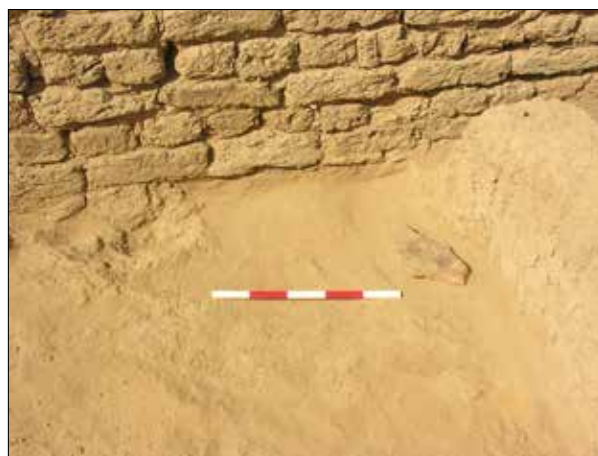
Plate 3.8. Building A5. The pivot stone and mud-brick fragments in the doorway – scale bar 500mm.

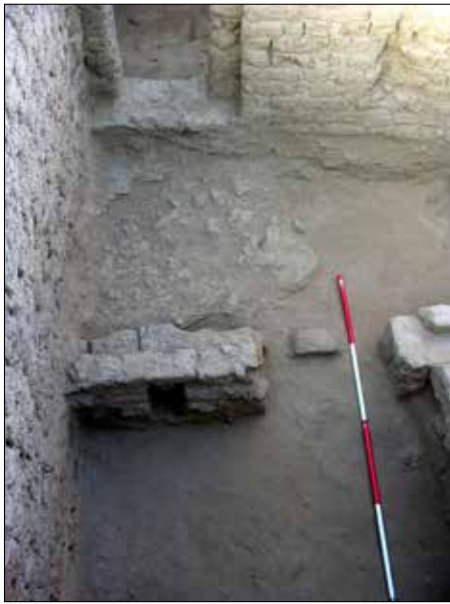
*Plate 3.9. Mud-brick rubble predating the construction of Building A3 – scale bar 2m.*

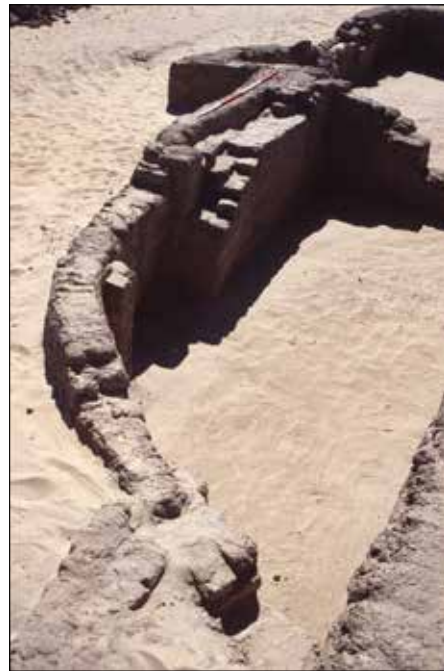
*Plate 3.11. Building A3. The highest surviving section of wall with the Phase II buttress inserted against the inner face of the east wall – scale bar 2m.*

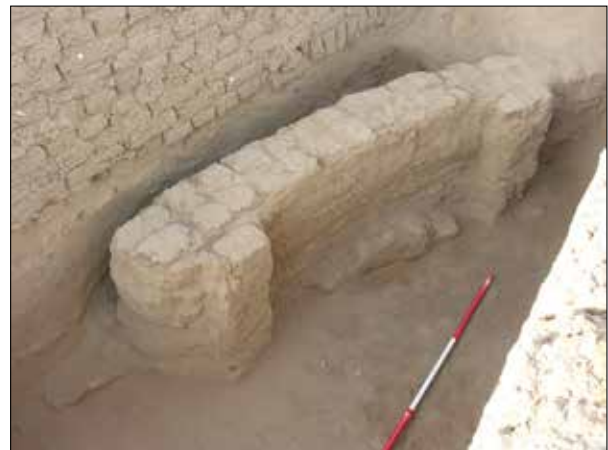
*Plate 3.12. Building A3. Section of wall with internal buttresses. Note remnants of what may be a fragment of walling [(AC5)164] contemporary with Buildings A5 or A6 – scale bar 1.5m.*

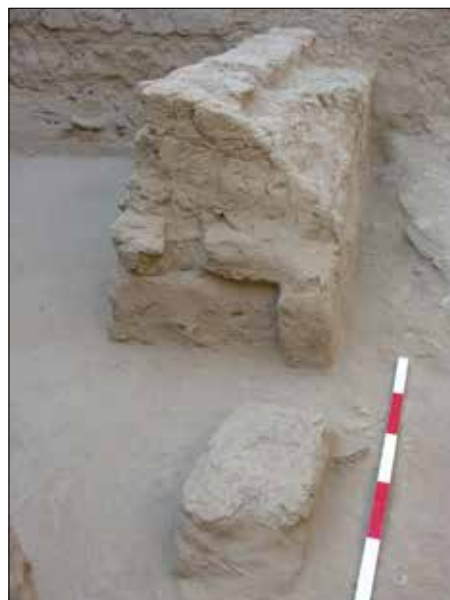
Plate 3.13 Building A3, wall (AD5)228 and its construction trench overlain by a later wall — scale bar 500mm.

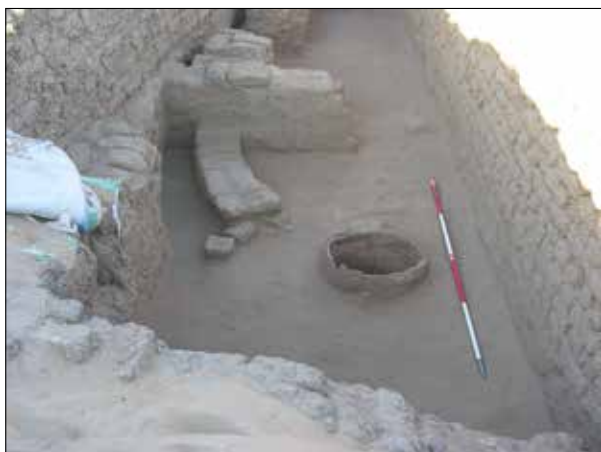
*Plate 3.15. Building A3. Ceramic oven (AC5)130 in the floor level contemporary with the building – scale bar 2m.*

Few internal features were noted relating to this building. In Room A3-1 the oven (AC5)130 noted above which, when Building A3 was constructed protruded through its floor to a height of 260mm, presumably remained in use

(Plate 3.15). Again, however, no burning associated with this use was noted within it nor any heat discolouration of the sand against its exterior.

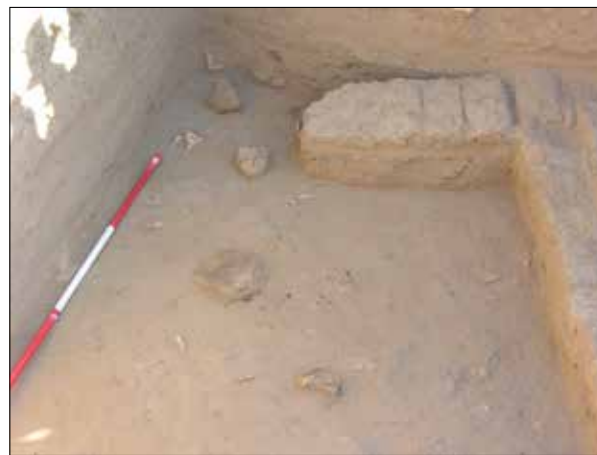
*Plate 3.16. Building A3. The primary floor surface in room A3-3/4 with post-pad and pottery – scale bar 1.5m.*

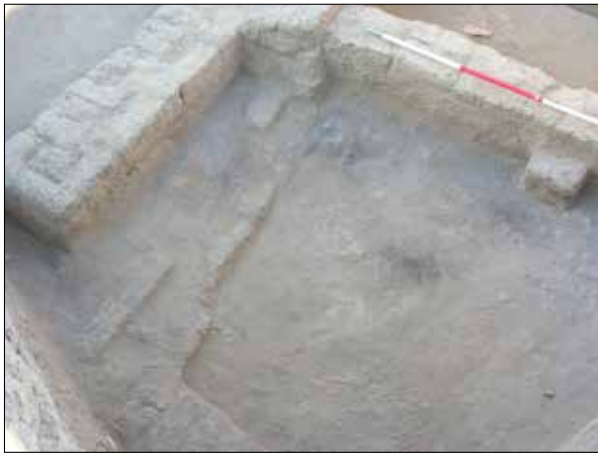
Plate 3.17. Building A3. The latest floor surface in room A3-3  
— scale bar 1.5m.

In room A3-3 and extending to the south on the other side of the wall into room A3-1 the latest surface was a large ashy deposit which includes some burnt mud bricks (Plate 3.17). This is thickest against the walls and fades out rapidly away from them. It formed the surface during the construction phase of Building A4.

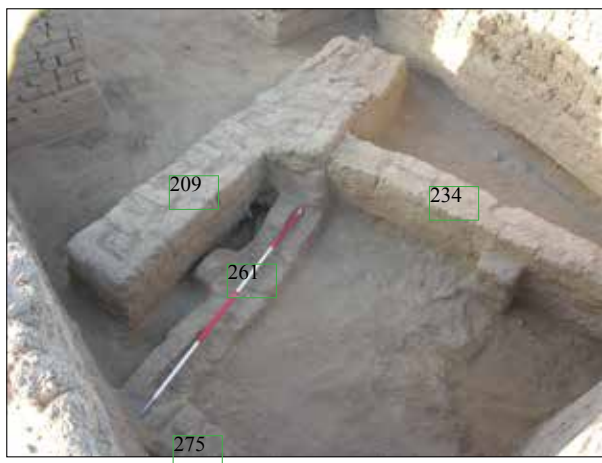
Plate 3.18. Building A4. Wall 209 is a new build while wall 234 is retained from Building A3. The earlier building's wall 275 has been demolished to floor level, wall 261 has been partly demolished and partly incorporated into the new structure (all numbers in area (AD5)) – scale bar 2m.

new floor levels (Plate 3.18). The building may have extended much further to the north than its predecessor, its walls extending beyond the excavation area (Figure 3.7). The walls of Building A4, constructed of mud bricks of a range of sizes ((AD5)172 and 173 320 x 160-150 x 90mm; (AD5)209 360 x 160 x 100mm; (AC5)69 300 x 170 x ?mm), varied in build and thickness. The thinner walls had alternating courses generally one header or two rows of stretchers and attained a thickness of 340mm. The

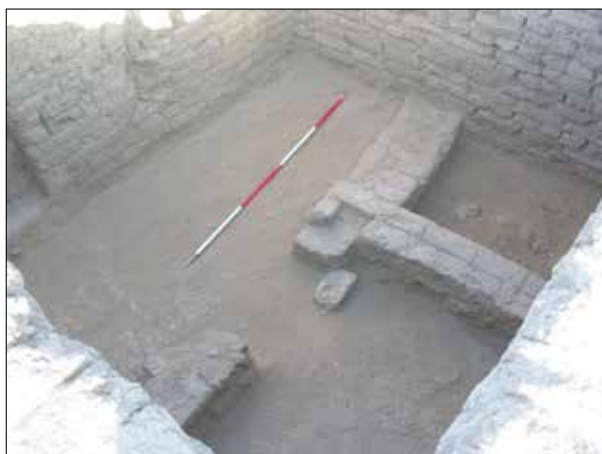
Plate 3.19. Building A4. Doorway between rooms A4-F and A4-G – scale bar 2m.

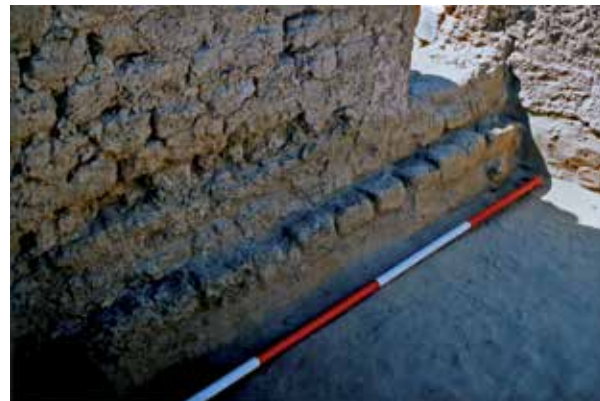
*Plate 3.20. The foundation courses of the south wall in room A1-II – scale bar 2m.*

the lowest course of headers extended 100mm beyond the wall face and this was surmounted by another foundation course of headers extending less from the wall face (Plate 3.20). The lower course is only to be found in the western two-thirds of the room levelling up the slope down from east to west. After the laying of these two foundation courses a deposit of silty sand and mud [(AB5)355] formed a level surface in the room and then the rest of the south

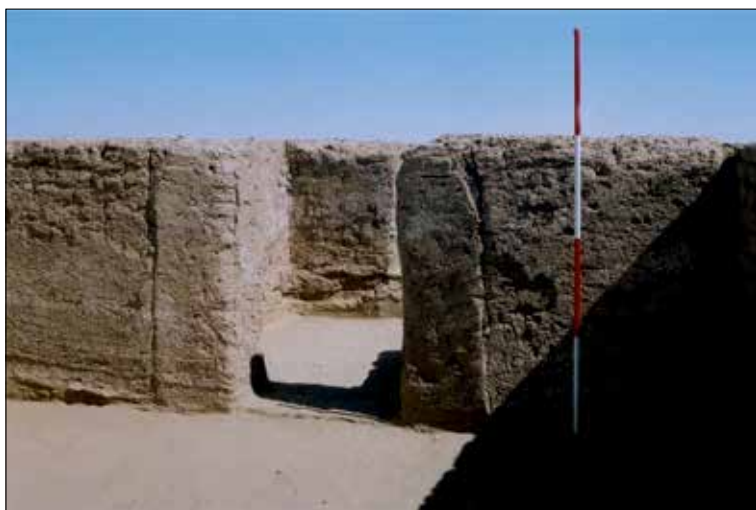
Plate 3.21. The doorway leading into the building from the west looking into room A1-III – scale bar 2m.

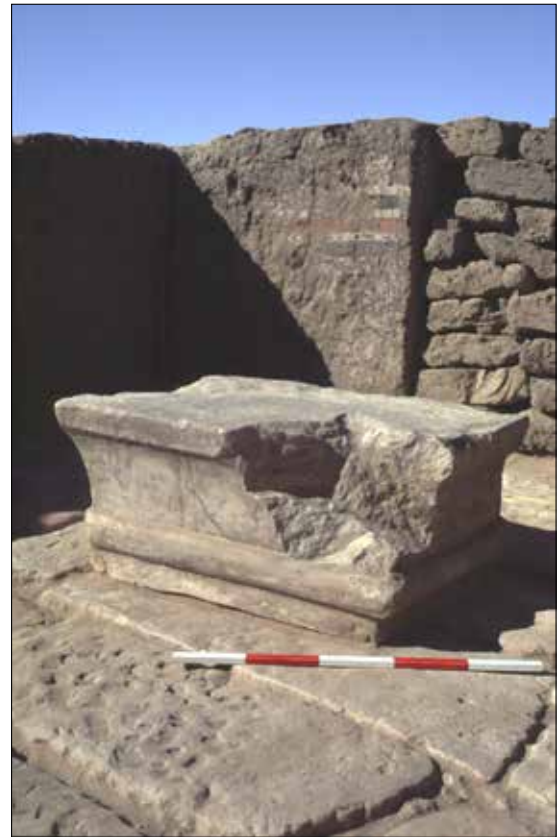
*Plate 3.23. The top of the barque stand (SF:4119) resting on the stone flagged floor in room A1-I – scale bar 500mm.*

When the barque-stand was dismantled the uppermost block and many of the stone blocks removed from the floor in the north-east and south-east corners of the room came to rest directly on the stone floor (Plate 3.23). Other blocks rested on fragments of painted wall plaster. The number of blocks found in the room suggests that, although the floor had been disturbed, no blocks were removed from the building. The blocks were abutted, and the floor was covered by a layer of wind-blown sand [(AC6)16] from 10-150mm thick, at its thickest where it had drifted against the walls and the sandstone blocks. In the south-west corner of the room this wind-blown sand was covered by a thin (10-60mm thick) deposit of mud. Extending into the room through the doorway from room A1-II was a sandy deposit [(AB5)254/(AB6)21] containing a number of small finds. It was 550mm thick in the doorway but rapidly diminishing to the east indicating that room A1-II filled with sand before room A1-I. At least one of the pits dug to remove the floor blocks was sealed by (AB5)59 probably a series of deposits (max. thickness 660mm) formed from the collapse of the south wall of the building, which settled around the large stone blocks but tailed off towards the south. Some sections of mud-brick rubble were articulated. In the lowest layers particularly in the south-west corner of the room was a large amount of painted plaster, with the lowest layer face down. Thereafter the room filled with wind-blown sand (Plate 3.36), interrupted by the digging of a number of robber pits, the largest 1.75 x 1.1m in size and 250mm deep, against the east wall.

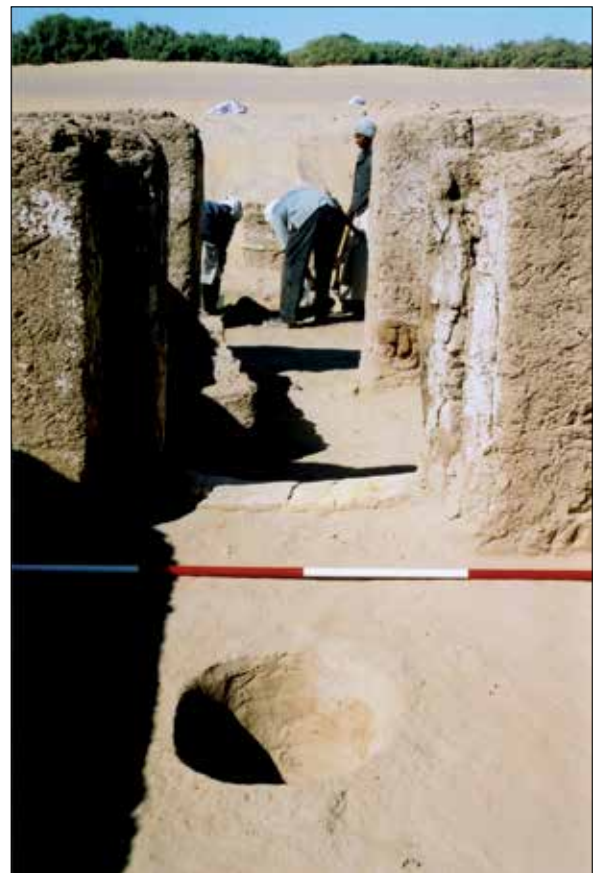
*Plate 3.24. The oval pit [(B5)352] in the centre of room A1-II looking west – scale bar 2m.*

The primary floor in room A1-II [(AB5)295] sloped down slightly from east to west. Presumably of sand little of it survived. Cutting through it, on the long axis of the building but towards the western end of the room was a well cut slightly oval pit [(AB5)352] with vertical sides and a rounded bottom ( $\varnothing$  560 x 540mm, depth 350mm) (Plate 3.24). It was filled with silt containing only a few

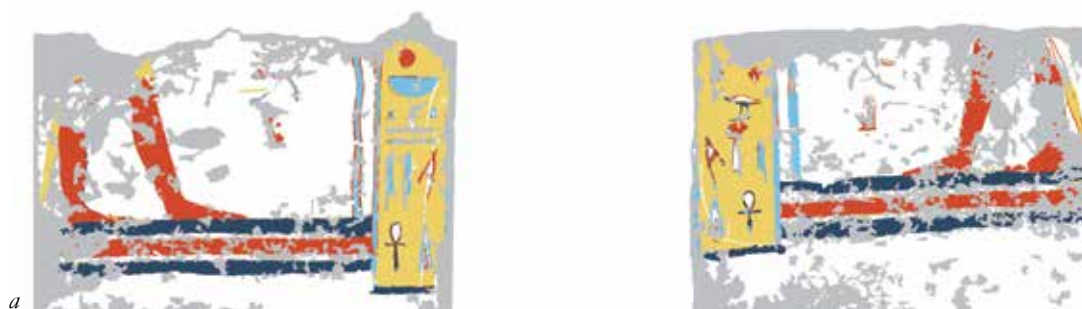
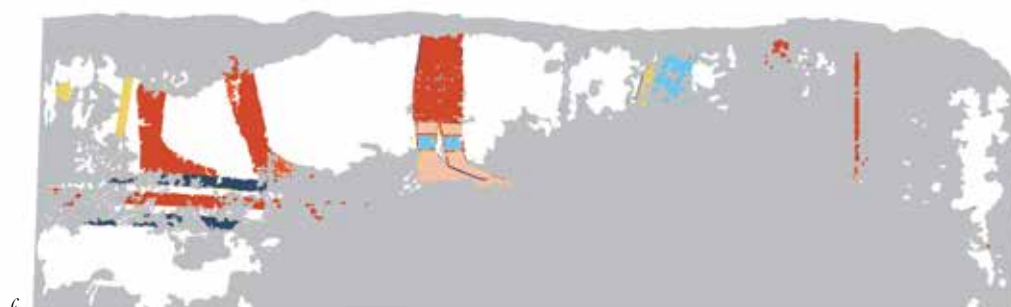
Figure 3.10. Room A1-II, painted wall plaster.  
a - east wall, b - north wall with fragment found  
amongst the rubble, c - south wall, d. plaster  
fallen from the lintel between rooms 1 and 2  
(scale a-c 1:20, d 1:10).

In room A1-II the painting was much better preserved right to the top of the walls, a maximum of about 1.4m above floor level (Figure 3.10). Running around the walls delimiting the top of the white dado was a triple horizontal band consisting of a dark blue stripe, surmounted by one of red and another of dark blue, the blue stripes c. 35mm high, the red c. 40mm high, and separated by the white background. The top of the upper stripe formed the base line for the main decorative panels. Little can be seen of the painted decoration on the west wall. The primary layer of plaster with its painted surface had been covered by a second coat of plaster the painted surface (traces of red and yellow pigments are visible) in its turn covered by another coat of whitewash. On the north wall figures were preserved up to their waist. On the left (west) we have a figure of the king with red skin, a yellow tail outlined in and banded with red lines, wearing fine golden sandals and a yellow kilt processing east towards Amun. Amun is painted blue with a white tail outlined in black and banded in red and dressed in a yellow kilt, holding a blue *was* sceptre. Behind the god are two barefooted goddesses (Plate 3.26) with yellow skin and clothed in a narrow red gown with blue dots. At the ankle are wide bands outlined in red, on the left hand figure they are infilled in blue, on the other in white. They both also hold what is probably a *was* sceptre. At the east end of the scene in the corner of the room is a narrow vertical register perhaps with rectangular blocks of colour, turquoise, yellow, white and red visible between vertical bands of blue outlined in red. Traces of what may be a similar vertical register remain in the western corner. Fallen fragments from the decoration include the hand and forearm of the king who

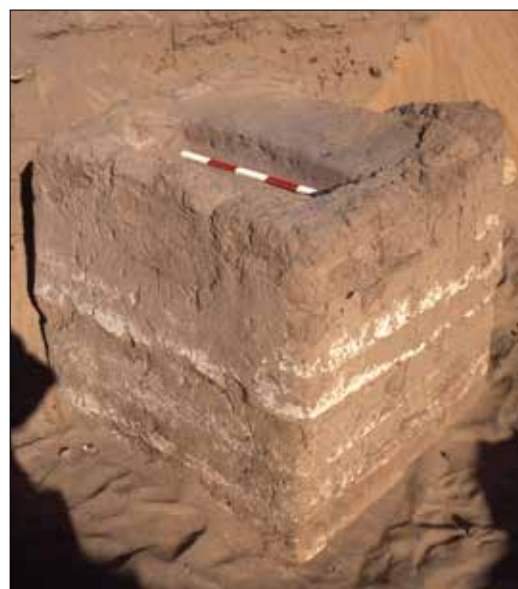
Plate 3.29. The mud-brick altar to the west of Building A1 with the fill in its recessed top half sectioned – scale bar 500mm.

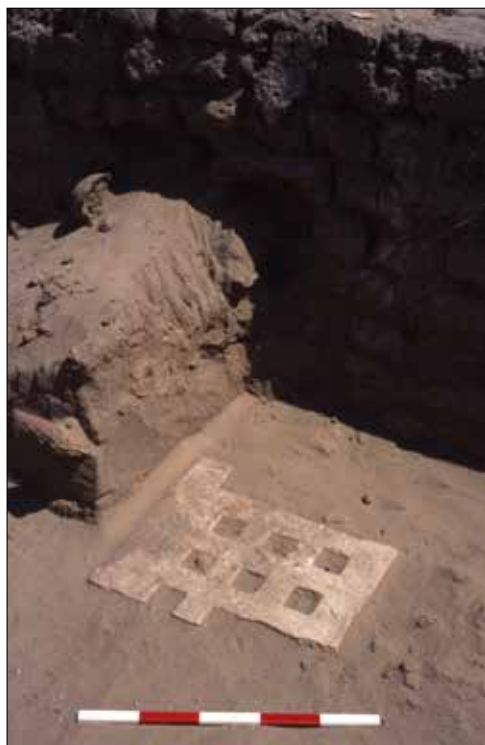
Plate 3.32. Building A1, room IV, surface (AB5)58/245 with a white sandstone window grille set into it – scale bar 500mm.

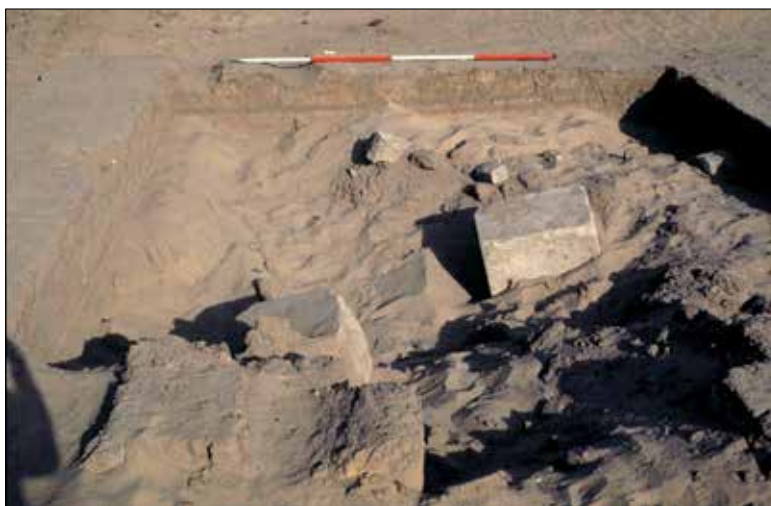
*Plate 3.36. Building A1, room I, blocks from the barque stand lying amongst the robber upcast material and wind-blown sand – scale bar 2m.*

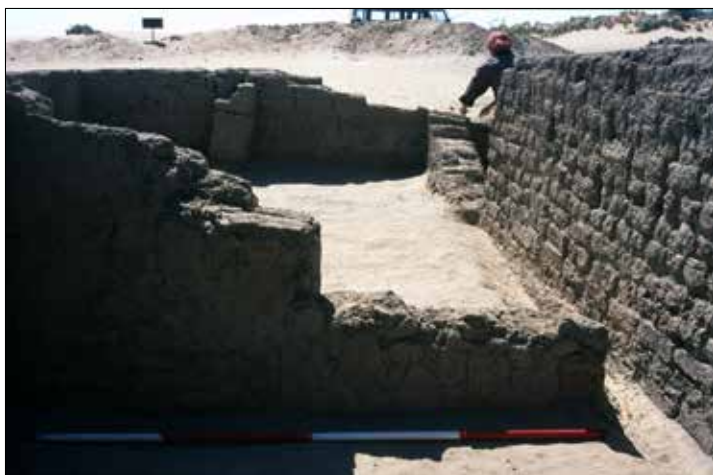
Plate 3.39. The walls of Buildings A3 and A4 demolished to make way for the east wall of Building A2 – scale bar 2m.

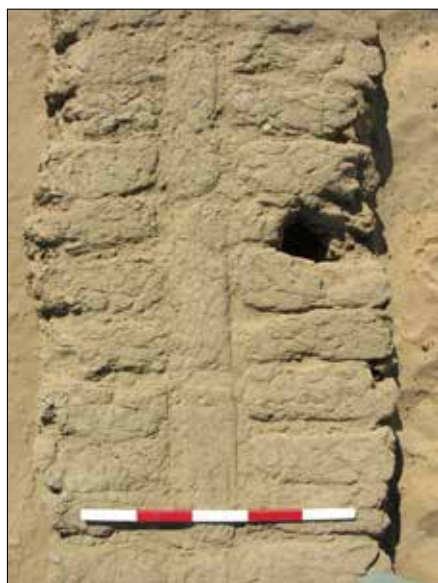
*Plate 3.40. Building A2, two rows of headers with a row of stretchers between in the west wall – scale bar 500mm.*

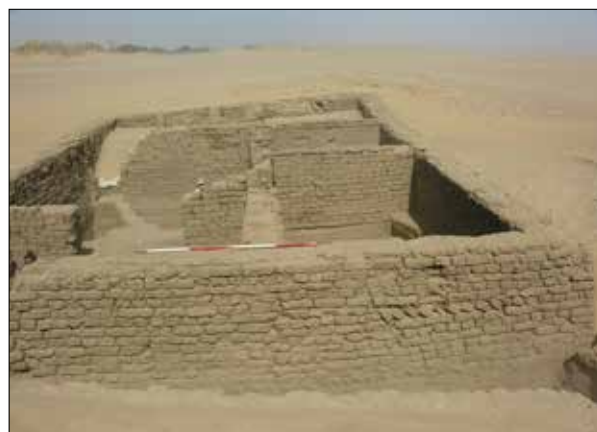
*Plate 3.41. Building A2, the south wall with levelling courses of angled bricks – scale bar 2m.*

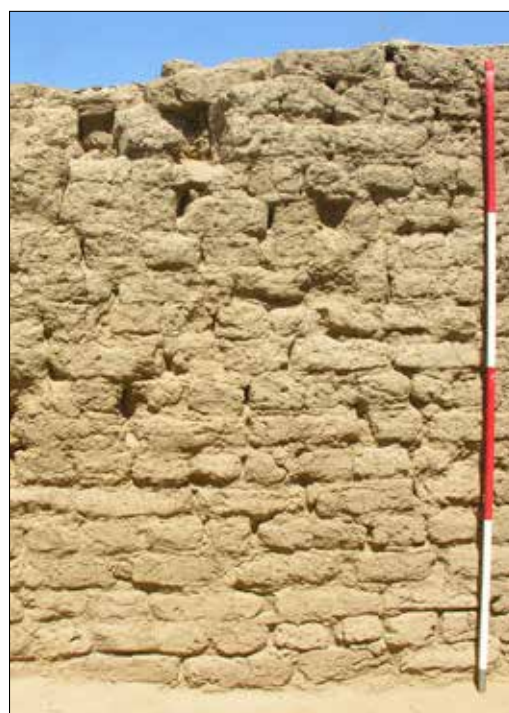
*Plate 3.42. Building A2, the windows in the north wall of room A2-VII – scale bar 2m.*

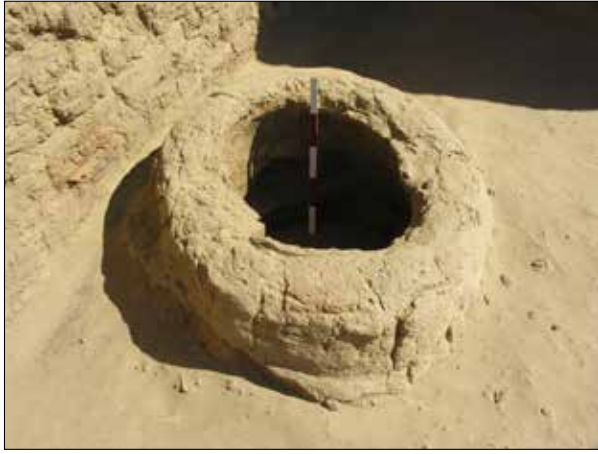
Plate 3.44. Oven (AD5)150 – scale bar 500mm.

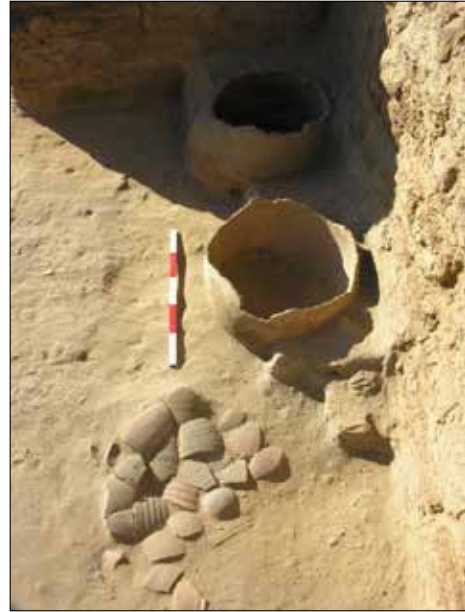
Plate 3.45. Ovens (AD5)197, 194 and 174 – scale bar 500mm.

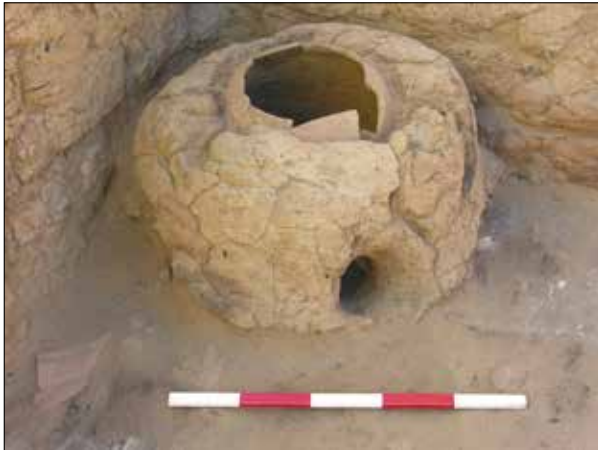
Plate 3.46. Building A2, room III, oven (AD5)90 – scale bar 500mm.

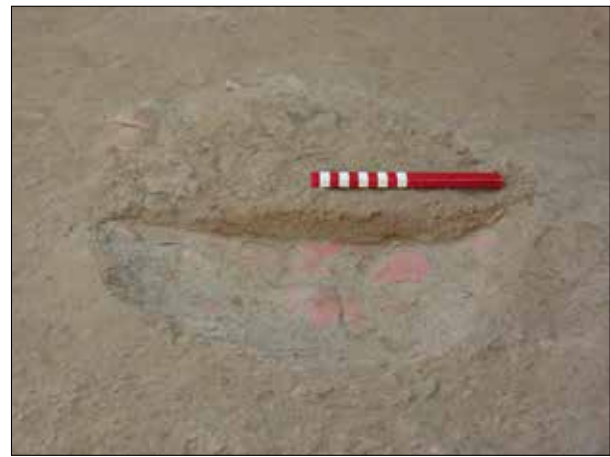
Plate 3.47. Building A2, room IV, bowl-shaped pit [(AD5)147] lined with pottery sherds – scale bar 200mm.

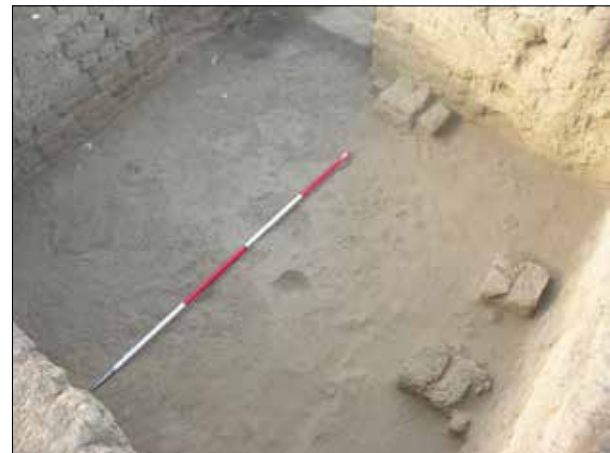
Plate 3.48. Building A2, room IV, surface (AD5)128 with mud-brick features – scale bar 2m.

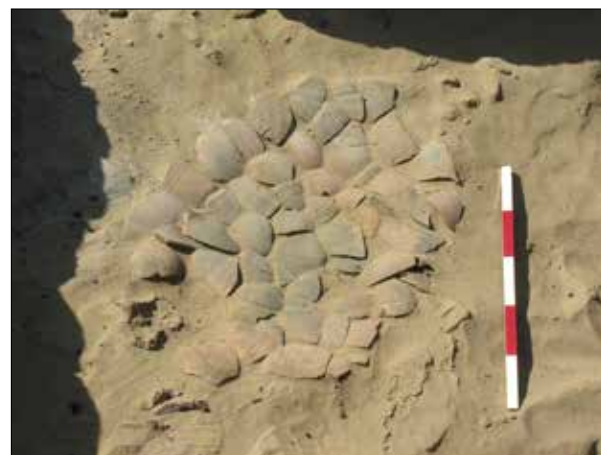
Plate 3.51. Building A2, room VI – the pottery sherd lined hearth (AD5)32 – scale bar 500mm.

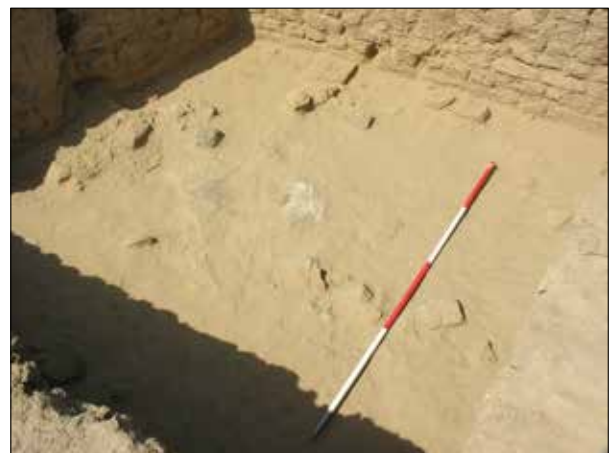
Plate 3.52. Building A2, room VII – surface (AD5)97 with feature 96 and hearth 98 – scale bar 2m.
