Church 3-J-18

Description of the church prior to excavation

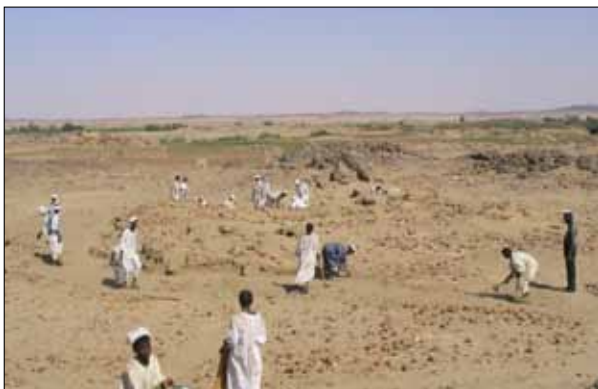
Plate 1. Site 3-J-18 at the start of the archaeological excavation.

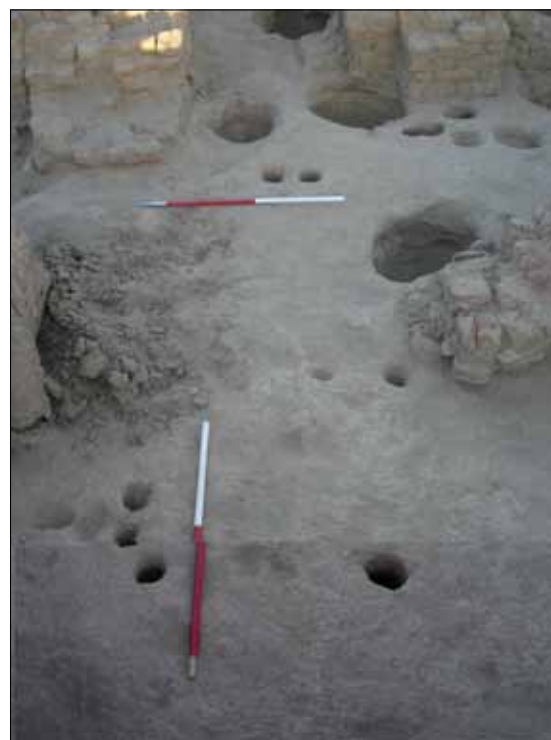
Plate 2. Post-holes and pits within the nave, looking east.

Cut into the silt/sand natural horizon onto which the church was built were a total of 16 post-holes (Figure 2). Excepting two of the post-holes, they were concentrated in the nave of the church (Plate 2). The post-holes in the nave of the church were of two distinct sizes. The larger ones (1117), (1118), (1119) and (1120) averaged 260mm diameter and 160mm deep, they had vertical sides and flat bases. They were positioned closely together next to the south-eastern pier. The smaller post-holes (1123), (1125), (1126), (1127), (1128), (1129), (1130), (1131), (1132) and (1134) averaged 120mm diameter and 140mm deep. The positions of the post-holes relative to each other did not produce any patterns which made sense with them forming structural entities. The post-holes may perhaps have simply held temporary posts in place during the construction of the church. The two post-holes not in the nave were located in the north aisle. (1138) was of the smaller size and was located in the south-western part of the aisle. (1166) was of larger size and was positioned in the north-eastern part of the aisle. Its position was such that it may have had some sort of association with the small partition wall and the vertical wall slot. No finds or wood remains were present in any of the post-holes.

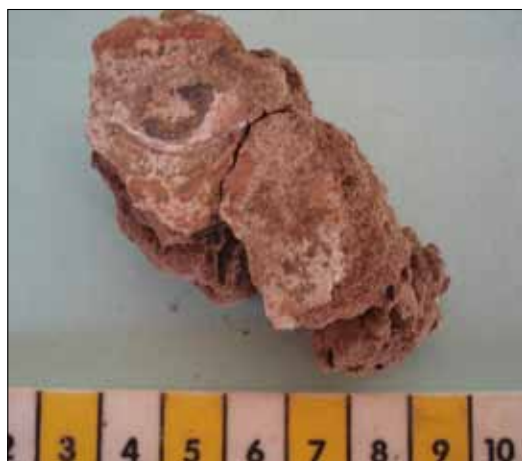
Plate 3. Painted plaster fragment (SF:2457).

The faces of all the internal walls and the internal faces of the outer walls were coated in a thick layer of mud plaster. It is likely that a very thin layer of white lime plaster was applied over the mud plaster throughout the church. Remnants of this white plaster survived in patches in several locations within the building, the larger areas being within the southern room and on the western wall in the vicinity of the stairs. Painted plaster decoration was not found *in situ*, probably on account of painted decoration being applied at a height above that to which the walls survived. However, two small fragments of plaster bearing painted decoration were evidence of what may have been extensive interior decoration. One piece, recovered from the lower silt build-up layers at the east end of the northern aisle had strong orange, yellow and red colours applied over the white plaster (SF:2445). The other piece, recovered from silt build-up layers in the southern room bore a representation of a human eye (SF:2457) (Plate 3). The eye measured approximately 30mm across, the correct scale for a life-sized representation of a saint or other holy figure.

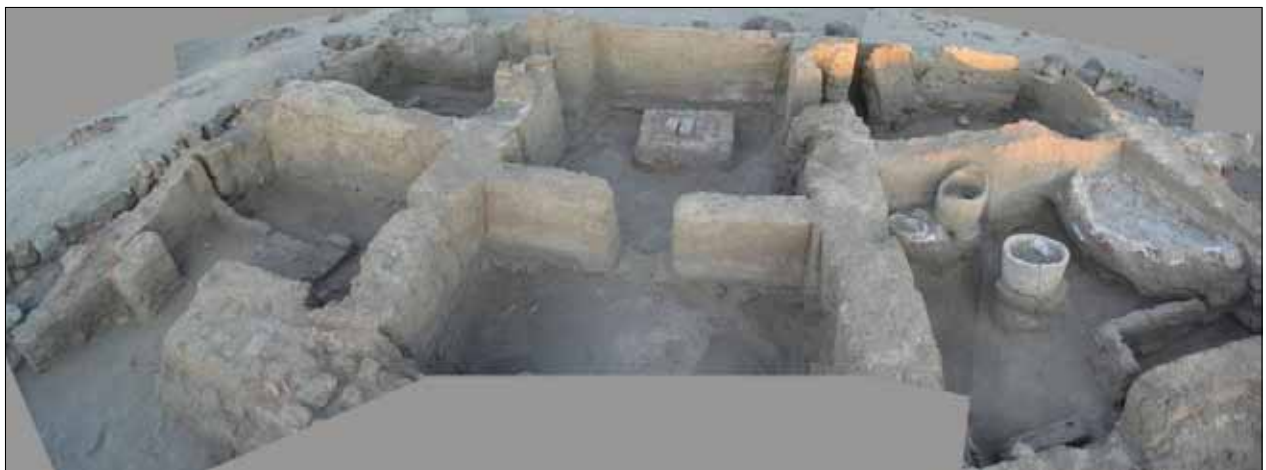
Plate 4. The interior of the church, looking east.

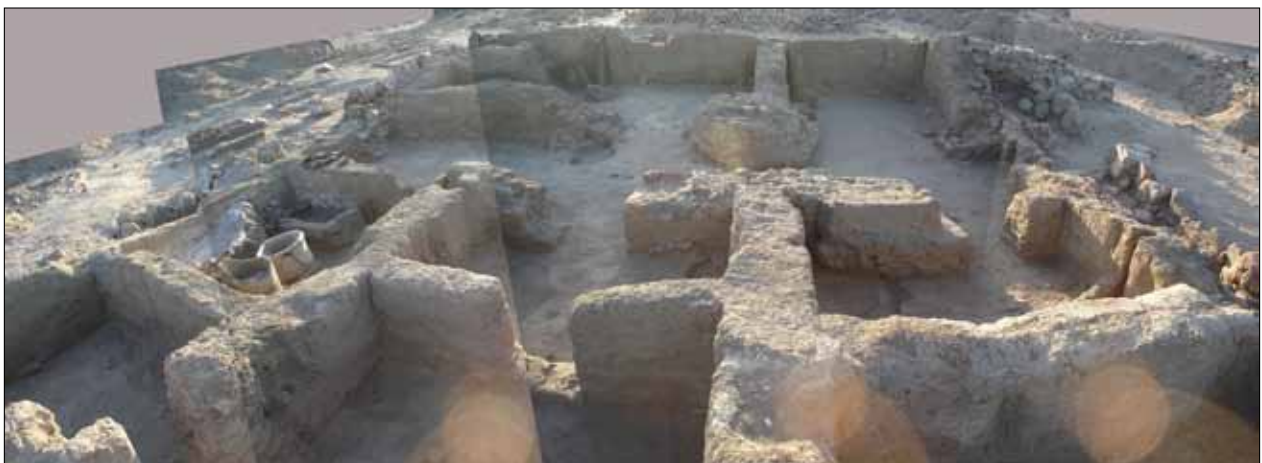
Plate 5. The interior of the church, looking west.

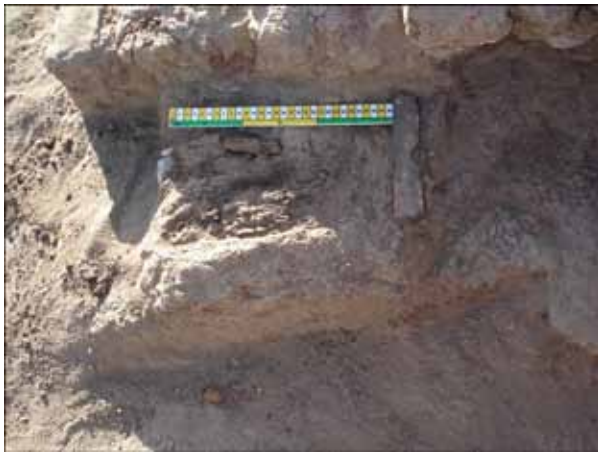
Plate 6. Iron hinge (SF:246) and disintegrated wood comprising the remains of the north entrance's door.

The building was entered via doorways in its northern and southern walls. The entrances were positioned slightly to the west of centre of these walls. The northern entrance led into the north aisle, central to that aisle's east-west axis. The southern entrance led into the much smaller south aisle, its position opposing the north entrance. Both doorways were 1m in width, their original heights obviously being unknown. Their original thresholds were not preserved due to later modifications/repairs. The sides to the entrances were lined with red bricks, in common with the outer faces of the main walls. No remains of the original door jambs or sockets were present. However, remnants from an original door (Plate 6) survived buried under the later modifications made to the north entrance. This was composed of an iron hinge (SF:246) and a parallel length of disintegrated wood. The door must have

been attached to a wooden jamb set against the western side of the entrance. It was in line with the inner face of the north wall. It is not known if this was part of a single leaf door or if the door was of two leaves. Although no door remains were present at the east side of the entrance, the entrance width of 1m is approaching a size where two doors may have been used.

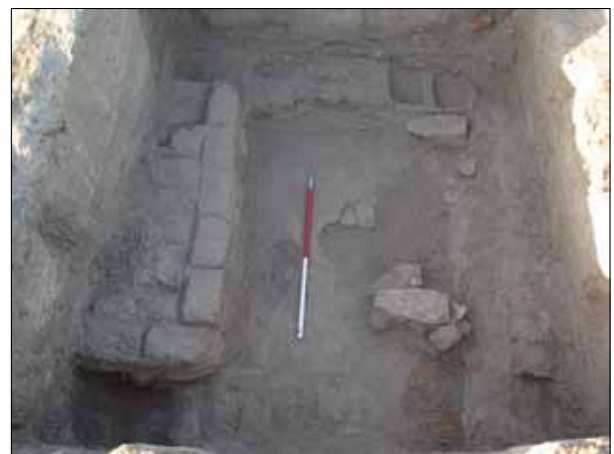
Plate 7. North sacristy interior with later phase mastaba (1062). Note the staining on the bricks near the south-eastern corner of the room.

north-south by 2.5m east-west (Figure 6, Plate 7). Immediately to the north of its entrance was a single line of bricks. As the tops of these bricks were flush with the mud-floor surface, their purpose was unclear. It is probable that they had an apportioned wall (1184), being the base of an east-west wall which was later moved due to a design change made to the eastern end of the church. The remnants of wall (1184) within this room seem to have performed some function. They were above the level of the floor surface and protruded to a maximum of 500mm into the room from its eastern wall. White plaster present on the outer faces of the lowest course of bricks indicated that the wall remains had seemingly been incorporated in a mastaba construction. This structural feature was mirrored by bricks (1168) laid as headers in a single row against the western wall of this room. The northern wall of the room was also provided with a row bricks laid as headers (1169), the room therefore, having mastaba against three of its sides. These mastaba survived to a maximum

In the south-east corner of the room, on the red bricks flush with the mud floor was an area where the bricks had been stained. This staining occurred over an area 300mm in diameter and was seemingly caused by some sort of oil or incense. This can be compared with similar deposits noted elsewhere formed by the dripping of an incense burner or oil lamp over a long length of time.

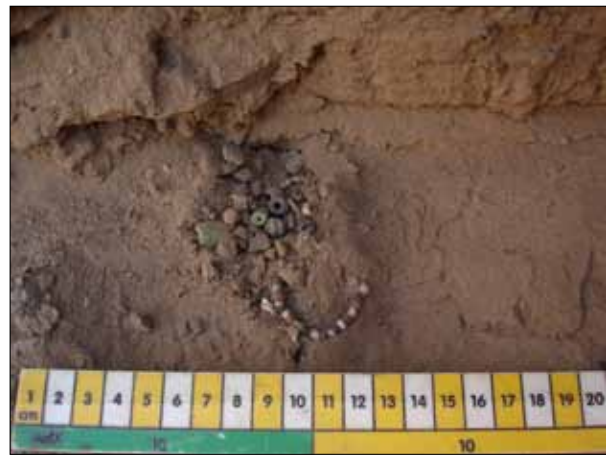
Plate 8. Assemblage of beads (SF:2506, 2507) deposited at the foot of the eastern wall of the south sacristy.

Deposited at the foot of the eastern wall of this room, midway along its length, was a collection of beads (SF:2506, 2507) (Plate 8). This assemblage, of over 200 beads, contained many different types made from a variety of materials. A large number were still strung on the preserved string of the necklace(s) they comprised. Their quality and obvious worth imply that the deposition of them may have been an intentional act akin to making a foundation deposit rather than them simply being lost. A not too dissimilar foundation deposit was found beneath the flooring in Church ED at Old Dongola. This was a jar which contained 100 beads (Jakobielski and Medeksza 1990, 170).

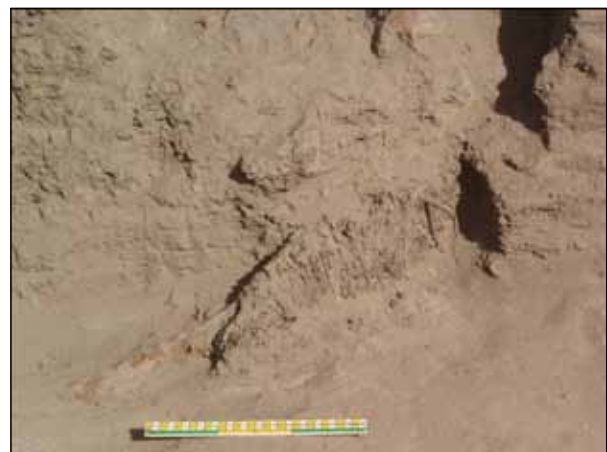
Plate 9. Door remains (SF:2522).

Remains of a door survived buried under later modifications made to the entrance of this room. This was composed of an iron hinge (SF:2522) and a parallel length of disintegrated wood (Figure 4, Plates 9 and 10). The door had seemingly been attached to a jamb set within the rebate on the western side of the entrance. The iron hinge was 750mm in length and will have extended across the entire width of the single door of the entrance. The door remains had been left in a partially opened position. It

seems that when the door was replaced, the bottom part of it was simply left *in situ*. Perhaps immediately after the majority of this door had been removed, the remaining part had been built over with mud bricks forming a raised threshold.

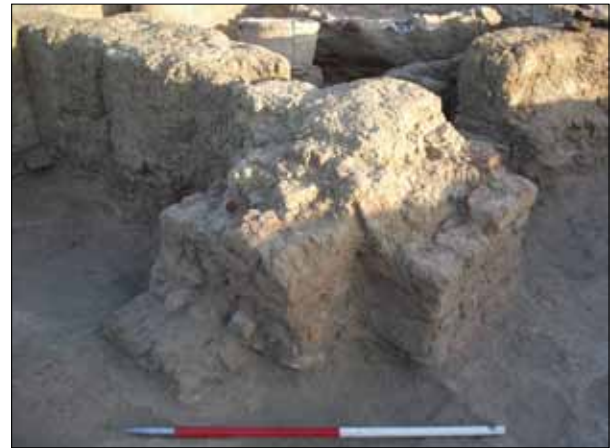
Plate 11. South-eastern pier (1143).

In the centre of the church were four piers which, with their adjoined walls, formed the northern and southern limits of the nave. Their cores were of mud bricks and their outer faces were made of red bricks. Their nature and shape imply that they were designed to support arches running between them. The 'L'-shaped southern piers (1143) (Plate 11) and (1144) supported a brick arch running from one to the other as well as arches running to the two northern piers. The northern piers (1145) (Plate 12) and (1147) were 'T'-shaped, indicating that as well as an arch running between them and arches running to the southern piers, they supported arches running to the north wall. The northern responds to these north arches are represented by the north wall in those places having its interior face constructed of red bricks (Plate 13). The average span of the central arches was 1.8m and the span of the two northern arches averaged 2.3m. Using the pier bases as a guide, the arches had widths of 600mm. The preservation of the piers ranged from three to eight courses or 300mm to 800mm in height. With arches spanning the central area of the nave, it is probable that they supported a central cupola. The two arches over the northern aisle perhaps aided the support of its roof. A roof across the southern side of the church would have obtained structural support from the internal walls it rested upon.

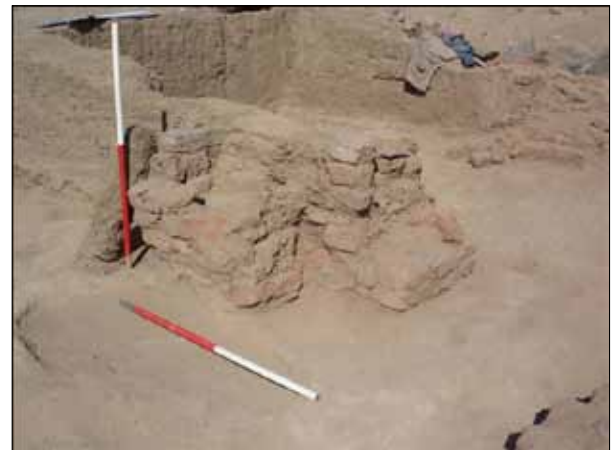
Plate 12. North-western pier (1145).

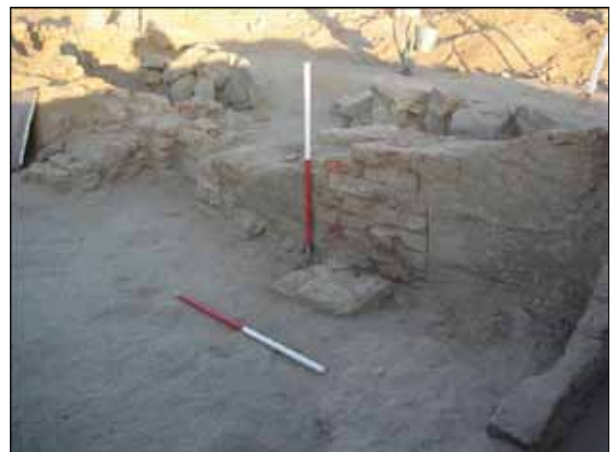
Plate 13. The fired-brick respond to the north-eastern arch. Note the lowest course of the (removed) later mud-brick reinforcement (1186) abutting the respond.

church (Figure 10). Construction (1186) associated with the north-eastern respond was 600mm east-west and 400mm north-south, it survived to seven courses (600mm) in height. The north-western respond's construction (1200) was the same dimensions in plan but survived to only two courses height. These constructions had been built onto the same sand/silt horizon as the original church and were formed of the same standard size of brick ($300 \times 150 \times 70\text{mm}$). This therefore implies that these constructions were contemporary with the original church construction (phase I) and had been part of the responds to the northern arches. However, with the outer faces of the piers and seemingly the arches also being of red brick, it is debateable as to why these would be constructed of mud brick if they were part of the original building phase. Also, these constructions had not been bonded into the northern wall but simply abutted it. Therefore (1186) and (1200) may represent either an alteration/amendment to

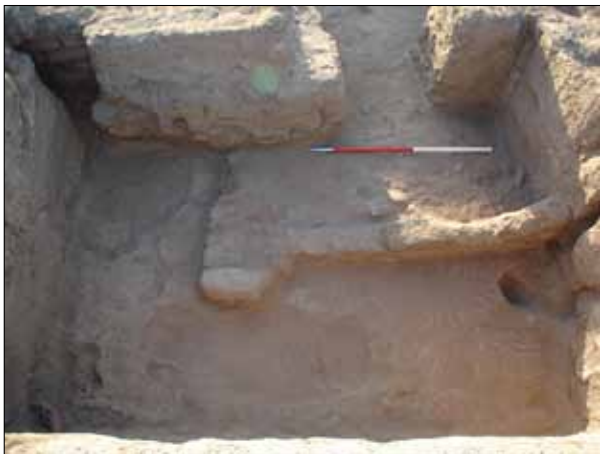
Plate 14. The eastern end of the northern aisle with partition wall (1112). The wall in the background dates to a later phase.

east-west was 8.1m and its width was 2.7m. As mentioned previously, the only opening from the north aisle into the nave was between the two piers. As such, that aisle would have afforded limited visibility of the central area of the church to any persons within it. The only original features within the northern aisle were a small partition wall (1112) and a vertical wall slot. The partition wall was located 1m west of the eastern end of the aisle (Plate 14). It was orientated north-south and abutted the

northern wall of the aisle. It was made from a single row of mud-brick stretchers giving a width of 150mm. It had a length of 1.95m and a maximum surviving height of 350mm (four courses) where it abutted the northern wall of the aisle. At its southern end it had a width of 550mm, its terminus seemingly being formed as a small buttress to provide support to the wall. This would suggest that the wall originally attained a greater height than that which was observed. Small walls of similar form to this have been noted in the east ends of the north aisles in several churches excavated in Nubia. They have been interpreted as screen walls enclosing a vestibule and providing a screened passage to the north-eastern corner room, which in those cases were entered from the north aisle (Adams 1965, 97). However, in the case of the Mis church, the north-eastern corner room was entered via the sanctuary chamber, so that interpretation cannot be applied in this instance. It is, therefore, unclear as to what the function of this wall could have been. A single example of a comparable church is the Kidinkoing Church at Sonqi East (Maystre 1980).

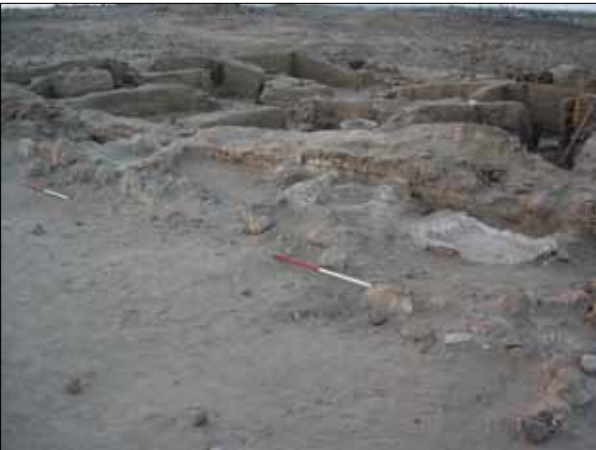
Plate 29. The external plaster basins.

The space bounded by the inner face of the rock perimeter and the outer face of the southern church wall eastwards of the entrance contained four plaster basins (Plate 29, Figure 19). These were all constructed in the same manner, broken red bricks were arranged to create the required

basin shape over which a thick layer of hard white lime plaster was then applied. The broken bricks may have been left over from the building of the church or from the construction of grave monuments rather than derived from an episode of church collapse. All of the basins bar one were broken, it is probable that only one or two basins were functioning at any one time, with replacements being made as required.

The earliest basin was (1054). It was built on 200mm of silt/sand deposits (1100/1160) suggesting it was broadly contemporary with the rock perimeter. The interior of the basin was a well defined rectangular shape measuring 720mm north-south by 850mm east-west, its depth was 120mm. The south-eastern corner of the basin was missing. This basin differed from the other three in that it was not built against the wall of the church, and it differed in orientation from the church wall.

its south-eastern corner missing. The basin interior was a sub-rectangular shape measuring 850mm north-south by 750mm east-west, its depth was 200mm. The only intact example was (1053), this was sub-oval in shape with internal dimensions of 1.05m north-south, 620mm east-west and 140mm deep. Built against (1053) was basin (1033). This was a narrow rectangular shape; a large part of its western side was missing. Its internal dimensions were 1.12m north-south, 410mm east-west and 200mm deep.

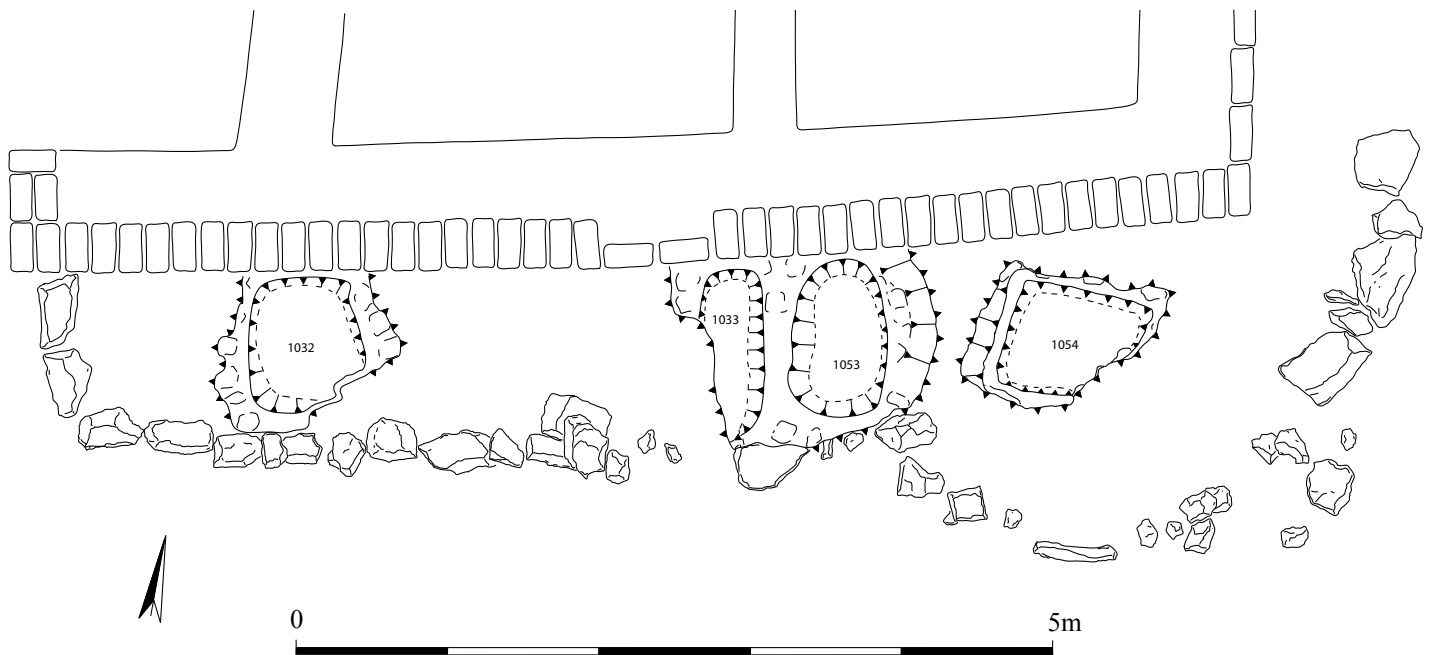
Figure 19. Location plan of the external plaster basins (scale 1:50).

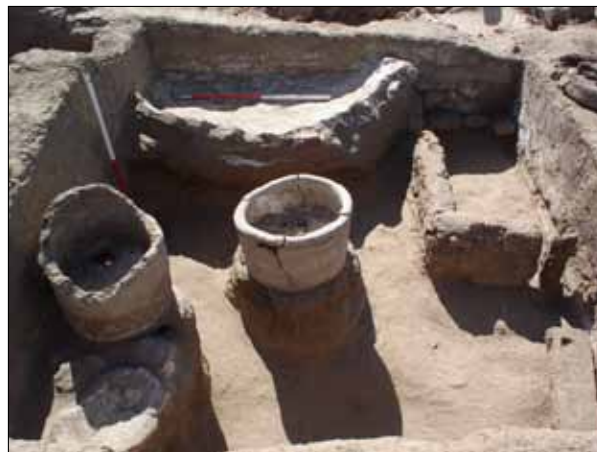
Plate 31. The southern room interior, looking south.
Note the earlier mud-brick installation (1058) and the section of door frame (1079).

The southern room contained a number of installations that had been placed on the build-up deposits within it (Plate 31). The installations were placed at various levels, reflecting the thickness of the deposits underlying them. With those deposits not changing in composition or characteristics, their nature of deposition must have been the same. The differences in elevations of the installations indicates a continuing use of the room as it gradually filled with wind-blown deposits.

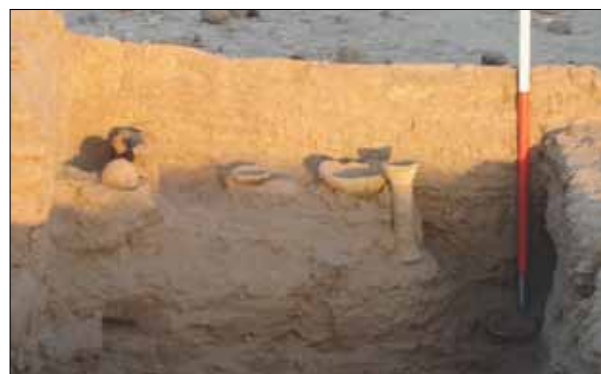
Plate 32. Ceramic assemblage within the eastern end of the sanctuary chamber.

Within the sanctuary chamber, at a similar stratigraphic level to the vessels within the *diaconicon* was a single crudely-made cup (1073) (Plate 32). This had been placed against the eastern wall of the room on 400mm of build-up deposits. What remained of the altar had been buried by the build-up deposits by the time this cup was placed into its location. After an accumulation of a further 300mm of wind-blown deposits, a ceramic pedestal/cup stand (1072D) was placed next to the eastern wall of the room. While that remained *in situ*, a further 200mm of wind-blown deposits accumulated around it. Onto these further deposits and in the vicinity of the pedestal, a crudely-made bowl (1072C) and a lamp (1072B) were placed upright

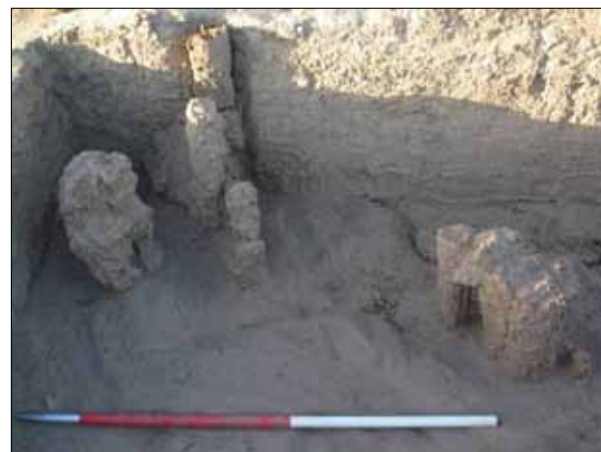
Plate 33. Wooden stakes and posts (1195) within the north-western corner of the sanctuary chamber.

Further wooden stakes and posts (1195) were present in the north-western corner of the sanctuary chamber (Plate 33). There were six in total and their dimensions ranged from 80-190mm, they survived to an average height of 300mm. Similar to the ceramic vessels, they had been put in place after a build up of wind-blown deposits had accumulated. Their stratigraphic levels were similar to the earlier cup (1073) and so, therefore, predated the two stakes in the north-eastern corner of the room. No obvious explanation for their location here is evident.

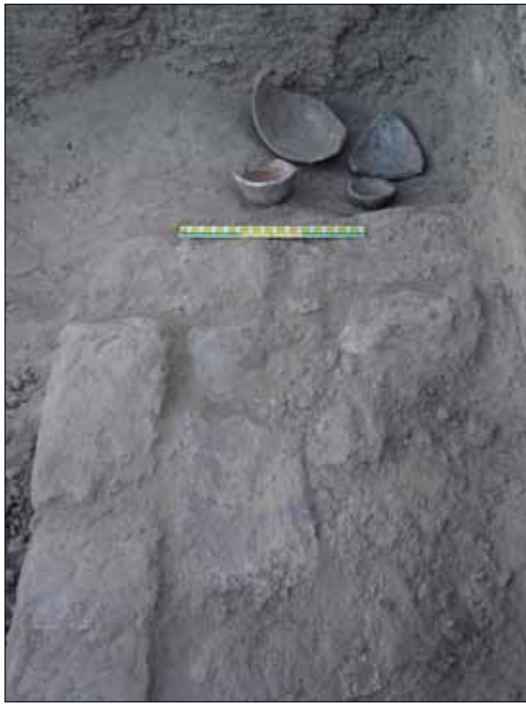
Plate 34. Ceramic assemblage in the south-western corner of the northern sacristy. The top of mastaba (1062) is visible in the foreground.

upside down onto 200mm of build-up deposits. After an accumulation of a further 100mm of wind-blown deposits, two vessels and two large potsherds were placed in the south-western corner of the room (Plate 34). One vessel was a ceramic cup with painted decoration (1080A) and was placed upright. The other vessel was the base of a rather crude mud bowl (1080B) also placed upright. The two large potsherds had been placed in such a way as to provide concave surfaces akin to bowls. After a further 100mm of wind-blown deposits accumulated, the *mastaba* (1062) had become completely buried. Onto these build-up layers, four vessels were placed within the northern side of the room. Cup (1097A) had been placed upright next to the western wall of the room. The other three vessels had been placed upside down, they were a small bowl (1097B) which had a slot cut into its rim so may

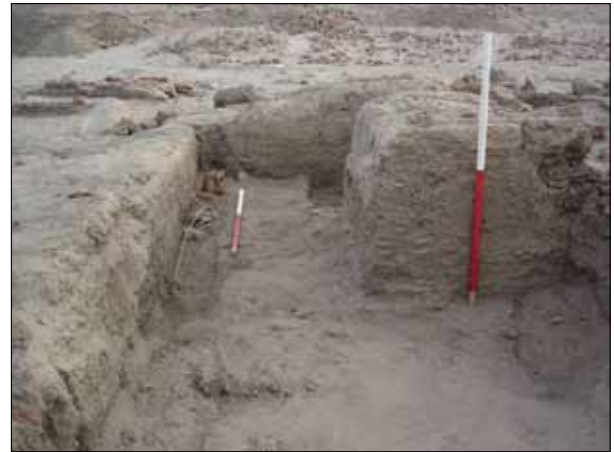
Plate 35. Burial 222, cut into the wind-blown deposits within the south-western corner of the building.

Grave 1203 (Burial 222) [Skeleton (1050), Grave cut L: 2.13m, W: 300mm, Depth: 400mm. Monument – none] A long narrow grave cut, the sides were straight and vertical, the ends were rounded. It was cut against the western side of the wall running from the southern entrance to the south-western pier (Plate 35). Into this grave cut, the body of an adult was laid on its right side with the head facing east (Figure 23). The body was orientated with the head to the south and the feet to the north. The right arm was under the body and the left arm was along the side of the torso. Post burial, this grave had suffered disturbance. The skull and mandible had been dislodged from their original positions. The legs had been truncated below the knee. No grave monument was present, so the original depth of the grave cut was not known.
SF - bone 2440
